Microphone cover for in vehicle voice control present during vehicle delivery

| Topic number | LI82.70-P-078425 |
| Function group | 82.70 - Telephone, Voice-control-system(VCS) |

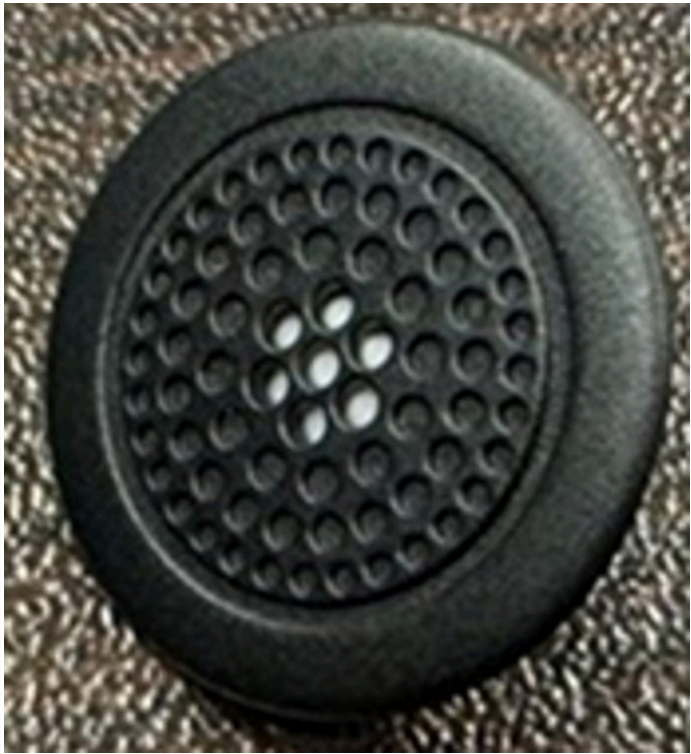
| Attachments | |
|---|---|
| Microphone cover Top.jpg | Figure A |

White plastic insert present on microphone assembly. See figure A for example.

The insert (breathable filter) is designed to be inside for dust protection and air flow control.

Do not remove the breathable filter from the microphone assembly. This part is designed to be in the microphone and should remain in the vehicle.
