SC321 (Rev 1, 09/27/2024)

2019-2022MY  
Niro EV (DE EV)

SUBJECT:  
IEB INSPECTION AND WATER PROOFING  
OR IEB REPLACEMENT (SC321)

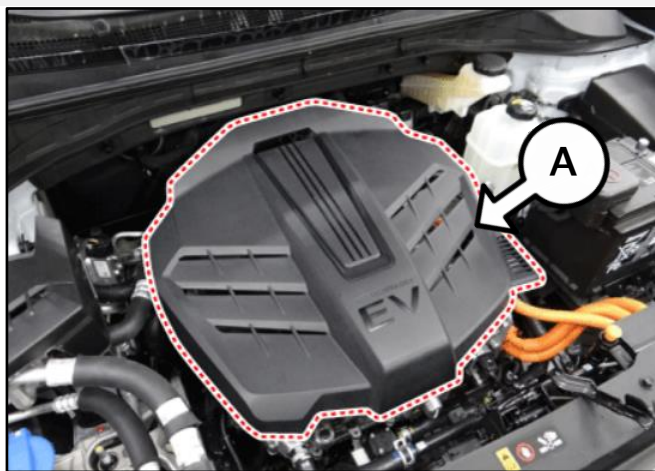
1. Remove the power electric cover (A).
