GROUP	MODEL
TRA	All Models with ISG/EOP
NUMBER	DATE
113	September 2024

TECHNICAL SERVICE BULLETIN

SUBJECT: **PRECAUTIONS FOR TRANSMISSIONS WITH ISG/EOP**

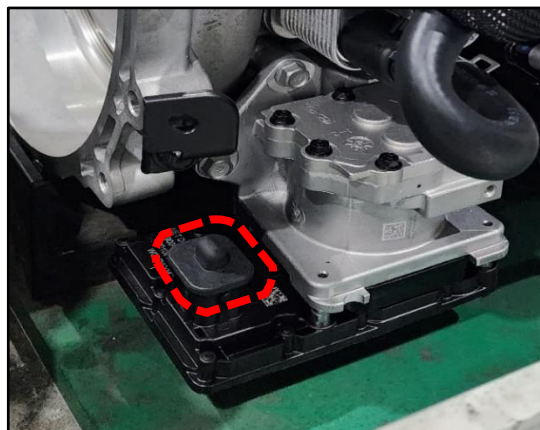
Note: EOPs for other models may not be identical to the one shown below. Refer to KGIS for the applicable EOP for the model vehicle you are working on.

(EOP cover sample pictured above)

1. Clean the HF EOP connector using shop air to remove any oil, coolant, or debris.
2. Cover the connector using non-residue tape or plastic covering.
3. Confirm the HF EOP remains covered/protected anytime the connector has been removed.
4. Confirm that the connector is also covered/protected while the vehicle is being serviced.
