Technical Service Bulletin (TSB)  
Replace K1 Clutch / Input Shaft Assembly

<b>REFERENCE:</b>	TSB: 21-051-24 GROUP: 21 - Transmission and Transfer Case	<b>Date:</b>	September 27, 2024	<b>REVISION:</b>	21-002-23 REV. B
<b>VEHICLES AFFECTED:</b>	<p>2019 - 2023 (DD) RAM 3500 Cab Chassis          2019 - 2023 (DP) RAM 4500/5500 Cab Chassis          2019 - 2023 (D2) RAM 3500 Pickup</p> <p>This bulletin applies to vehicles built on or before December 01, 2022 (MDH 1201XX) equipped with a 6SPD Auto Aisin AS69RC HD Transmission (Sales Code DF2) or a 6SPD Auto Aisin AS66RCHD Trans (Sales Code DF3).</p> <p>For 2019 - 2021 MY vehicles, this Technical Service Bulletin (TSB) only applies to vehicles that have had a complete NEW transmission replaced between 02/01/2022 and 12/18/2022.</p>				<b>MARKET APPLICABILITY:</b>
<b>CUSTOMER SYMPTOM:</b>	<p>Customers must experience a Malfunction Indicator Lamp (MIL) illumination and the vehicle must exhibit/set the following Diagnostic Trouble Code (DTC):</p> <ul style="list-style-type: none"> <li>• P0731-00 - Gear 1 Shift Incorrect Ratio (This DTC will set during a key cycle and shifting into Drive).</li> </ul> <p>Customers may also comment on the follo

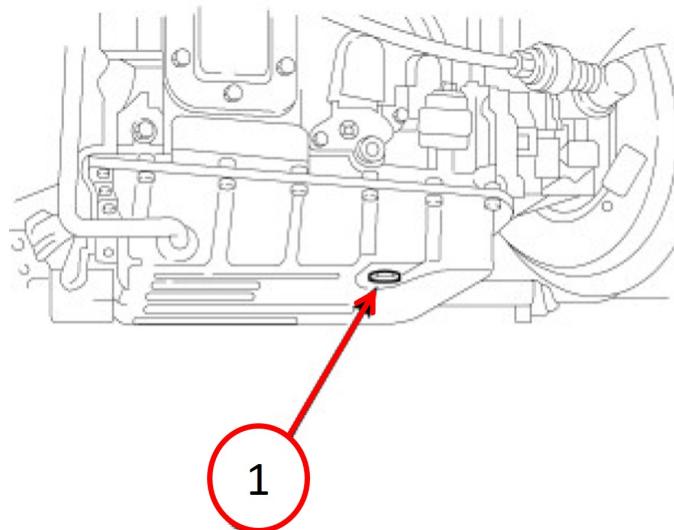
**Fig. 1**  
Oil Pan Drain Plug

4. Remove oil pan drain plug [Fig. 1](#) and drain fluid from transmission pan. **DISCARD** the drain plug gasket.

1 - Transmission Oil Drain Plug

34. Using a **NEW** gasket, install the transmission oil pan drain plug [Fig. 1](#).

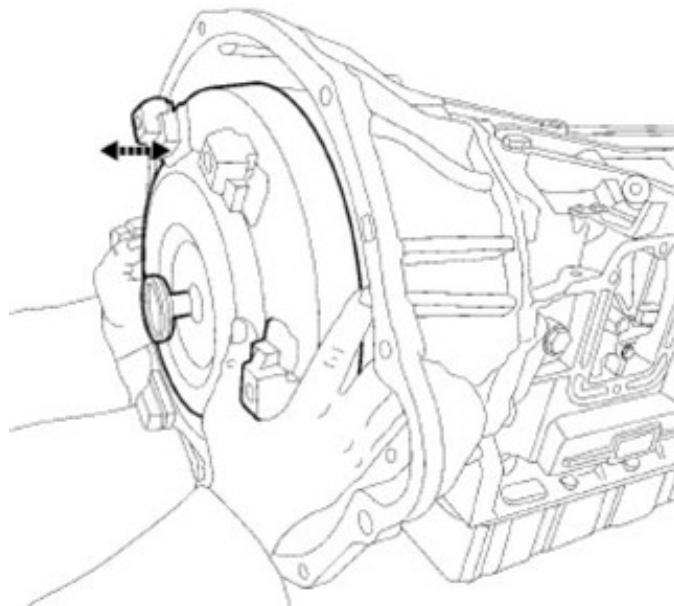
**Fig. 2**  
Removing Torque Converter

5. Remove the torque converter from the transmission [Fig. 2](#).

32. Install the torque converter onto the input shaft while applying inward pressure and rotating back and forth at the same time in order to align the input shaft splines and the two teeth on the oil pump drive gear [Fig. 2](#).

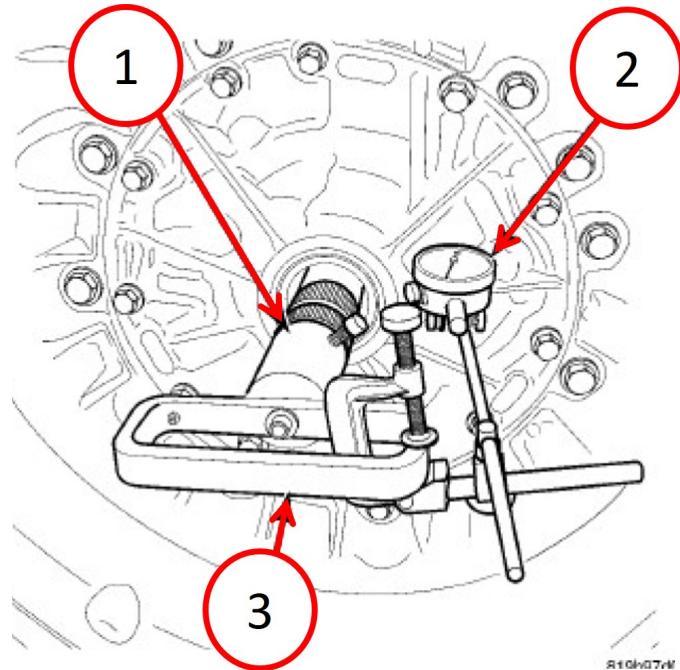
**Fig. 3**  
Recording The Input Shaft End-Play

**NOTE: Gear train end play is a critical pre-disassembly check to help determine the condition of the transmission. An end play reading greater than specification (larger gap) indicates that a bearing or thrust plate is either missing, worn or has disintegrated, in which case there will be debris found in the transmission oil pan.**

6. Using special tools Adapter Socket, End Play 8266-22 and the handle from End-Play Tool Set 8266B and Dial Indicator C-3339A, measure and record the input shaft end-play [Fig 3](#).

1 - 8266-22  
2 - 8266B  
3 - C-3339A

25. Install the Dial Indicator Set C-3339A with Input Shaft Spline Socket, End Play 8266-22 and Handle 8266-8, to check the input shaft end-play clearance. The input shaft end-play clearance for both 2WD and 4WD is 0.50 - 0.90 mm (0.019 - 0.035 in.). **If the clearance is not within tolerance you must choose the correct selectable thrust bearing race.**

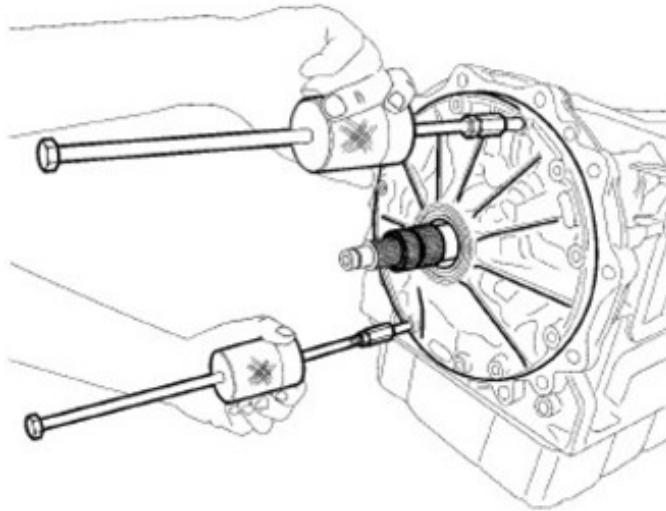
**Fig. 5**  
Slide Hammers C-3752 And 9981 Adapters

8. Remove the bolts securing the oil pump to the transmission case and use Slide Hammers C-3752 with Adapters 9981 to remove the oil pump assemble from the transmission spline [Fig. 5](#).

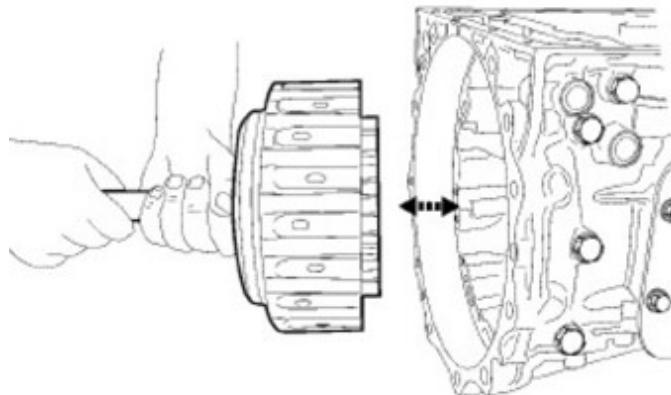
**Fig. 6**  
K1 And K2 Clutch Assemblies

9. Remove the input shaft assembly with the K1 and K2 clutch assemblies attached [Fig. 6](#).

**NOTE: If the K1 snap ring has become dislodged, the K1 clutch assembly will not come out as a complete unit.**

20. Install the K2 clutch assembly and the K1 clutch/input shaft assembly into the transmission case [Fig. 6](#).

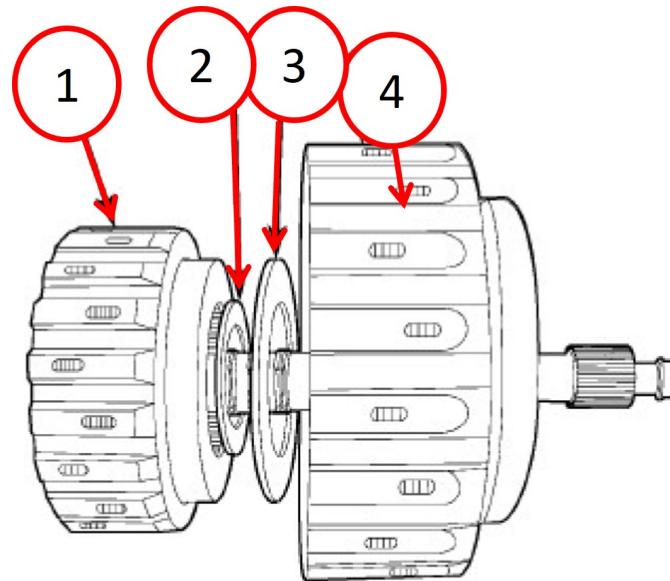
**Fig. 7**  
K1 And K2 Clutch Assemblies

10. Remove the K2 clutch assembly and the selectable input shaft end-play thrust bearing number one and thrust washer from the K1 clutch/input shaft assembly [Fig. 7](#).

1 - K1 Clutch/Input Shaft Assembly

2 - Thrust Bearing Number One

3 - Thrust Washer

4 - K2 Clutch Assembly

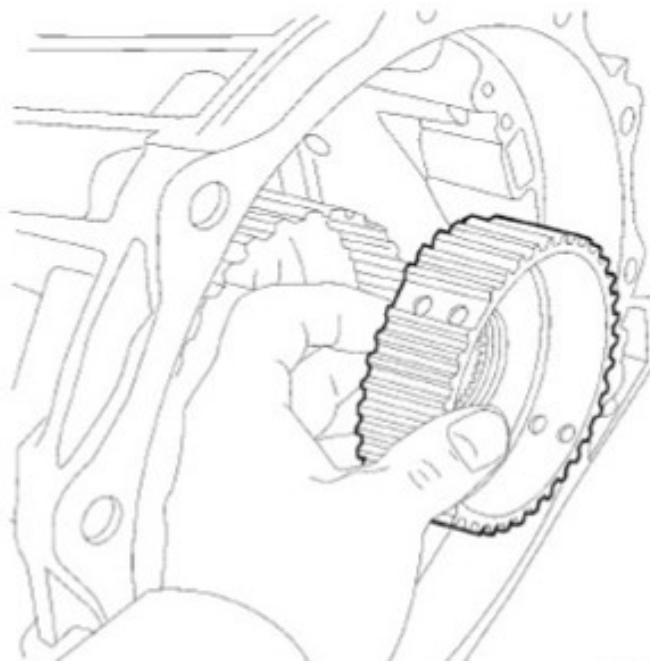
**Fig. 8**  
K1 Clutch Hub

11. Remove and inspect the K1 clutch hub [Fig. 8](#) and [Fig. 9](#). **Replace only if needed.**

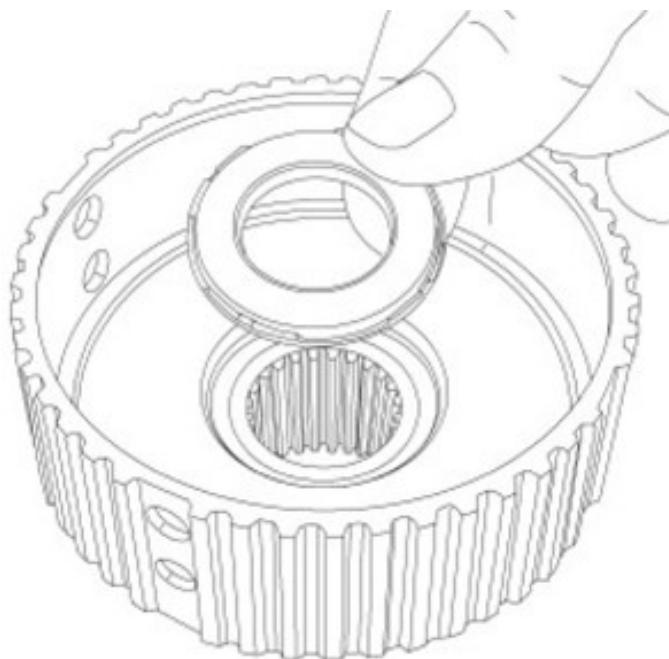
**Fig. 9**  
K1 Thrust Bearing Number Two

12. Remove and inspect the K1 thrust bearing number two [Fig. 10](#). **Replace only if needed.**

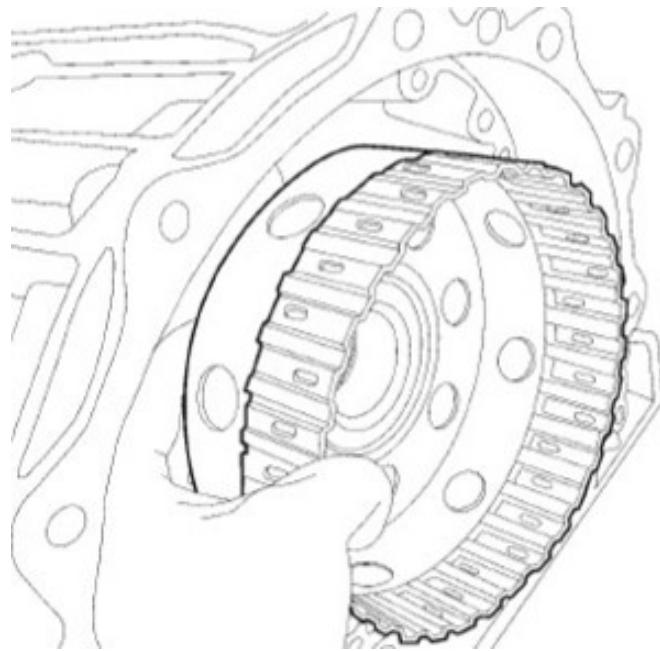
**Fig. 10**  
K2 Clutch Hub

13. Remove and inspect the K2 clutch hub [Fig. 11](#). **Replace only if needed.**

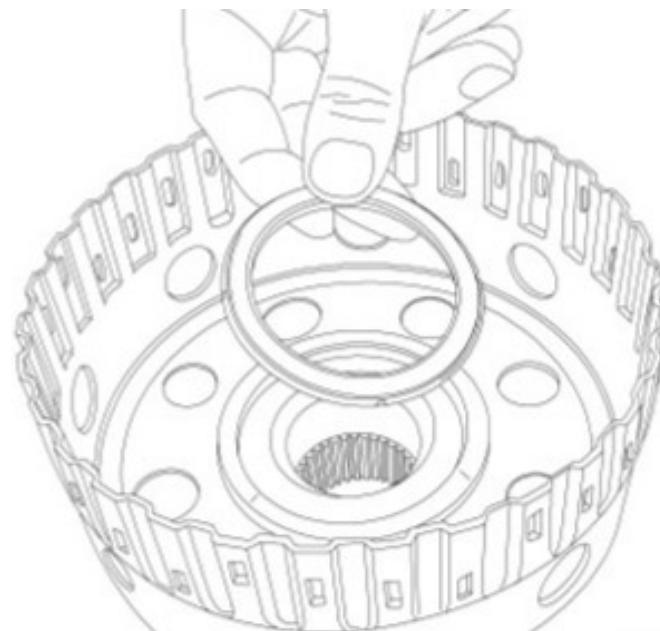
**Fig. 11**  
K2 Hub Thrust Bearing Number Three

15. Lubricate with trans gel or petroleum jelly and install K2 thrust bearing number three [Fig. 12](#).

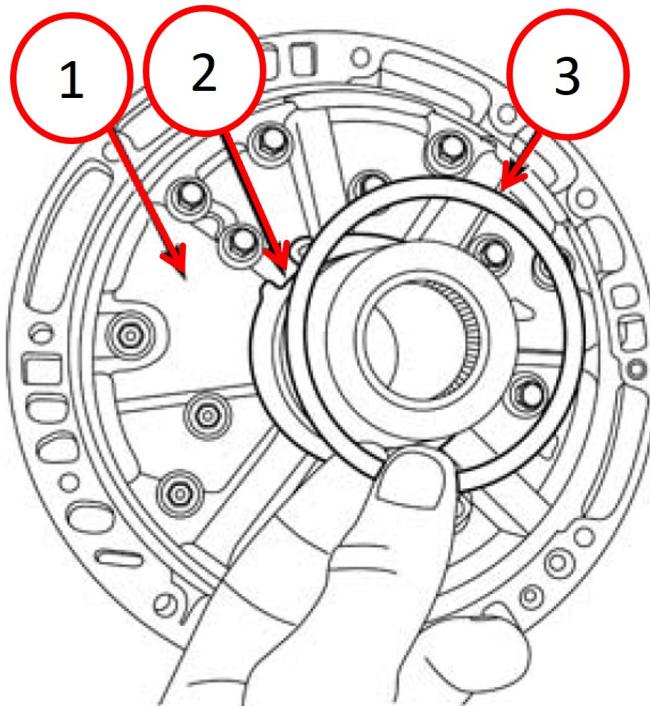
**Fig. 12**  
Oil Pump Assembly

21. Lubricate with trans gel or petroleum jelly and install the nylon thrust washer onto the oil pump [Fig. 12](#).

**NOTE: The nylon thrust washer is keyed to the oil pump [Fig. 12](#).**

**NOTE: Two pin punches inserted through the oil pump mounting holes will aid in the installation of the oil pump [Fig. 12](#).**

- 1 - Oil Pump
- 2 - Nylon Thrust Washer
- 3 - Input Shaft Seal Ring

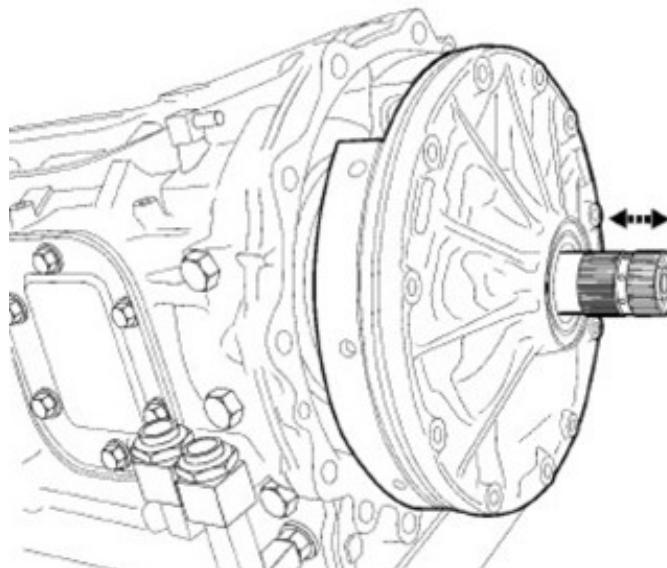
**Fig. 13**  
Oil Pump Assembly On Transmission Spline Shaft

23. Install the oil pump with a **NEW** gasket onto the transmission case [Fig. 13](#).

24. Apply a light coating of MOPAR thread sealant onto the oil pump bolts and install the bolts. Tighten the bolts in a crisscross pattern to 21 N·m (15.5 ft. lbs.).
