Technical product information

Topic	Lower and/or upper front suspension lever bushes - Warranty replacement guidelines
Market area	Bentley: worldwide (2WBE), China 796 VW Import Comp. Ltd (Vico), Beijing (6796)
Brand	Bentley
Transaction No.	2075041/1
Level	EH
Status	Approval
Release date

Bentayga Series

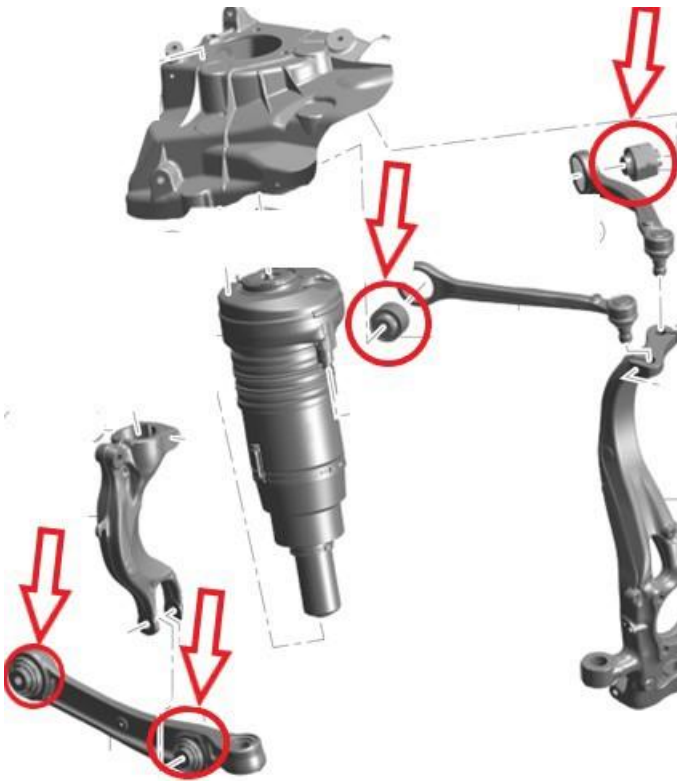
The left or right hand front lower and/or upper lever bushes (Figure 1) are exhibiting minor cracks (on inspection)

Before proceeding with replacing any of the lower and/or upper lever bushes shown in Figure 1 the operative must refer to the Technical background section of this TPI

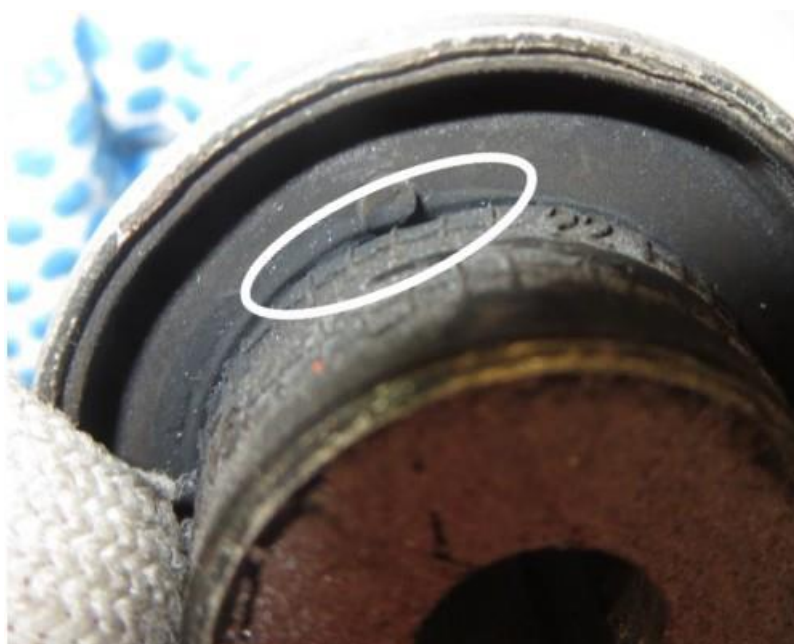
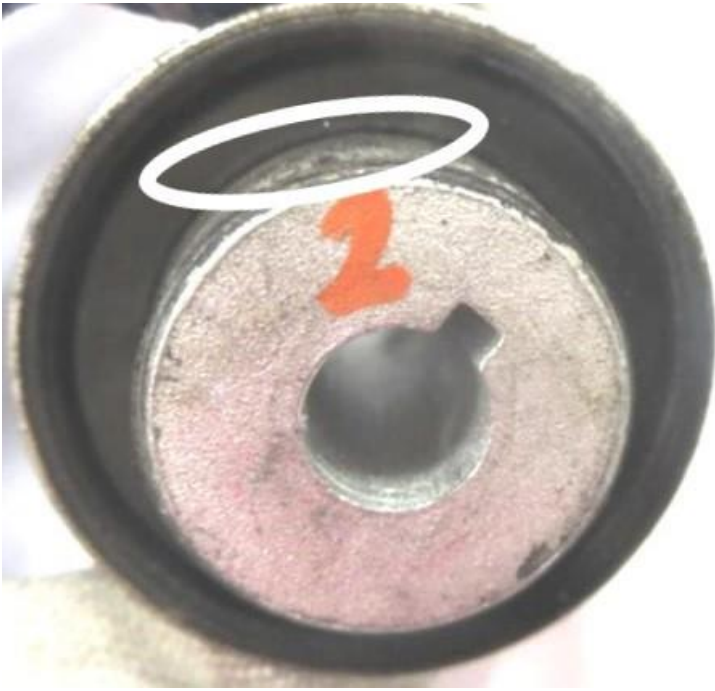
Should the bushes be in the condition shown in Figure 2 and 3 replacement is not required unless a customer complaint has been received relating to suspension noise - bush wear or overall serviceable condition

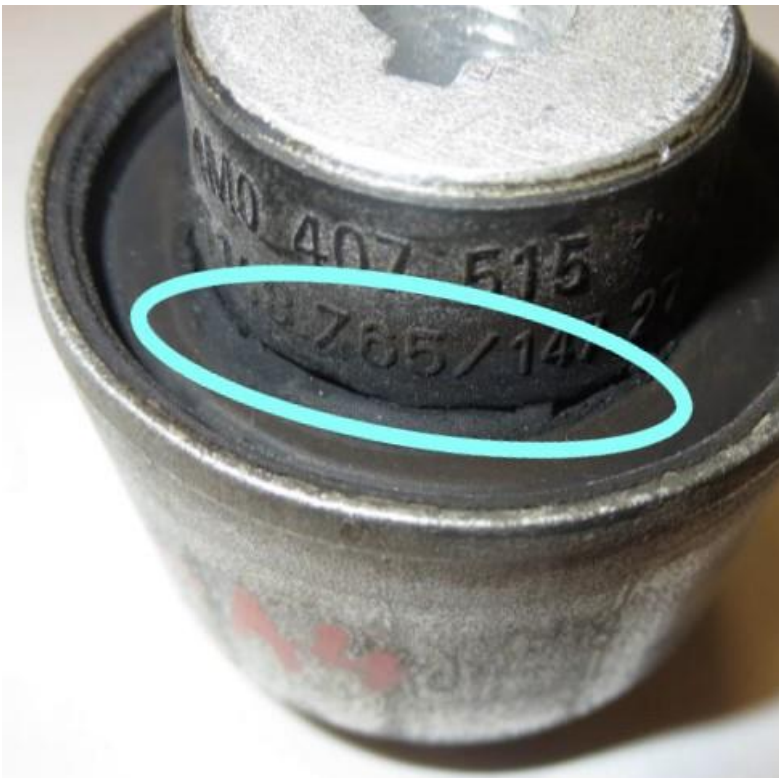
Figure 4

Should the bushes be in the condition shown in Figures 4, 5 or 6 - The bushes should be replaced as described within Rep.Gr 40

Please ensure photographs of all bushes (which require replacement) are attached to a non-technical DISS query. The warranty claim could be cancelled if the replacement criteria was not met
