Preview Solution CBR-2398-1

Volvo Chassis - HVAC Fresh Air Door Binding

Valid for Volvo models VNL,VNR,VNX,VAH,VHD model years 2017 to current

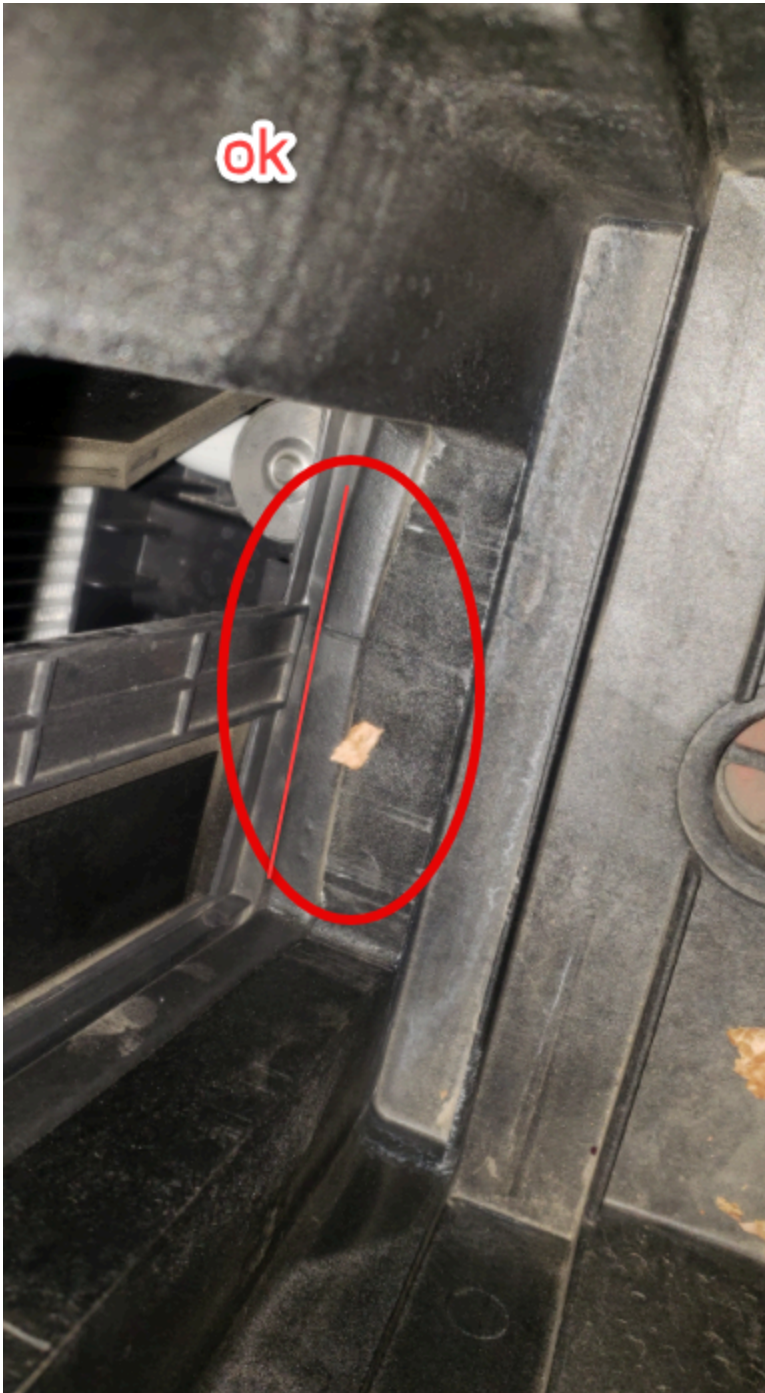
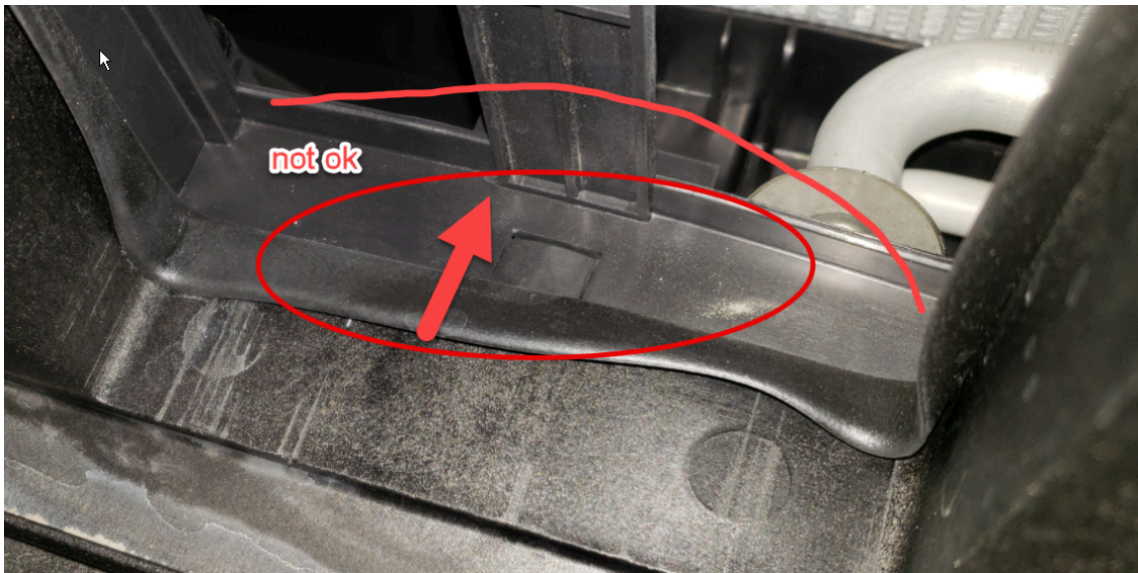
- During installation, the outer air filter housing must be perfectly aligned with the body-in-white.
- If the outer and inner boxes are not precisely aligned, the lower flange of the outer box may come into contact with the inner box's flange, causing binding and warping.

1. **Remove the Air Filter Housing** to access the HVAC filter housing.
2. **Remove the HVAC Filter Housing.**
3. **Reinstall the HVAC Filter Housing** using soapy water on the rubber seal to facilitate proper positioning and alignment.

We recommend applying soapy water to ensure the rubber seal is positioned correctly during installation, reducing the risk of binding and warping.
