## TECHNICAL SERVICE BULLETIN

### WSB-04 Midas Rear Mudflap Installation

**Tiffin Motorhomes SB# WSB-04**

**Models Involved:** 2022 – 2024 Midas Motorhomes

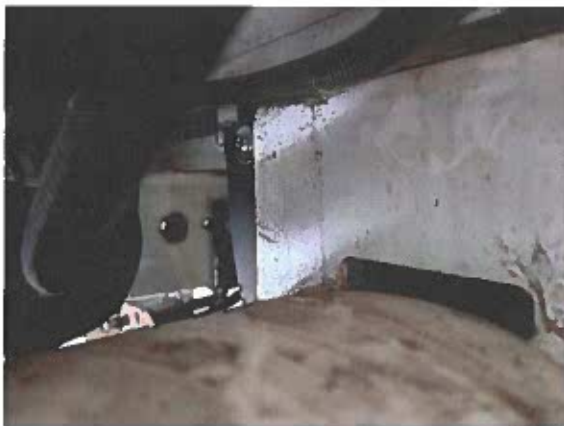
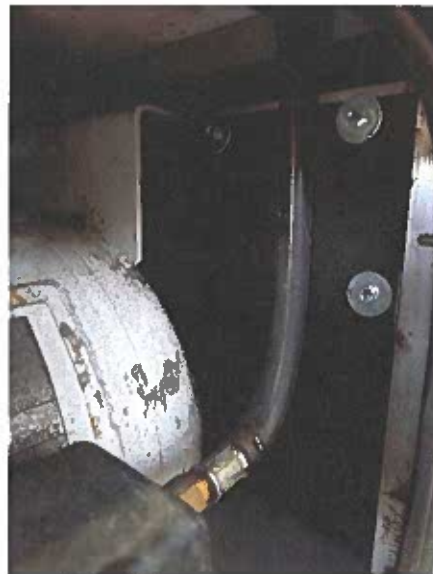
1. Lift unit by placing floor jack under rear OEM frame member allowing axle to drop for more clearance installing mud flaps.
2. Orient the mud flap so the solid side is towards ground. Note the pre-drilled holes on either side for easy alignment of fasteners. The holes will align in the vertical direction along the outer leg structure.
3. Using the drill, fasten mud flap to aluminum body structure using the screws and washers.
4. For the passenger's side, open the LP compartment located directly behind the rear wheels for easy access to the aluminum frame that should be used to fasten the mudflap.

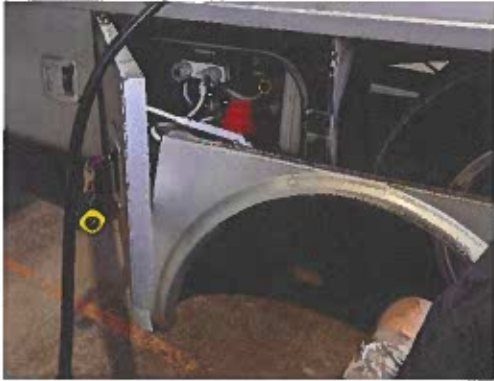
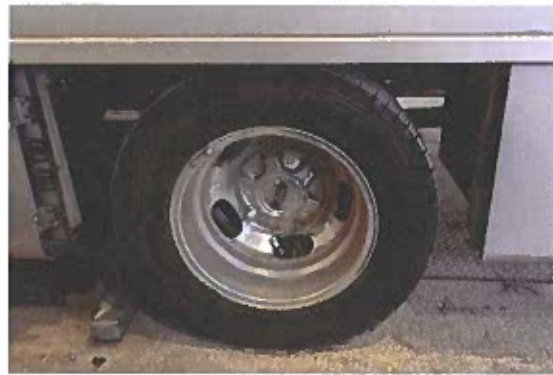
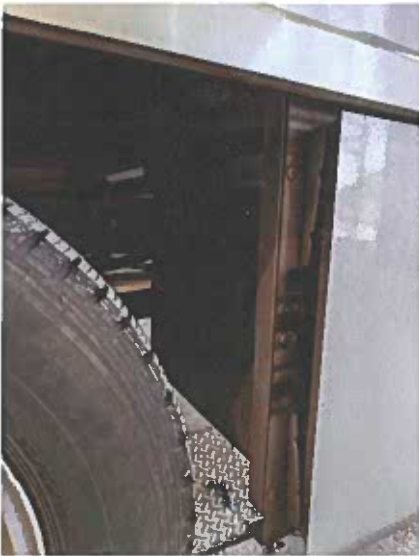
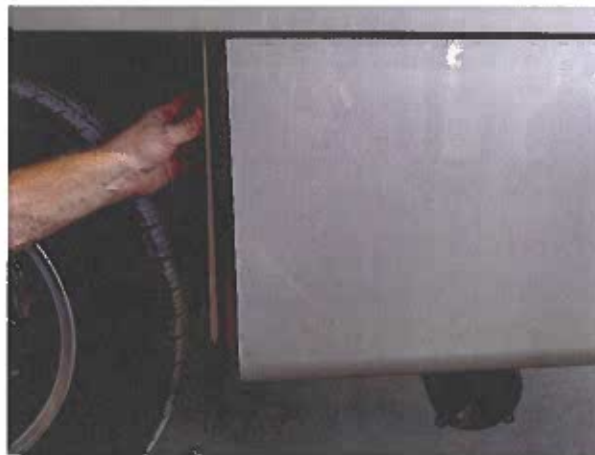
5. For the driver's side, the fiberglass fender directly above the wheel will need to be removed for access to the frame. On the MT floorplan, opening the compartment door adjacent to the fender. Locate the (4) total fender brackets that fixate the fiberglass fender to the metal underbody. Remove all fasteners and carefully uninstall the fiberglass fender to install the mudflap.
