# Technical product information

Topic	Flying B mascot clear wings replacement procedure
Market area	Bentley: worldwide (2WBE), China 796 VW Import Comp. Ltd (Vico), Beijing (6796)
Brand	Bentley
Transaction No.	2074992/2
Level	EH
Status	Approval
Release date

## New Flying Spur

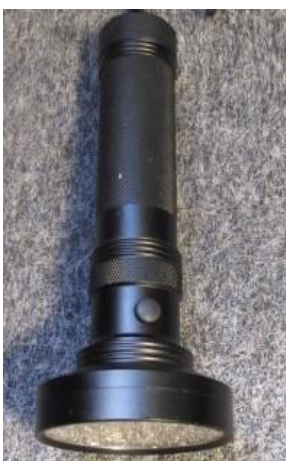
Figure 2

UV light (Figure 2) the specification must be as follows:

- Minimum power output must be 5W

### The UV Wavelength must be as follows:

- Minimum wavelength of 395nm (nanometres)
- Grey or dark brown UV safety glasses must be worn when conducting the adhesive bonding procedure
- Standard safety glasses must be worn whilst conducting all other steps other than the UV adhesive bonding procedure
- Dymax Ultra light weld 3094-GEL-REV- A - 30 ML (Figure 3)
- 3M surface cleaner or same specification

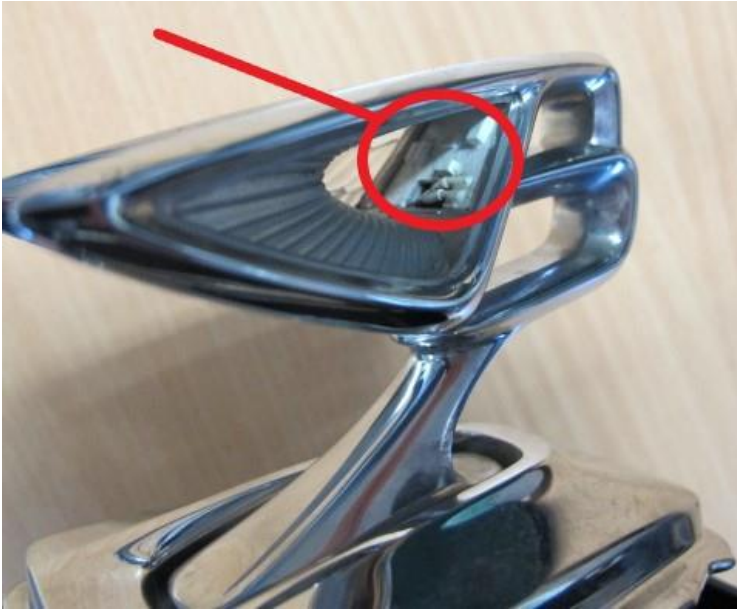
Figure 5

1) Due to the location of the LED light (Figure 5) damage can be caused to the Flying B mascot therefore it is imperative the wings are drilled at the exact location shown within Figure 6

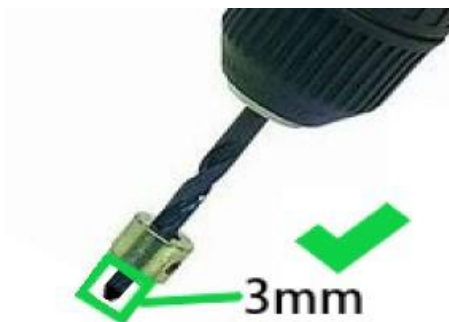
Figure 9

Hint: A standard 3mm drill bit can be used however the drill must be used in conjunction with a drill stop tool to ensure a depth of 3mm is not exceeded (Figure 9)

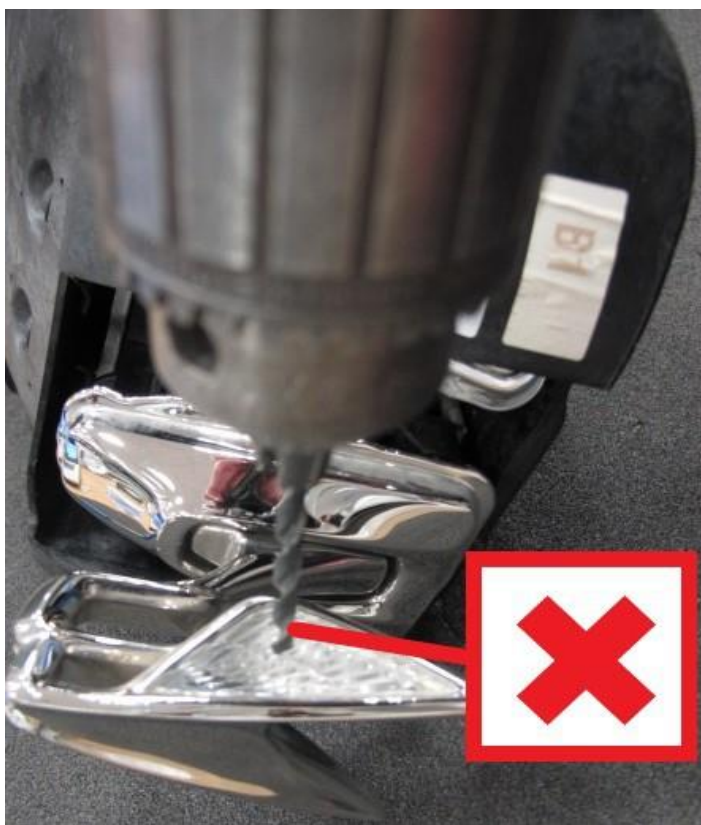
Figure 10

- Do not use a standard drill without using a drill stop as damage can easily be caused to the mascot or LED (Figure 10)

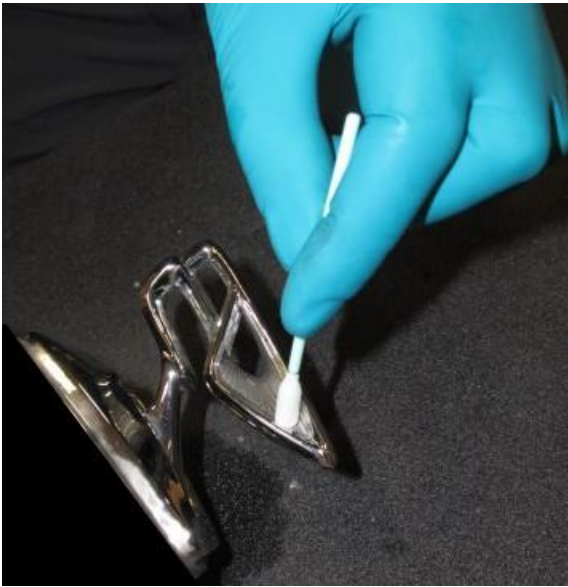
2) Referring to Figure 11 - Using foam cleaning tips in conjunction with 3M surface cleaner thoroughly clean the Flying B aperture

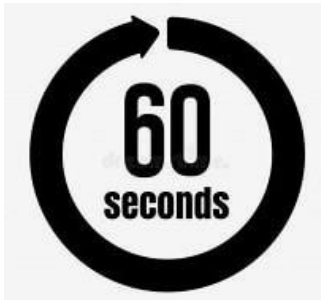
Once the adhesive has been removed using the 3M cleaner the operative should wait 60 seconds to allow the liquid to evaporate

3) Check to confirm that no traces of the original adhesive are evident

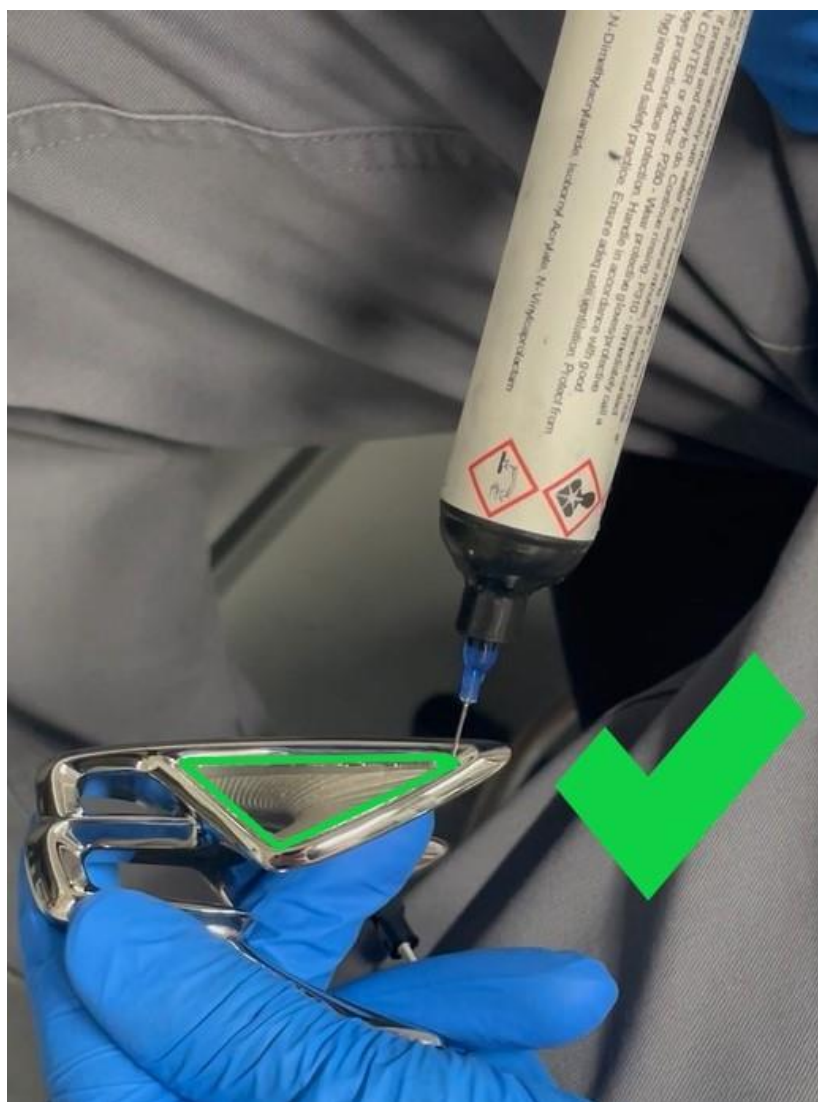
4) Referring to Figure 12 - Apply the adhesive as shown ensuring the adhesive is applied in a consistent manner noting the following:

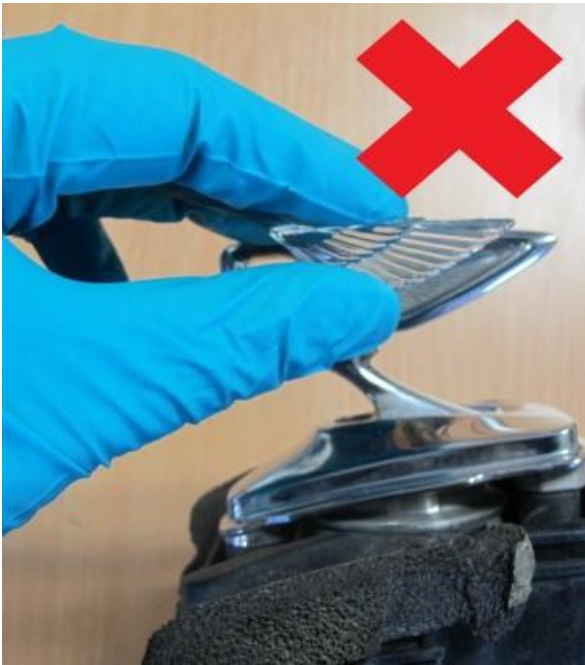
Do Not hold the wing as shown in Figure 17 as the adhesive can easily be disturbed when using this method

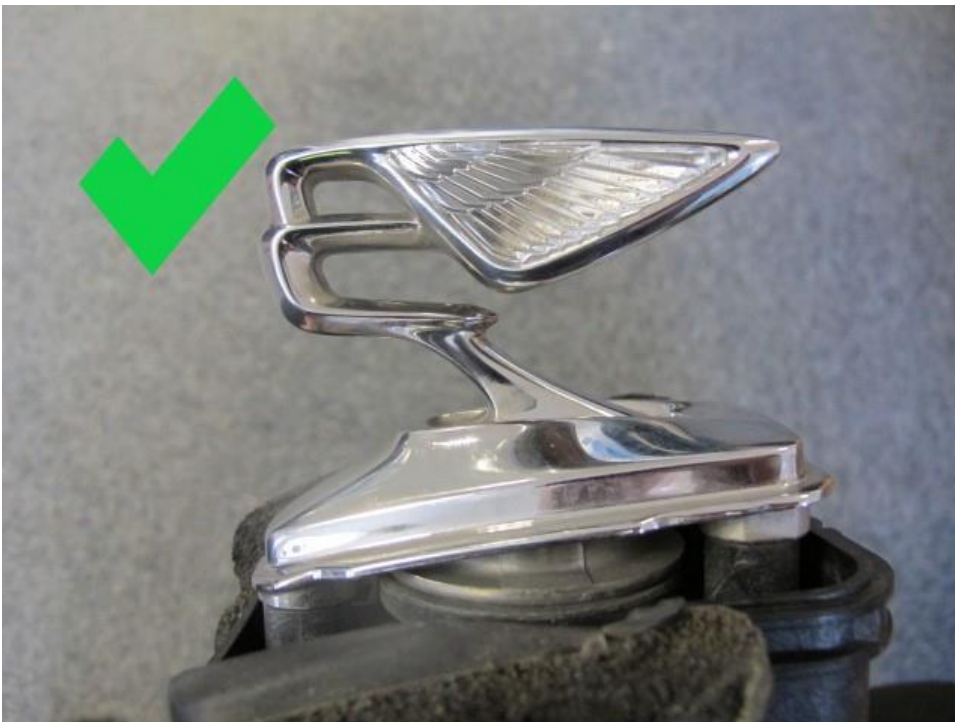
6) Once fitted the wing should be as shown in Figure 18
