## Technical product information

<b>Topic</b>	Engine cooling system over cooling - One or a combination of DTC's may be evident P218100 - P1BB400
<b>Market area</b>	Bentley: worldwide (2WBE),China 796 VW Import Comp. Ltd (Vico), Beijing (6796)
<b>Brand</b>	Bentley
<b>Transaction No.</b>	2075140/1
<b>Level</b>	EH
<b>Status</b>	Approval
<b>Release date</b>

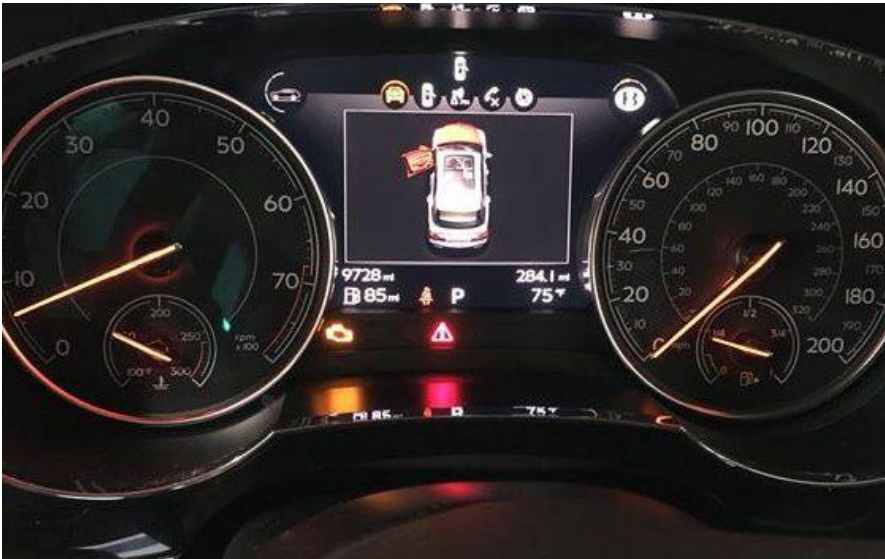
Figure 1

- DTC P218100 - Cooling System Performance and / or DTC P1BB400 Cylinder head temperature too low is stored in the Engine Control Module (ECM)
- Emission Control Lamp illuminated on the Driver Instrument Panel (Figure 1)
