Play Or Noise On The Height Adjuster Or In The Seat Rail Of The Front Seats

Topic number	LI91.10-P-076097
Version	3
Function group	91.10 - Front seats
Date	10/3/24
Validity	BR 206 / 214 / 294 / 295 / 296 / 297 / 254 up to clean-point: Production status higher than or equal to E105
Reason for change

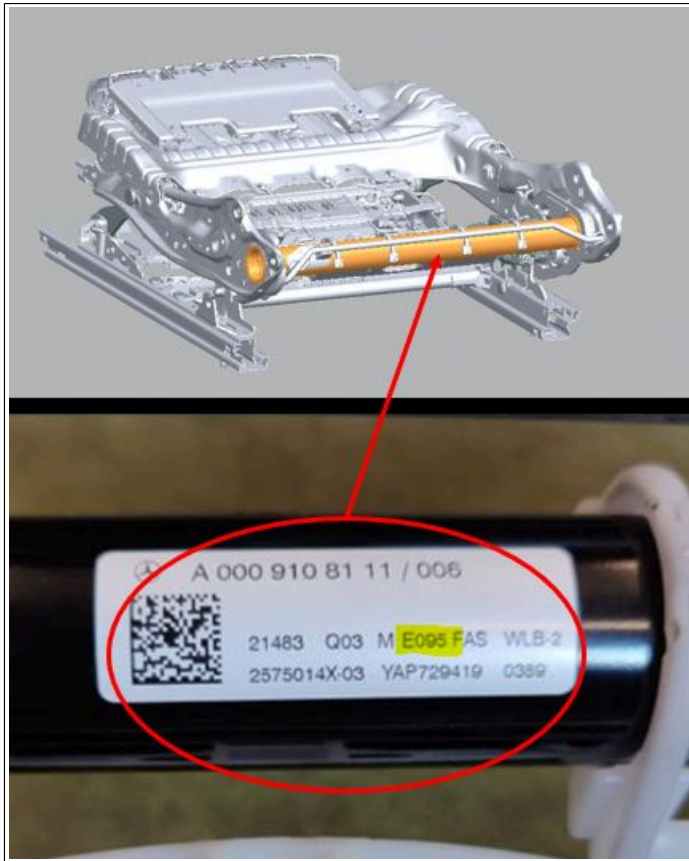
Attachments	
File	Description
Pic.1 seat label.jpg

Review of barcode adhesive label on air intake pipe of height adjuster. The seat frame base with the height adjuster motor can be replaced if the production status is lower than E105 (pic.1: seat label)

In isolated cases, the label may be located on the inside of the air intake pipe; for this, the seat cushion must be removed.

If the production status is higher than or equal to E105, please create a TIPS case with videos and photos and send to B/C/E inbox.
