GENERAL MOTORS
DCS7049
URGENT - DISTRIBUTE IMMEDIATELY

Subject: N242453170 - Service Update
Right Front Brake Pipe Contact

Models: 2025 Buick Enclave
2024-2025 Chevrolet Traverse
2024-2025 GMC Acadia

N242453170 Right Front Brake Pipe Contact

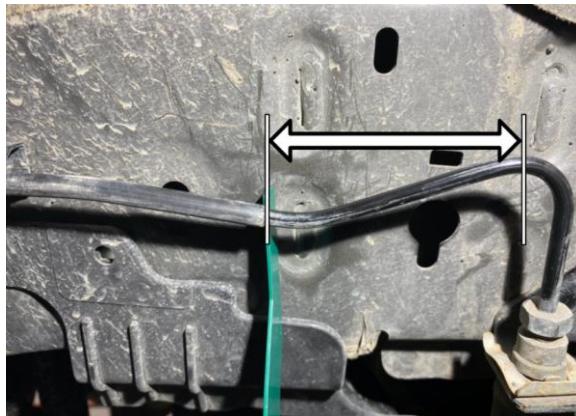
6731773

Note: When measuring clearance, ensure the gauge is measuring between the vehicle frame and the full length of the hard Brake Pipe, NOT the protective rubber coating.

2. Using a 5mm Brake Lining Thickness Gauge, inspect for clearance between the RH Front Brake Pipe and the vehicle frame.

- If the indicated section in the above graphic of the RH Front Brake Pipe is at least 5mm away from the vehicle frame, no further action is required.
- If the indicated section in the above graphic of the RH Front Brake Pipe is NOT at least 5mm away from the vehicle frame, proceed to Step 3.

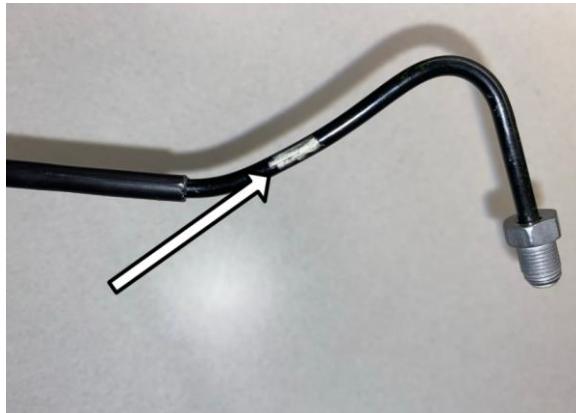
6742085

3. Inspect the RH Front Brake Pipe for any damage to the protective nylon coating.

- If bare metal is not visible on the Brake Pipe, the protective nylon coating is NOT damaged, proceed to Step 4.
- If bare metal is visible on the Brake Pipe, the protective nylon coating is damaged, ADJUSTMENT OF THE FRONT BRAKE PIPE IS NOT NECESSARY. Replace the Front Brake Pipe. Refer to *Front Brake Pipe Replacement* in SI. DO NOT PERFORM STEPS 4 THROUGH 5.

Note: If replacement of the RH Front Brake Pipe is deemed necessary, Steps 4 through 5 WILL NOT NEED TO BE PERFORMED.

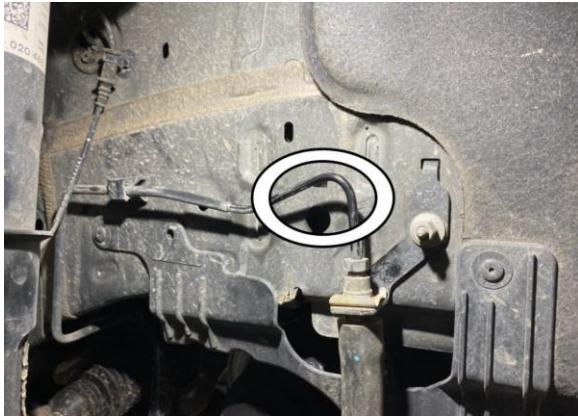
6728824

4. Support the bend in the brake pipe by applying gentle force on the brake pipe towards the frame of the vehicle.

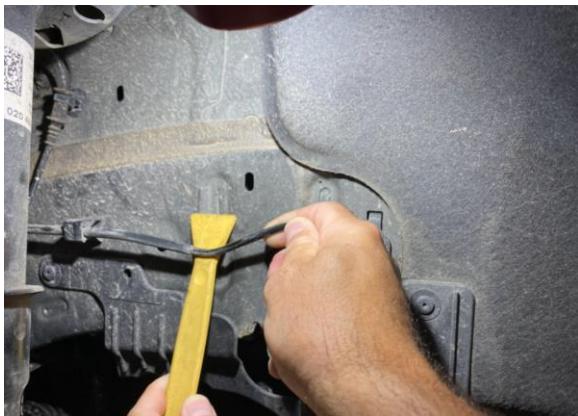
6728825

Important: Use caution when adjusting the brake pipe. Applying too much force or bending the line too far may cause damage to the brake pipe or surrounding components.

Caution: DO NOT use a steel/metal prybar to adjust the Front Brake Pipe. Doing so may damage the protective nylon coating on the Brake Pipe.

5. Still supporting the bend in the brake pipe, use a Nylon Prybar and gently bend the brake pipe away from the vehicle frame until 5mm of clearance is achieved.
6. Install the RH Wheel Assembly. Refer to *Tire and Wheel Removal and Installation* in SI.
