Subject: Hybrid/EV Battery Stability, High Priority DTCs, Potential Loss of Isolation, Vehicle Handling and Battery Pack Return Shipping Requirements

Service Procedure

Initial Vehicle Inspection

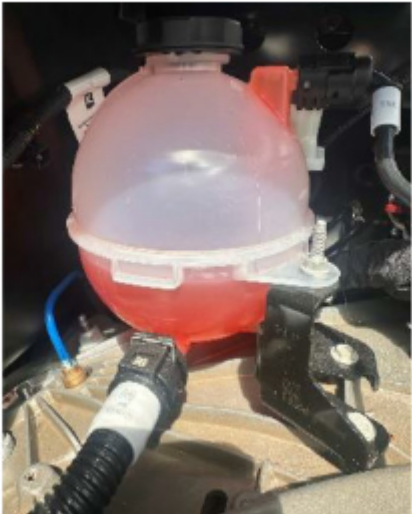
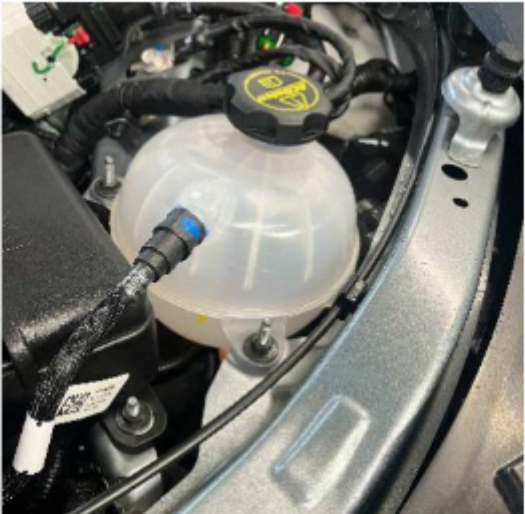
Steps	Results		Subm sion Chec Lis
Inspect Coolant Level. Photograph result.	<p style="text-align: center;">Passed Example</p>

<p style="text-align: center;">Failed Example</p>

Steps	Results		Subm sion Chec Lis
<p>Danger: DO NOT add coolant without first confirming the Lithium-Ion Hybrid/EV Battery Pack internal coolant passage can maintain proper vacuum and pressure. Adding coolant to the coolant system with an internal lithium-ion Hybrid/EV Battery Pack coolant leak may result in Fire, which could result in vehicle or component damage, and cause severe body injury or death.</p>	6715474	6715476

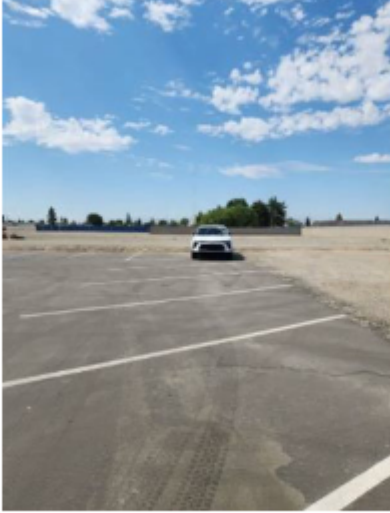
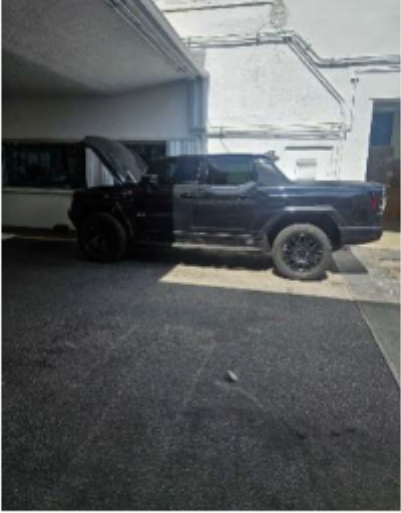
<p>6715481</p>	<p>Failed Example</p>

<p>6715479</p>	<p>Pack Isolation 1 _____ohms 2 _____ohms Thermal Sensor _____C/F Thermal Gas _____PPM Thermal Pressure _____psi/kPa Interface Temperature (average) _____C/F</p>	<p>GDS2 Vehicle Battery Pack Thermal Stability Data Capture</p>
<p>Move vehicle to stable location away from buildings and other vehicles. Photograph results.</p> <p>Warning: Never leave a vehicle or battery pack with a high-risk DTC indoors overnight, all work should be completed during normal business hours.</p>	<p>Passed Example</p>

7. Move the vehicle to a stable location outdoors: isolated and away from buildings, vehicles, and foot traffic while waiting direction to repair. Document location via photo. The recommended method for moving the vehicle would be with HVSL pulled, Service Mode in neutral until directed otherwise.

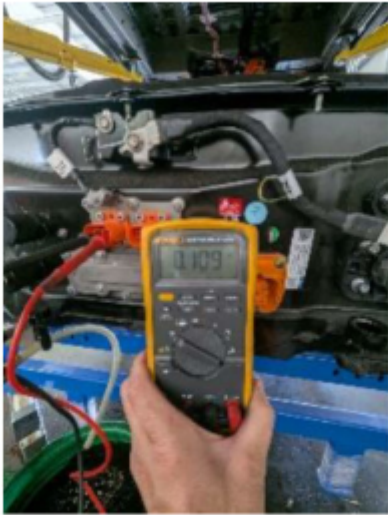
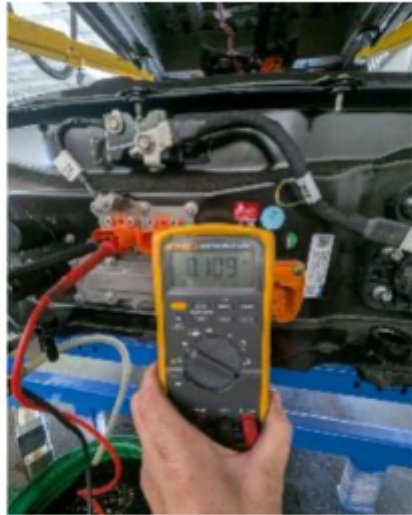
<p style="text-align: center;">6715483</p>	<p style="text-align: center;">Failed Example</p>

This process should be started at Hybrid/Electric Vehicle Battery Pack Removal and Installation.			
Steps	Results		Submission Checklist
High Voltage Disabling at the A4 Hybrid/EV Battery Pack. Photograph results and advise TAC if greater than 3 volts is observed.	<p style="text-align: center;">Passed Example</p>

- 9.2. Check for High Voltage at the Hybrid/Electric Vehicle Battery Pack X1 through X7 (as equipped) by following High Voltage Disabling – High Voltage Disable Confirmation Table – A4 Hybrid/EV Battery Pack in Service Information.

Note: If more than 3V is found, continue but contact TAC immediately upon completion.

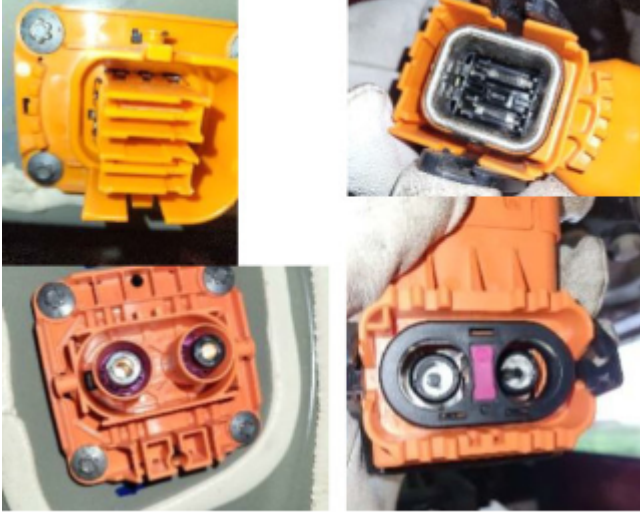
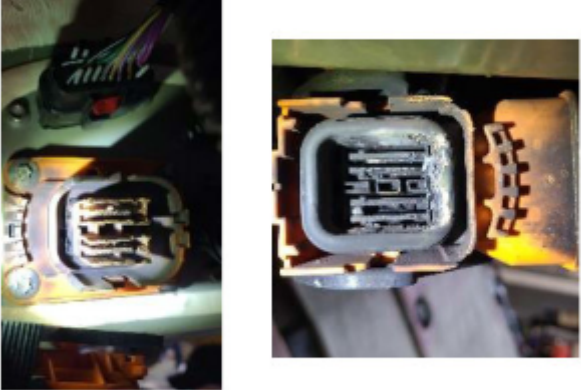
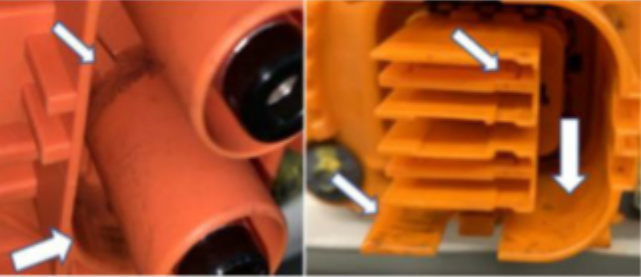
<p>6715486</p>

<p style="text-align: center;">6715485</p>	Photograph Captured
Inspect all HV connections	Passed Examples	Failed Heavy Soot Examples	Photograph

Steps	Results		Sub si Ch li
<p>tors and headers for soot, moisture, coolant or any signs or damage. Photograph every connector/header and advise TAC of findings.</p>

<p>6715487 Failed Light Soot Examples</p>

9.1. Inspect the High Voltage Connectors at the High Voltage Battery for corrosion, moisture, and/or soot. Take clear, close-up photos of the vehicle side HV connectors and High Voltage Battery connection headers. Review Fig 2 for examples of light and heavy soot and the photo clarity required. Attach photos to TAC Case.

Note: If soot, corrosion or moisture is observed, continue but contact TAC immediately upon completion.

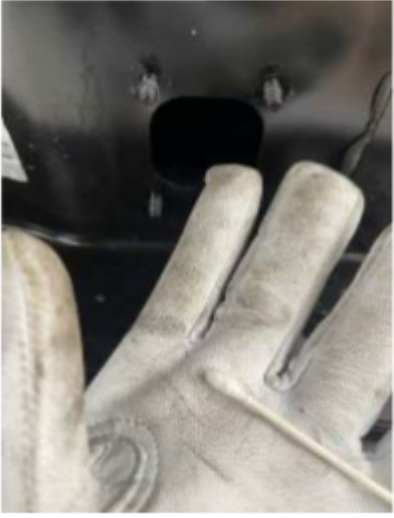
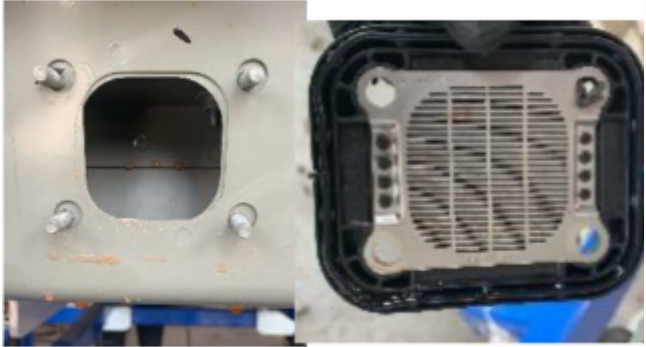
<p>Pict Ca turec mit</p>
	<p>6715489</p> <p>On some vehicles the pressure equalizer vent is accessible prior to battery pack removal.</p>	<p>6715491</p>

<p>tery pressure equalizer vent and inspection plug (if equipped). Insert a cotton swab as an aid to detecting moisture/coolant. Photograph and advise TAC of findings.</p>

- 9.3. Remove the High Voltage Battery Pressure Equalizer Vent and Battery Inspection plug (if equipped) (Fig 3). The equalizer vents have 4 fasteners, never remove the valves that fasten with 2 fasteners. Using a cotton swab or paper towel to swab inside the enclosure for moisture or coolant. Take photos and attach to TAC case.

Note: If fluid is observed, continue but contact TAC immediately upon completion.

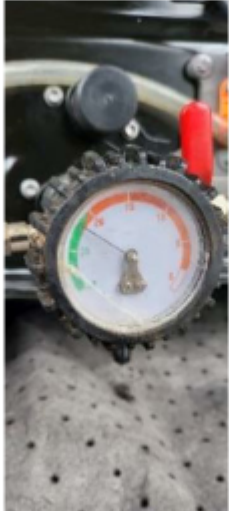
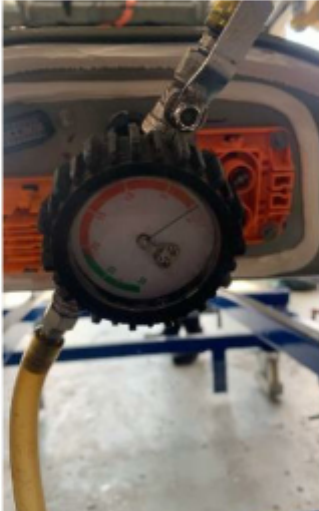
<p>Pa F Pict Ca turec mit</p>
	<p>6715492</p>	<p>6715493</p>

<p>Hybrid Battery Pack Coolant Passage Leak Test. Inspect coolant passage for leaks, should maintain 20 inches of vacuum for 2 minutes. Photograph and advise TAC of findings.</p>	<p>Passed Example</p>

- 9.5. Vacuum test the High Voltage Battery coolant circuit for leaks. See Hybrid Battery Pack Coolant Passage Leak Test. Attach photos to the TAC case.

Note: If the High Voltage Battery coolant circuit does not hold vacuum, continue but contact TAC immediately upon completion.

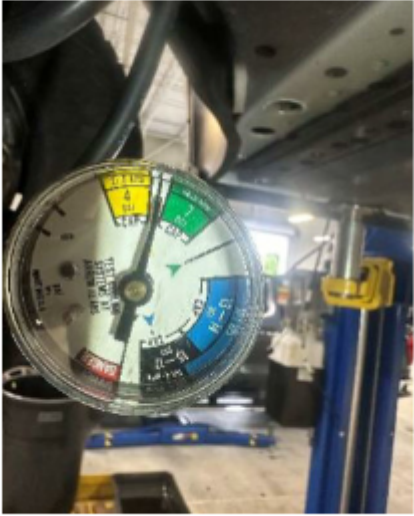
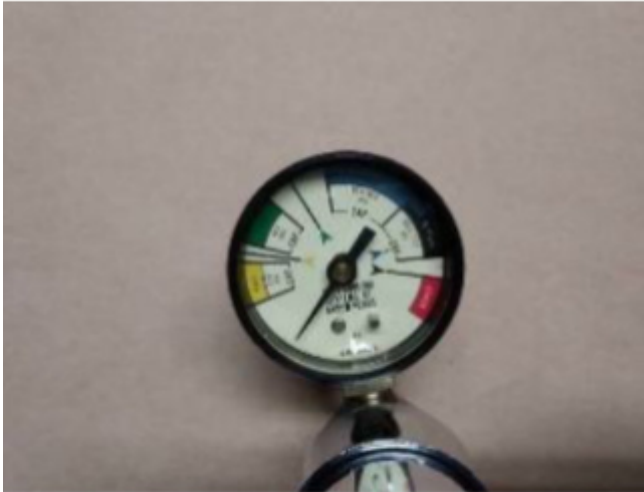
Steps	Results		Sub si Ch li
Hybrid Battery Pack Coolant Passage Leak Test. Inspect coolant passage for leaks, should maintain 5 psi of pressure for 2 minutes. Photograph and advise TAC of findings. Note: ONLY PERFORM PRESSURE TEST IF VACUUM TEST WAS PASSED	Passed Example

6715495	Pa F Pict Ca ture mit
	Stable to Ship determination		R SU
If moisture/coolant/soot was detected at the HV connectors the HV battery is NOT STABLE. If moisture/coolant is detected at the equalizer vent and/or inspection plug the HV battery is NOT STABLE.			
NOT STABLE	STABLE		
Immediately Place the HV battery in the provided DDR Crate and move to a stable location outdoors, away from buildings, vehicles and foot traffic. Cover the DDR crate with a tarp. Photograph location and immediately advise TAC.	Place the HV battery in the provided DDR crate. Advise TAC of the results and request the core return process.

- 9.6. Pressure test the High Voltage Battery coolant circuit for leaks (Only complete if passes vacuum test). See Hybrid Battery Pack Coolant Passage Leak Test. Attach photos to the TAC case.

Note: If the High Voltage Battery coolant circuit does not hold pressure, continue but contact TAC immediately upon completion.

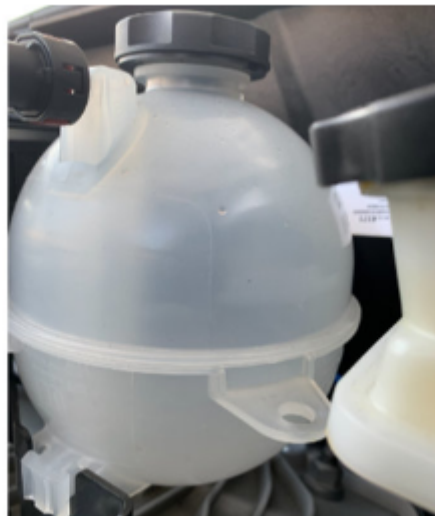
Figure 1

1. Verify if DTCs U2BFC or P1C34 are set as current or history? If yes, immediately report results to TAC now as review will be necessary to help determine stability.
2. Verify any of the following DTCs are set as current; P0AA6, P0AA7, P0AE3, P0C78, P1C34, U359E, U1666, U1667, U2426, U2427. Verify if DTC U35B5 set as current or history.
3. Obtain and document a clear and thorough description of the concern from the customer. Was the vehicle towed because of a no start concern or loss of propulsion, did they hear a 'pop' or abnormal noise.
4. Visually inspect the coolant level in the high-voltage battery surge tank (Fig 1) and document via photo. Inform TAC if coolant has previously been added.
