Diagnostic Sheet

Rear Exhaust Silencer Noise

DATE: October 7, 2024

SUBJECT: Noise from Rear Exhaust Silencer

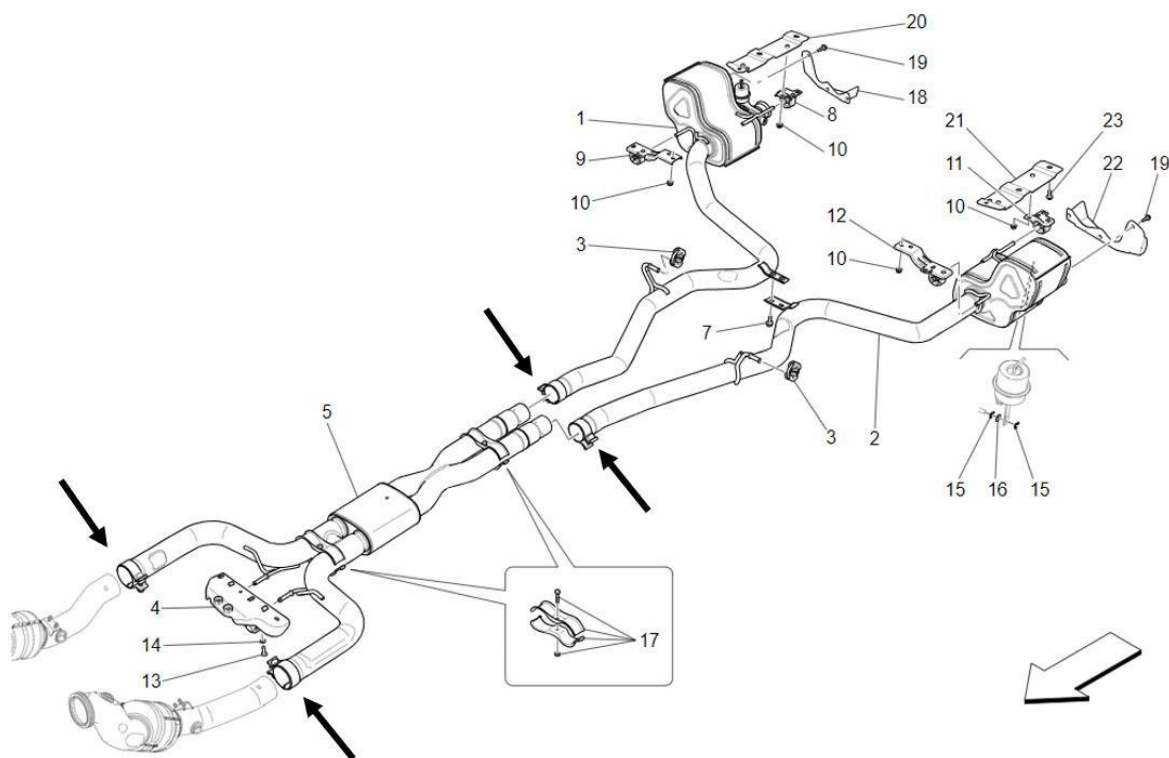
- 1) Describe the customer's complaint and the conditions which it occurs: Engine warm or cold? In which driving mode (Sport, Normal, etc.)? At idle or during acceleration?
- 2) Attach a video of the complaint to the BOL (to be sent as a "support request") before proceeding with any action.
- 3) Carry out the checks below, referring to the following image:

3a) Check the tightening and the conditions of the anti-vibration pads (items n. 8,9,11 and 12). 3b) Check the tightening of the collars indicated by the arrows, see picture.

3c) Check the tightening of the nuts of the central silencer support (item n.17).

4) Highlight any NOT OK check in BOL (documenting with photos and/or videos) and check whether the problem persists even after correct tightening has been restored. If so, proceed to step 5.

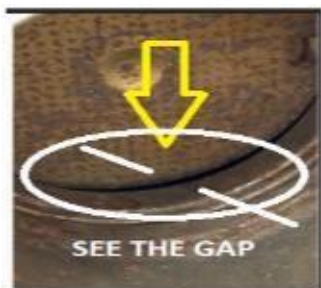
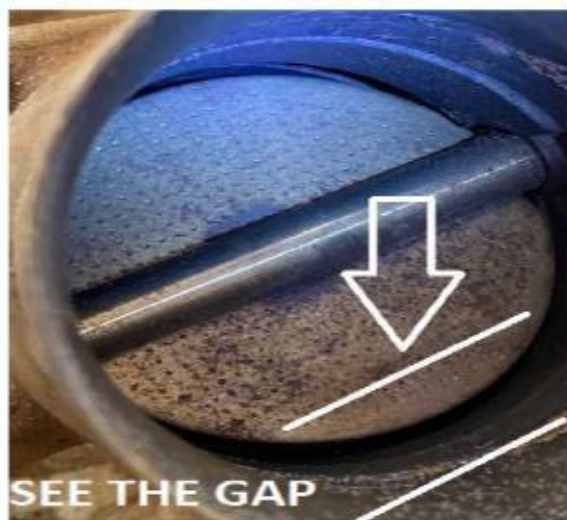
5) Remove the silencer and check whether there is incomplete closure of the by-pass valve in "Normal" mode which could cause vibrations/rattling (below, an example photo relating to poor closure of the valve):

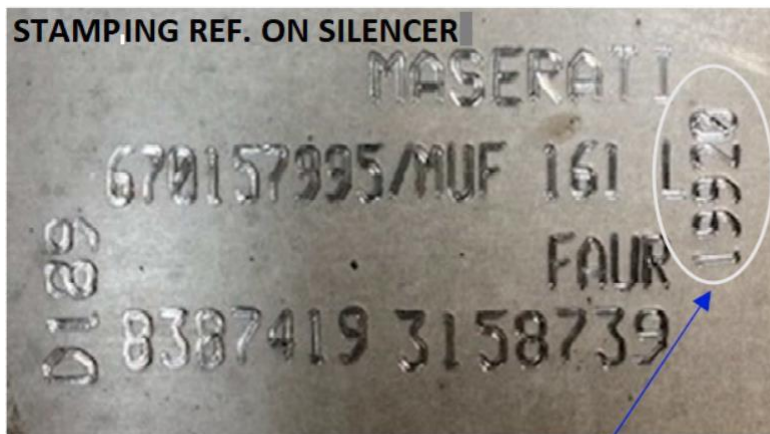
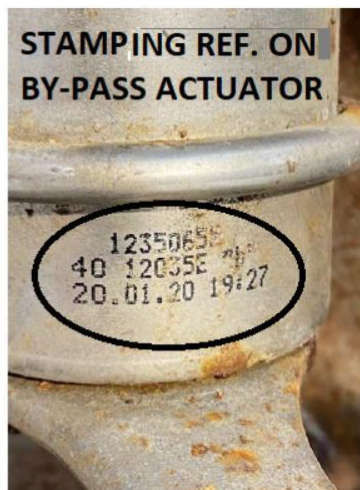
6) Provide the results of the checks carried out in BOL and attach a photo of the identification references stamped both on the rear silencer, which is suspected to be noisy, and on the relevant bypass valve. Below are some examples.

SUPPLIER PROD. DATE ← 17/07/2020

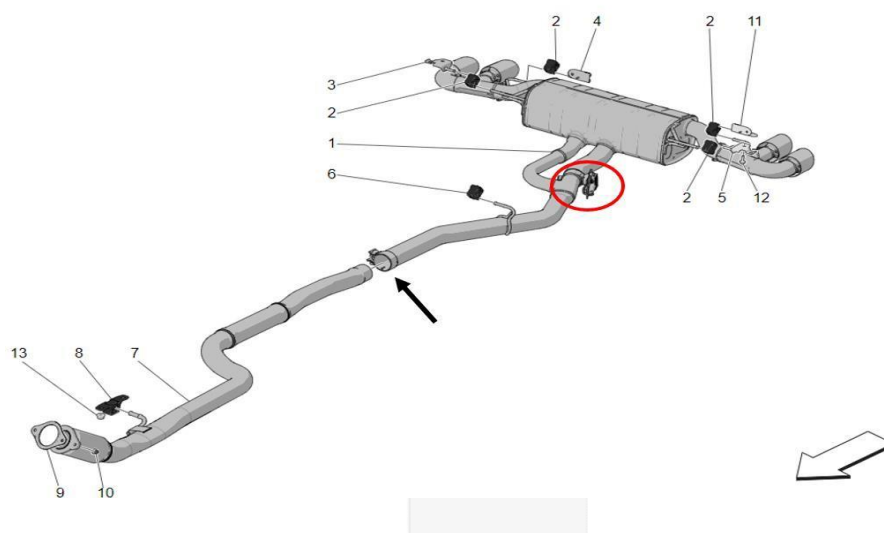
4) Carry out the checks below, referring to the following image:

- 4a) Check the tightening and the conditions of the rear anti-vibration pads (items n. 2).
- 4b) Check the tightening of the collar indicated by the arrow, see picture.
- 4c) Check the tightening and the conditions of the central silencer support pad (item n. 8).

NOTE: do NOT dismantle the bypass valve actuator from its seat. See red circle in the figure.

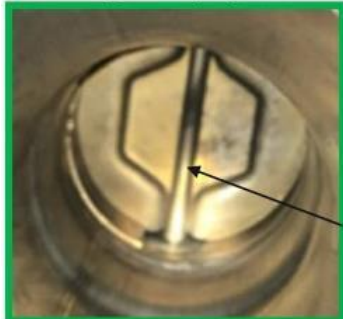
Shaft

7) Disconnect the rear silencer from the central silencer. With an endoscope, inspect the valve as shown in the images below. Document the condition of the valve with photos.

OK mounting of valve group show this visible shaft:

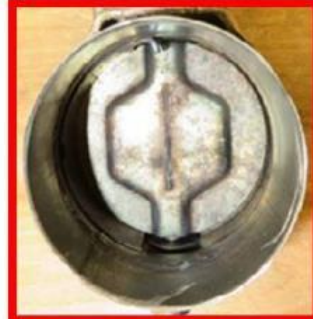
NOK mounting of valve group show this covered shaft:

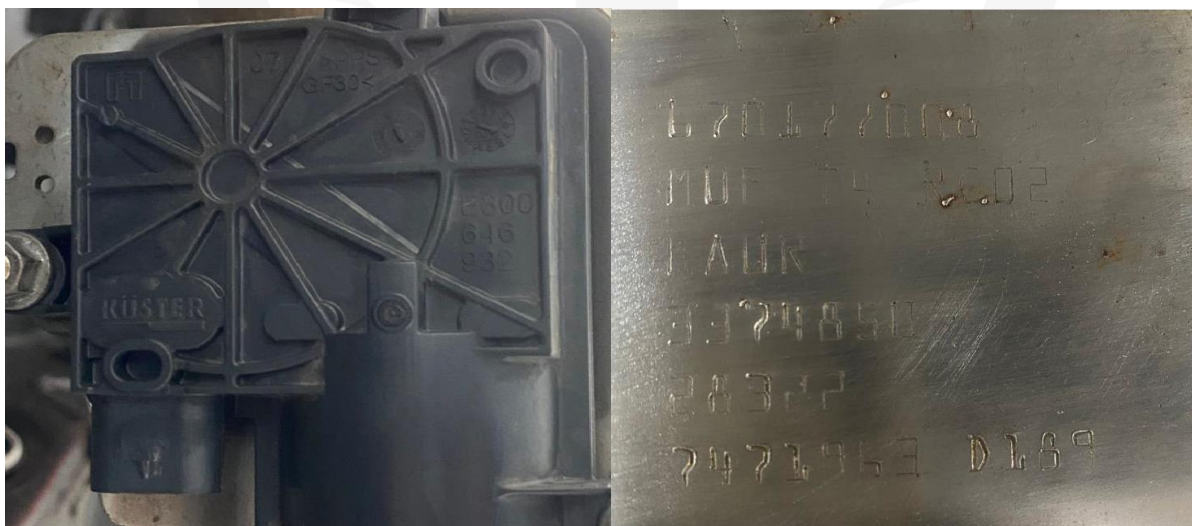
8) Provide the results of the checks carried out in BOL and attach a photo of the identification references stamped both on the rear silencer, which is suspected to be noisy, and on the relevant bypass valve. Below are some examples.
