GROUP	MODEL
Voluntary Emissions Service Campaign	2021-2024MY K5 (DL3a) w/1.6L T-GDI
NUMBER	DATE
SC288 (Rev 3, 10/11/2024)	April 2024

VOLUNTARY EMISSIONS SERVICE CAMPAIGN

FUEL TANK AND/OR PCSV CHECK VALVE

INSPECTION/REPLACEMENT + ECU SW UPGRADE (SC288)

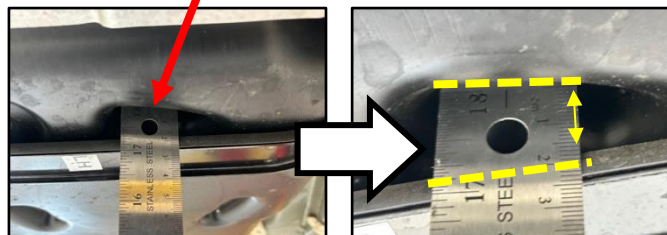
2b. Left Hand Fuel Tank Band

- If the gap measures 21mm or LESS (OK), proceed to measure the right hand fuel tank band.
- If the gap measures 22mm or MORE (NG), attach one clear photo using KDS Tablet Warranty Claim Attachment Tab of the **NG** measurement, then proceed to step 3.

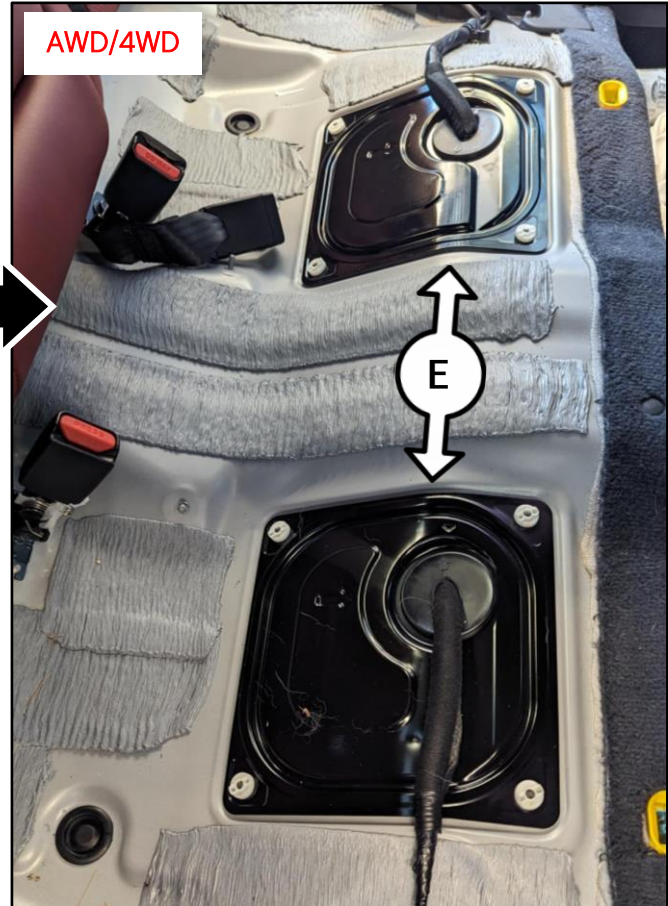
Note: AWD model shown on the right for reference, the FWD models shown below feature a single fuel tank service cover access.

4. Inspect the seat floor to fuel pump service cover (E) (4 sides) for any gaps:

- **If a gap is NOT present (OK)**, the cover is seated flush with the seat floor panel, then proceed to replace both the PCSV check valve and Fuel Tank (page 12). After completing the two replacements, perform the 'ECU Upgrade Procedure' (page 8).

- **If a gap IS present (NG)**, the cover is lifted/detached from the seat floor panel, create a Techline Repair Assistance (RA) case, and **attach one clear photo using KDS Tablet Warranty Claim Attachment Tab of the NG condition to the Techline case and Warranty Claim.**

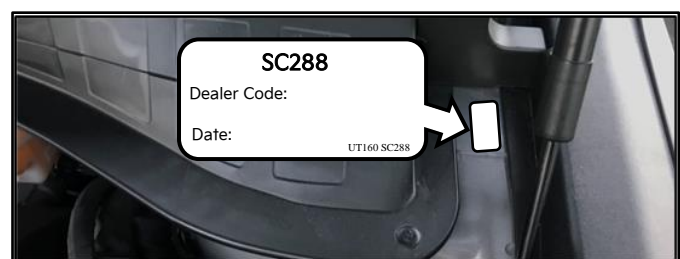
The dealer must fill in the Dealer Code and Date information fields on the Campaign Completion Label. Once complete, affix the campaign completion label under the hood of the vehicle, as shown below.

CA and S.177 States Only: Apply SC288 Campaign Completion Label onto the body in the area next to the shock tower, as shown. **NOTE: Be sure to clean the mounting surface to ensure proper label adhesion.**
