## Damage To The Leather Strap Of The Seat Backrest Lock On The Front Seats

Topic number	LI91.10-P-078471
Version	1
Function group	91.10 - Front seats
Date	10/22/24
Validity	BR 236 up to cleanpoint 01.11.2024
Reason for change

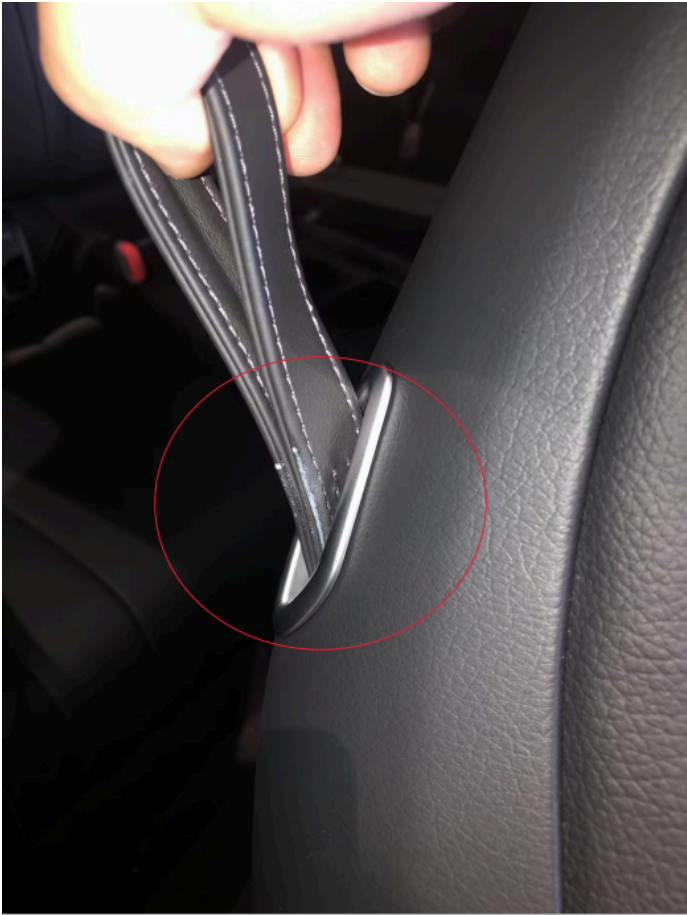
File	Description
Pic.1.PNG

Damage to the leather strap of the seat backrest lock on the front seats (Pic.1).

Gap between seat backrest lock and trim ring

- Ordering of new component parts (seat backrest lock and trim ring)
- Clipping of trim ring to the seat backrest lock (holder)
- Push the trim ring downwards
- Apply the hot-melt dot from the inside - at the bottom between the trim ring and the holder of the seat backrest lock (the holder of the seat backrest lock and trim ring must be fixed together) (Pic.2)
