Technical Service Bulletin

| GROUP HVAC | NUMBER 24-HA-001G |

SUBJECT: REDUCED HEATER PERFORMANCE – TEMPERATURE CHECK & HEATER CORE REPLACEMENT

Description: Certain Genesis vehicles (listed below) equipped with Lambda-III 3.5T-GDI engines may exhibit reduced heater performance due to engine coolant deposits clogging the heater core. This bulletin provides instructions to verify the concern and to replace the front and rear heater core (if applicable).

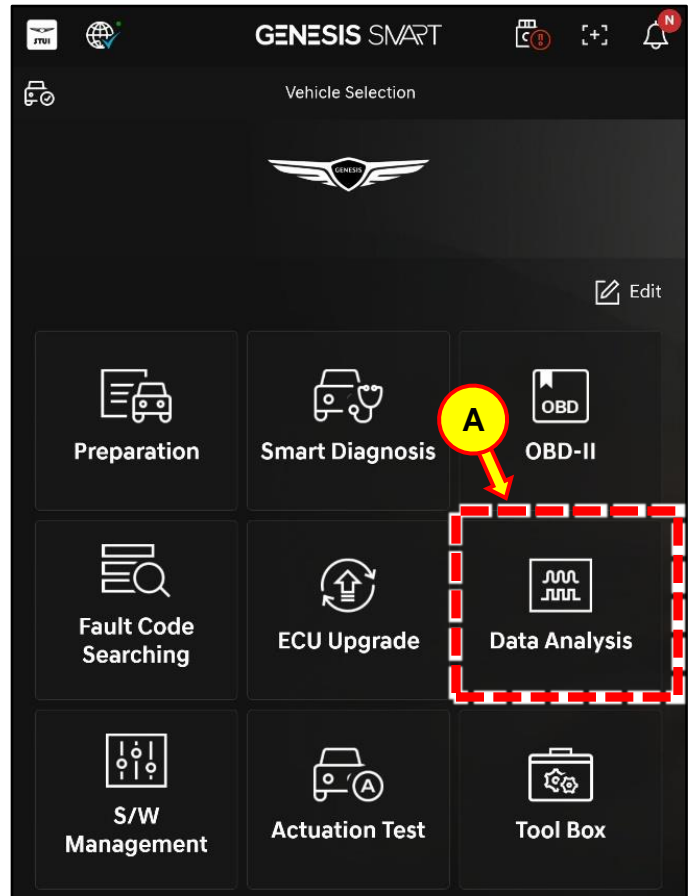
1. Connect GDS.
2. Turn **ON** the IG switch.
3. Select **Data Analysis** (A) on the Genesis Smart home screen.

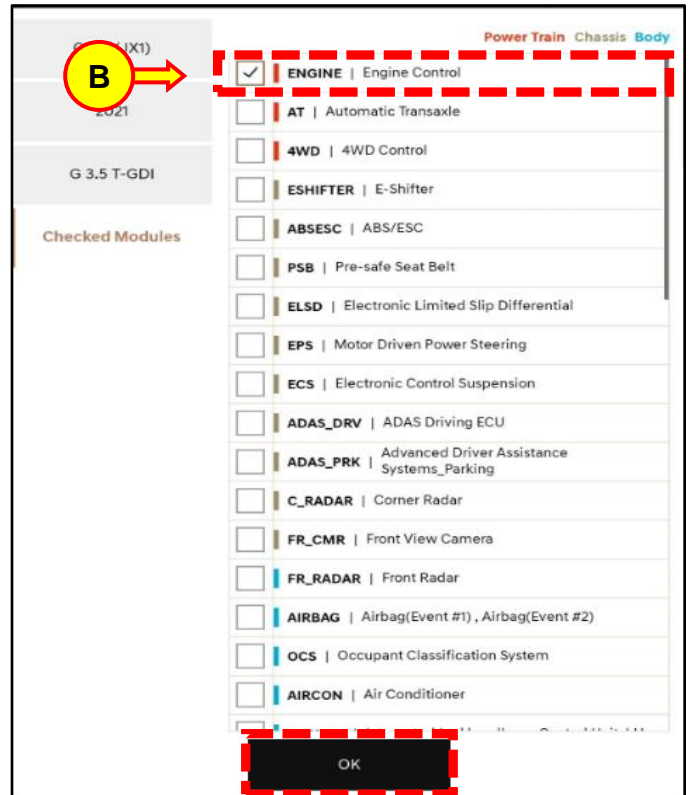
4. Select **ENGINE** (B) and press **OK**.

5. Check the **Water Temperature Value (C)**.
6. Maintain the engine RPM at 2000-3000 until the Water Temperature Value is 194°F (90°C) or higher.

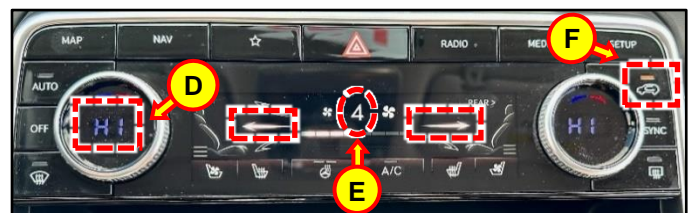
7. Set HVAC temperature to **HI (D)**, fan speed to **4 (E)**, recirculation mode **ON (F)**, and direct the airflow to the face vents.

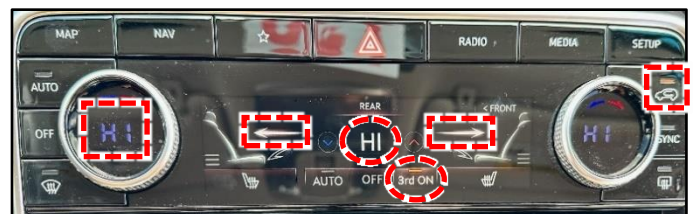
For GV80 (JX1) 7-Passenger models, do the same settings for the 3rd row.

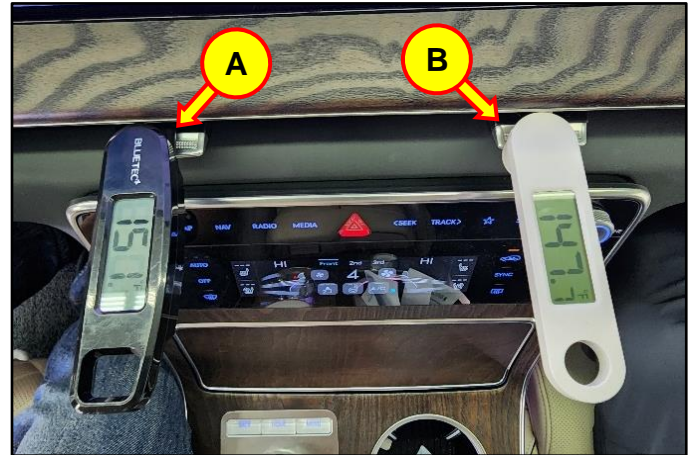
Front Center Vents

1. Using a thermometer, measure the temperatures at the front center vents on the driver side (A) and passenger side (B).

- If the temperature difference between the front center vents is less than 18°F, then **proceed to step 2** to take a picture of the temperature readings.
 - Use OP Code **40D158R0** to finish this inspection procedure after following step 2.
- If the temperature difference between the front center vents is 18°F or higher, **proceed to step 2** to take a picture of the temperature readings.
 - **Proceed to step 3 for front heater core replacement.**

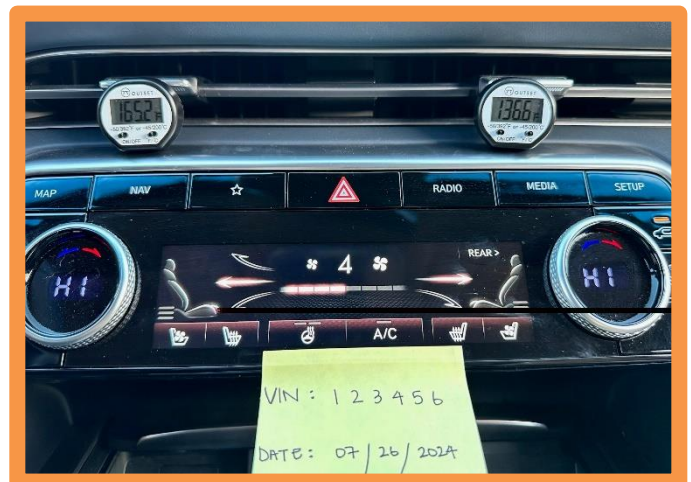
Using STUI, take a photo clearly showing the temperature readings on both thermometers with the last 6 digits of the VIN and the date of repair on a piece of paper.

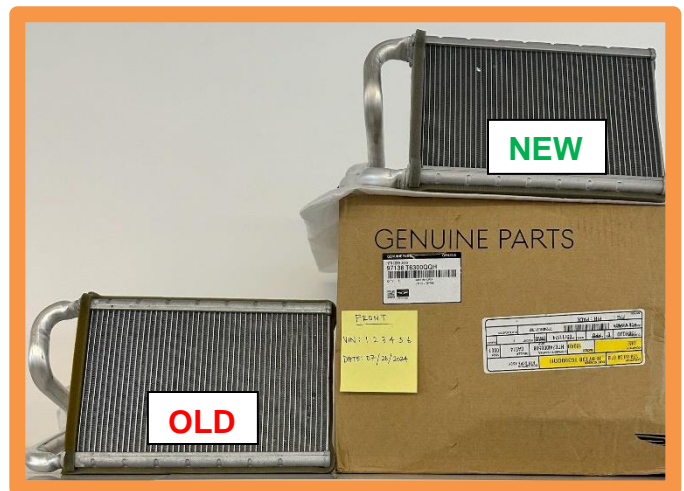
Using STUI, take a clear photo of the **OLD** heater core removed next to the **NEW** heater core on top of the box with the 'QQH' label showing with the last 6 digits of the VIN and the date of repair on a piece of paper.

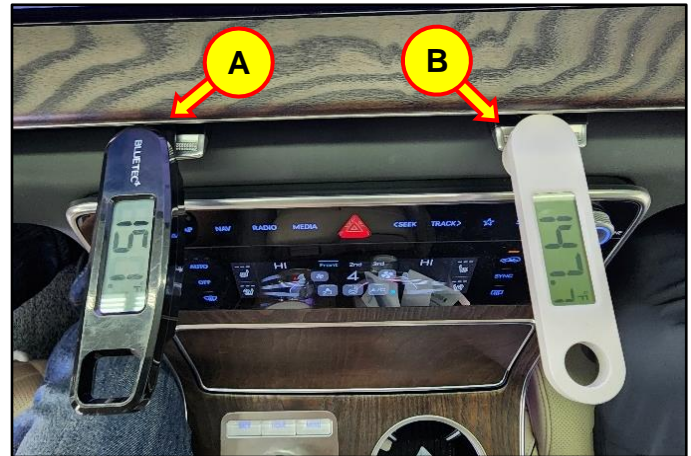
Front Center Vents

- Using a thermometer, measure the temperatures at the front center vents on the driver side (A) and passenger side (B).

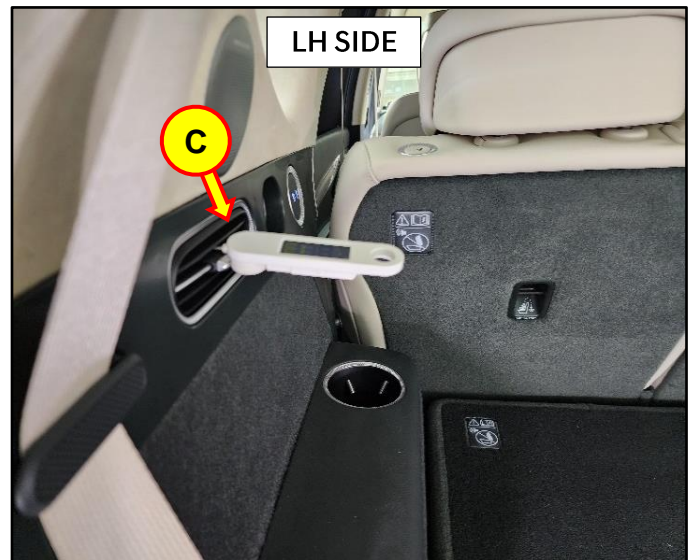
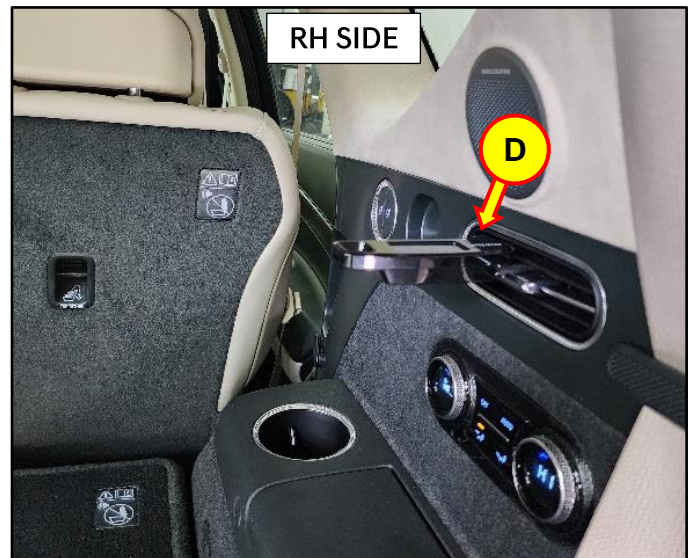
Rear/3rd Row Vents

- Using a thermometer, measure the temperatures at the rear vents in the 3rd row on the LH (C) and RH (D) sides.
 - If the temperature difference between the vents in **both** locations – front center and rear/3rd row – is less than 18°F, then **proceed to step 3 and 4** to take a picture of the temperature readings.
 - Use OP Code **40D158R1** to finish this inspection procedure after following step 3 and 4.
 - If the temperature difference between the **front** center vents is 18°F or higher, replace the front heater core after following step 3.
 - Proceed to step 5 for front heater core replacement.**
 - If the temperature difference between the **rear** vents is 18°F or higher, replace the rear heater core after following step 4.
 - Proceed to step 6 for rear heater core replacement.**

If the temperature difference between the vents in both locations is 18°F or higher, replace **both** the front and rear heater core.

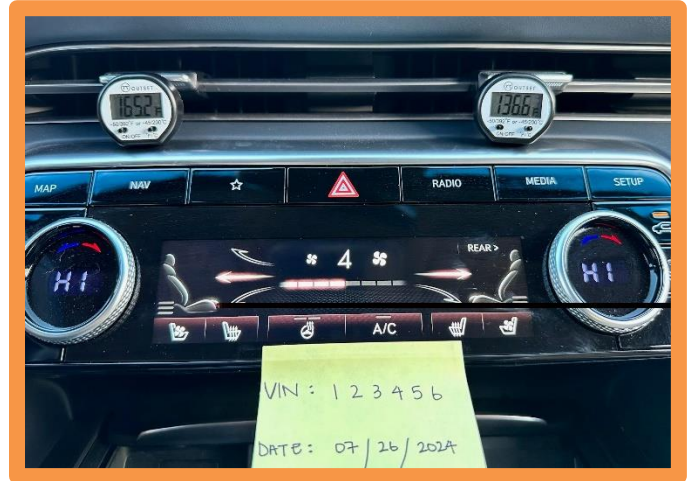
Using STUI, take a photo clearly showing the temperature readings on both thermometers for the front vents with the last 6 digits of the VIN and the date of repair on a piece of paper.

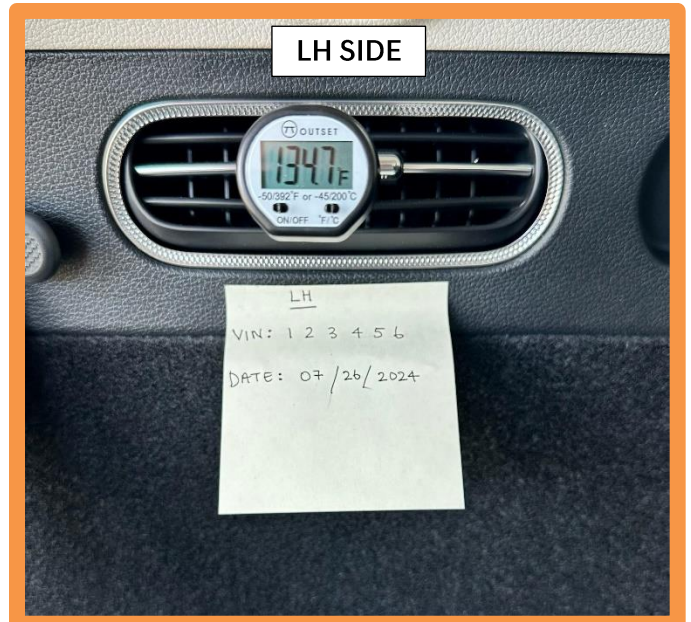
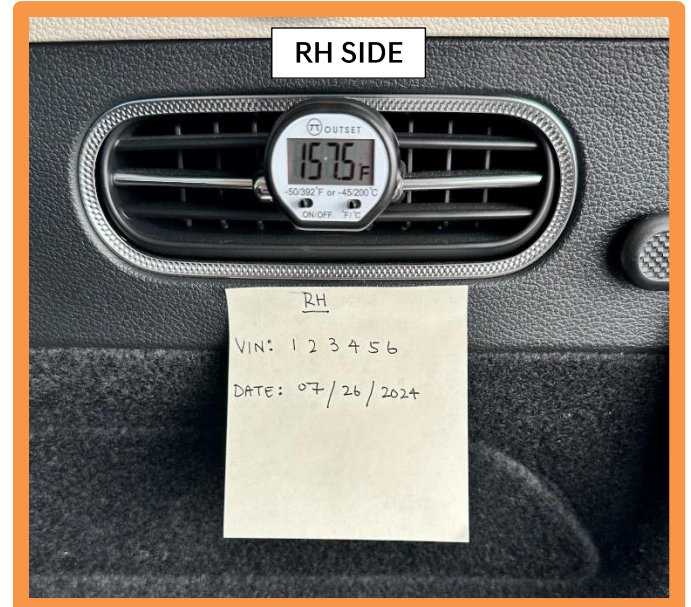
Using STUI, take a photo clearly showing the temperature readings on both thermometers for the rear vents with either 'LH' or 'RH' notation, the last 6 digits of the VIN and the date of repair on a piece of paper.

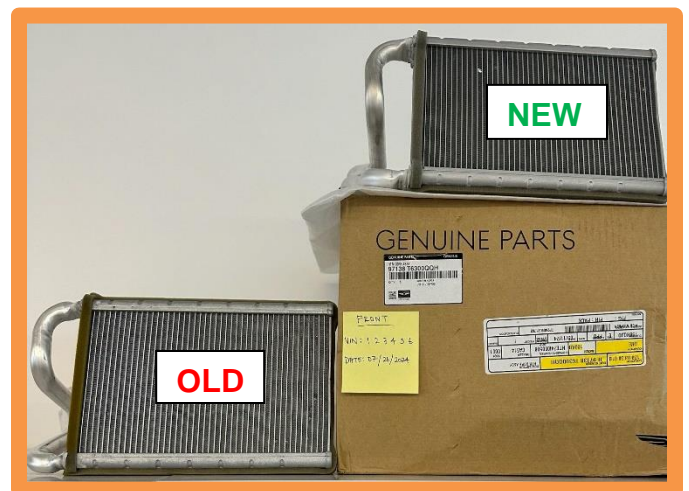
Using STUI, take a clear photo of the **OLD** front heater core removed next to the **NEW** front heater core on top of the box with the 'QQH' label showing with the last 6 digits of the VIN, 'Front' notation on the top, and the date of repair on a piece of paper.

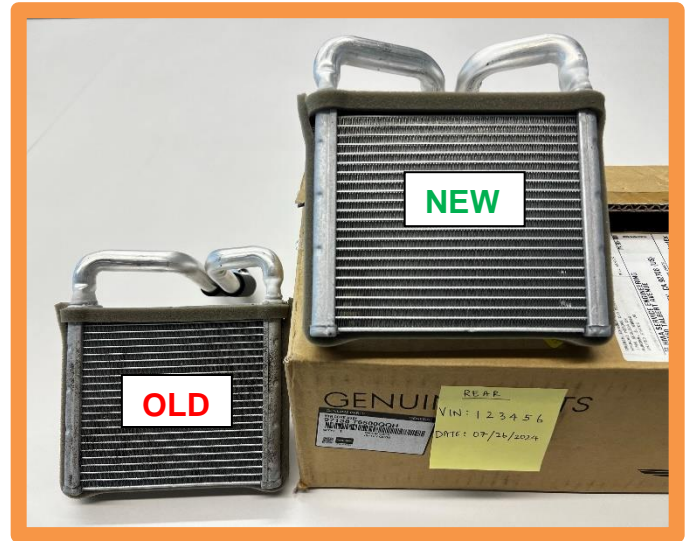
Using STUI, take a clear photo of the OLD rear heater core removed next to the NEW rear heater core on top of the box with the 'QQH' label showing with the last 6 digits of the VIN, 'Rear' notation on the top, and the date of repair on a piece of paper.
