TECHNICAL SERVICE BULLETIN

Transmission Fluid Cooler Tubes Leaking At Transmission Case

24-232722 October
2024**Model:**

Ford 2020-2022 Mustang Shelby GT500

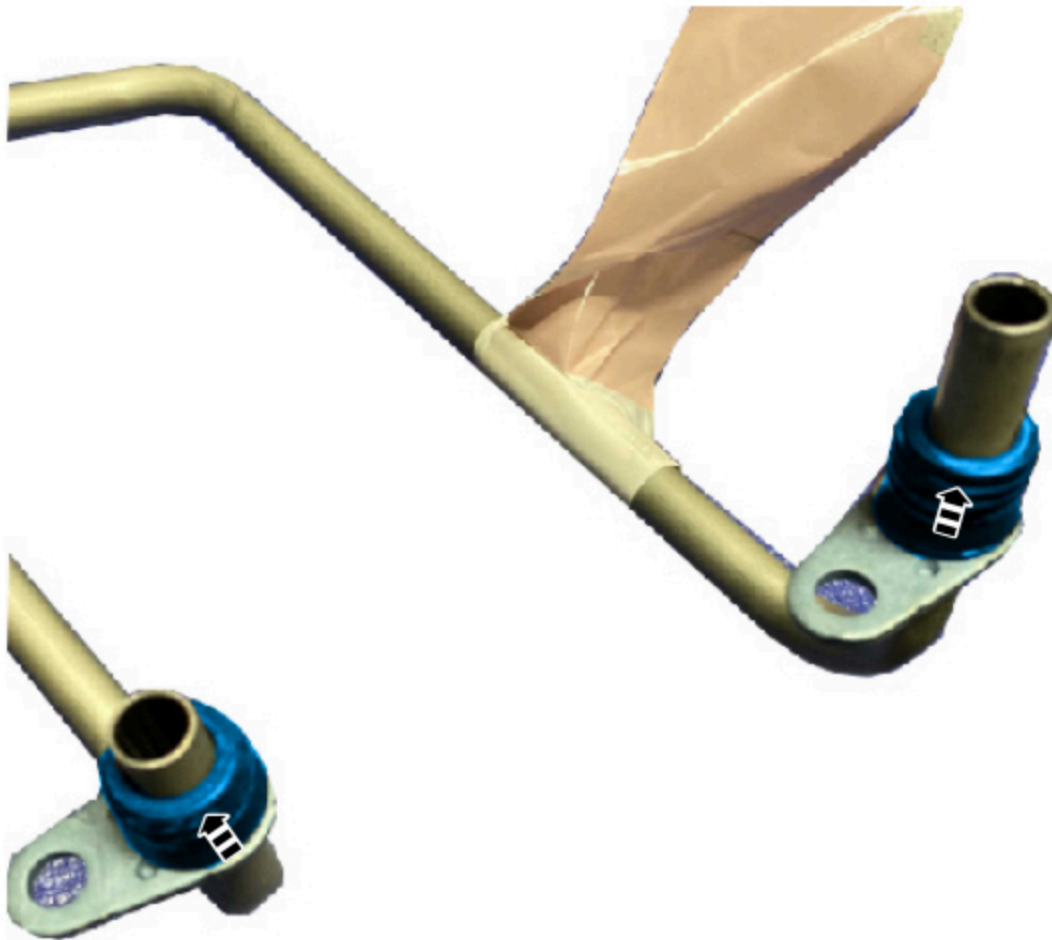
Figure 1

- (1). Remove the seals and backing rings and place them aside for later reinstallation. (Figure 1)

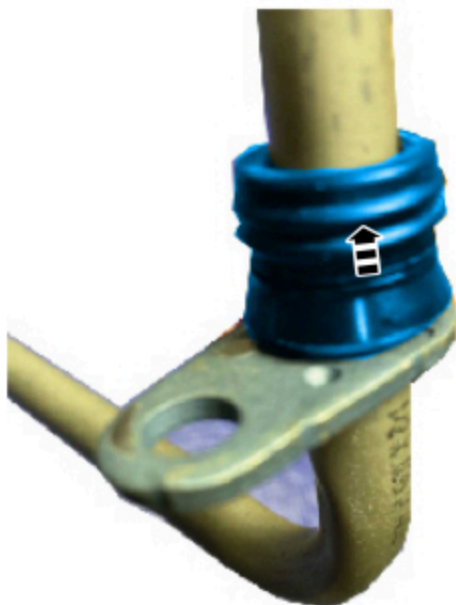
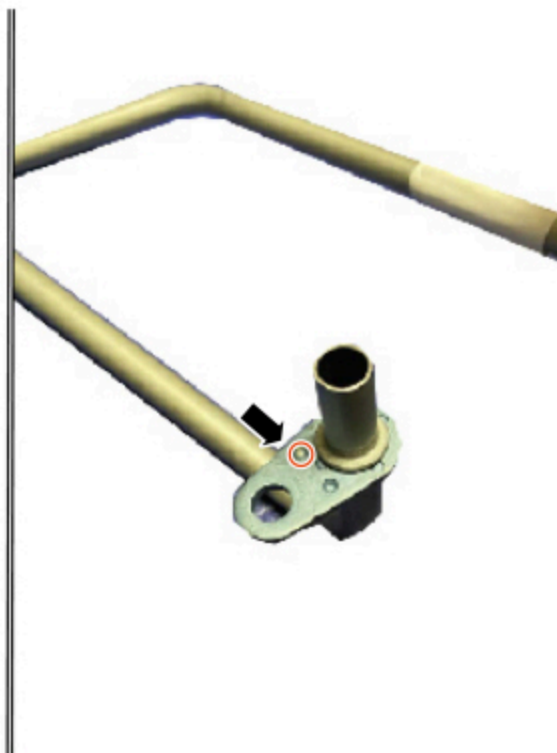
Figure 2

- (2). Use a file to grind away the dimple on the sealing side. Be careful to not scrape the surrounding mating surface, bracket, or tube. (Figure 2-3)

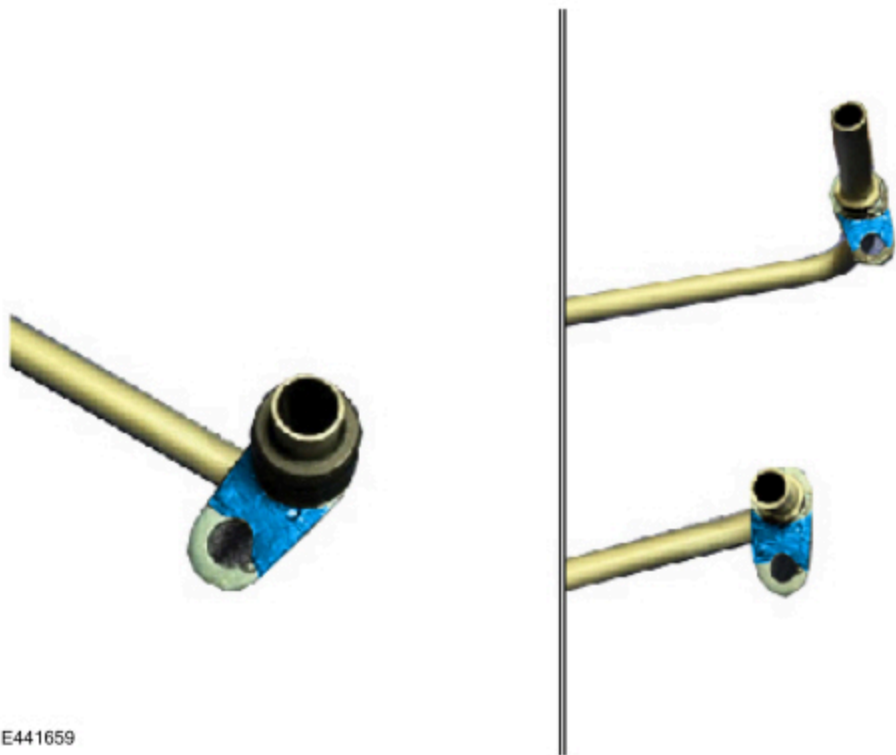
Figure 4

(4). Apply Motorcraft® Anti-Corrosion Coating with small brush and make sure all bare metal is covered. Coating must be dry to touch before proceeding to Step 3. (Figure 4)

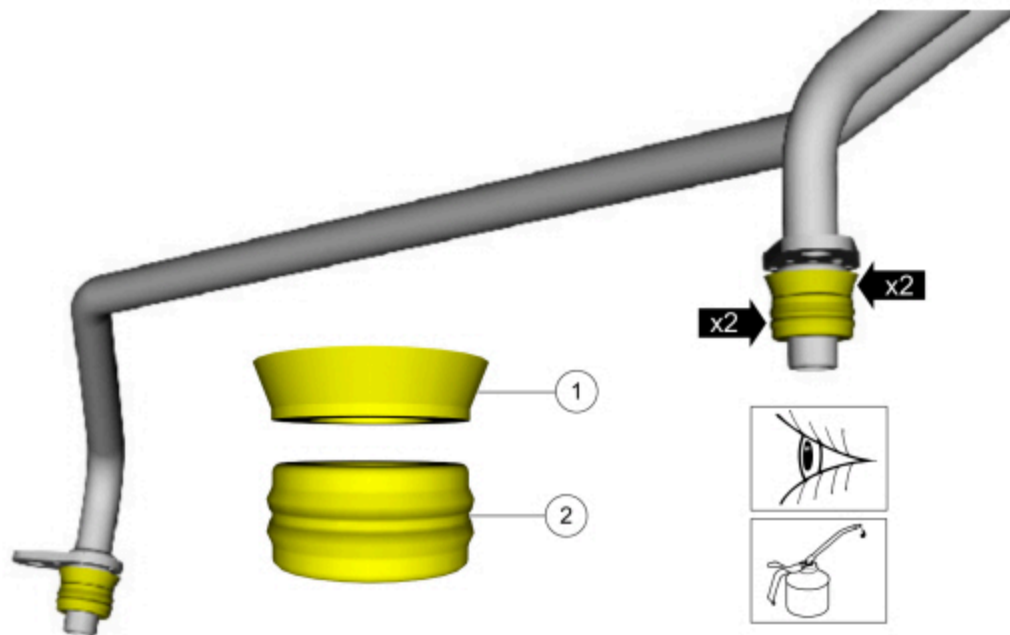
Figure 5

(1). Inspect, lubricate, and install the band seals and backing rings onto the line set. (Figure 5)

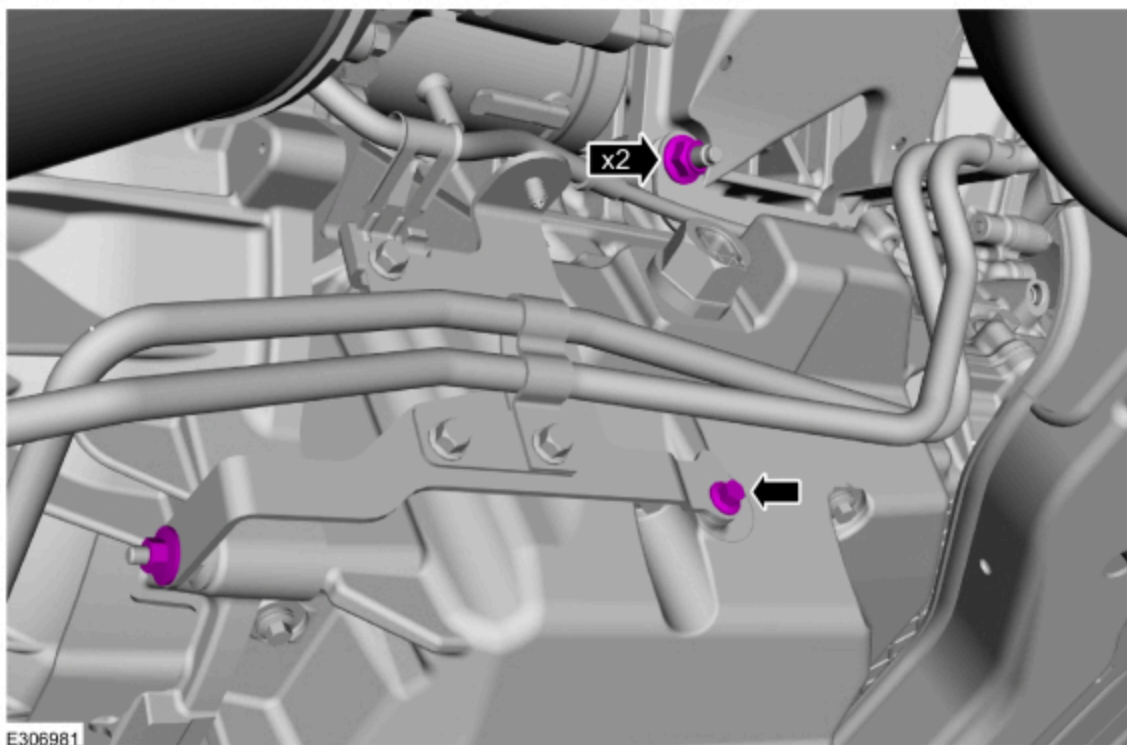
Figure 6

(2). Install the fluid cooler tubes bracket retainers but do not tighten. (Figure 6)

(6). Tighten the fluid cooler tubes bracket nuts to 35 lb.ft (48Nm), and bracket retainers bolt to 89lb.in (10 Nm).

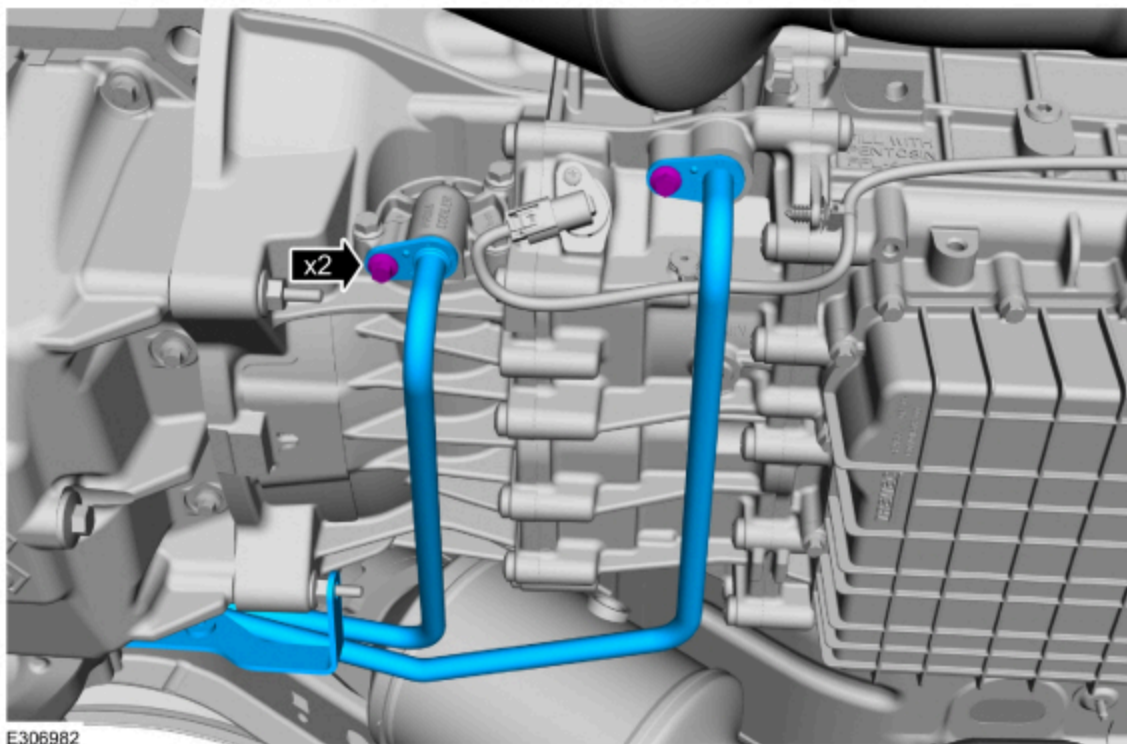
(3). Insert the transmission fluid cooler tubes into the transmission case and tighten to 89 lb.in (10 Nm) (Figure 7)
Figure 7

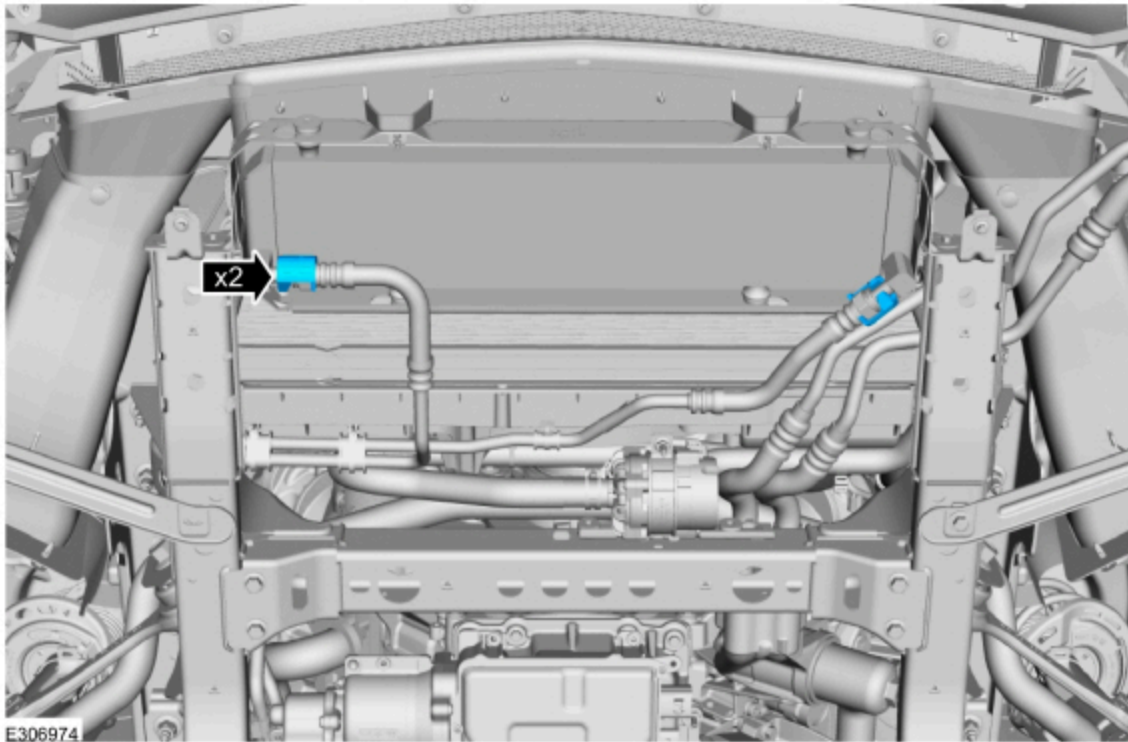
Figure 8

(5). Install the transmission fluid cooler tubes secondary latches. (Figure 8)

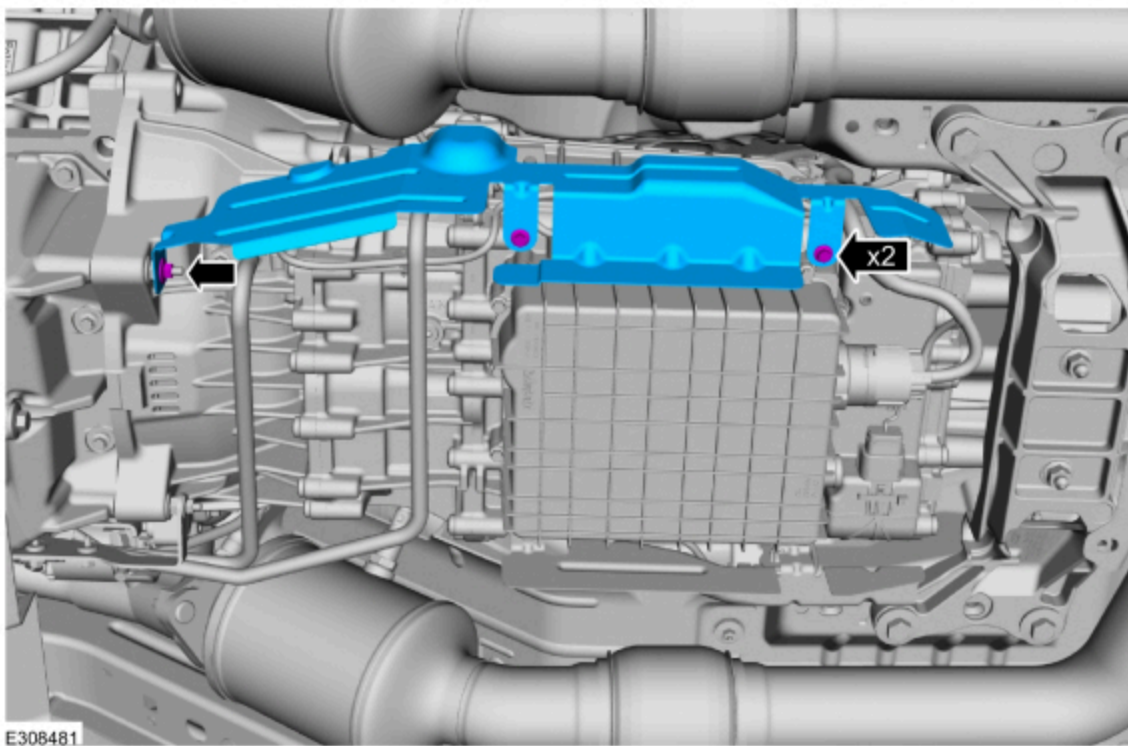
Figure 9

(8). Install the transmission heat shield and tighten the retainers nut to 53 lb.in (6 Nm), and bolts to 62 lb.in (7 Nm) (Figure 9)
