# Service Bulletin

Bulletin No.: 24-NA-148

**Subject:** Transmission Slip, Harsh 3-4 Shift or Harsh 5-6 Shift, Delayed Shifts, Delayed Shift into Reverse, Harsh Shift into Reverse, Slips in Reverse or No Reverse, Malfunction Indicator Lamp (MIL) Illuminated - DTC P2714 and/or P2732 Set

**Attention:** This TSB only applies to the 10L1000 RPO (MKM) with the 6.6 (L8T) gas engine. This does not apply to 10L1000 (MGM) (MGU) with 6.6 (L5P) diesel engine.

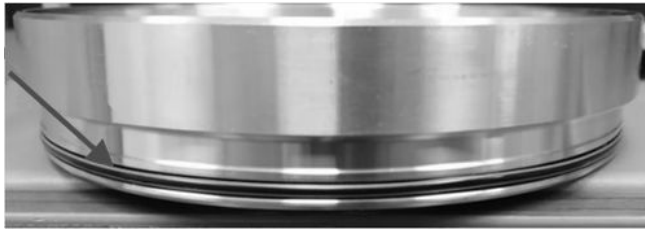
6712757

| Cause | <p>This condition may be caused by the 1-2-3-4-6-7-8-10-Reverse Clutch (C4) may have experienced premature degradation of the C4 Apply Piston Outer Seal (525) due to the seal contact area machine finish of the Triple Clutch Housing (518):</p> |

- A good seal will have an orange stripe.

| Correction | <p><b>Note:</b> Inspection of the transmission oil pan in many cases, will show no or minimal clutch sediment present.Replacement of the valve body does not resolve the condition.</p> <p>Replace the Triple Clutch Housing (518), 1-2-3-4-6-7-8-10-Reverse Clutch (C4) Apply Piston (523), C4 Apply Piston Outer Seal (525) and the 4-5-6-7-8-9-10-Reverse Clutch (C6) Apply Piston (534).</p> |

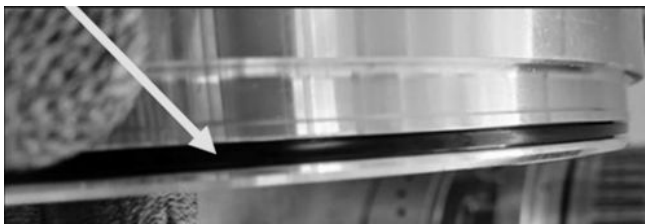
6712755

- A degraded seal will be all black.

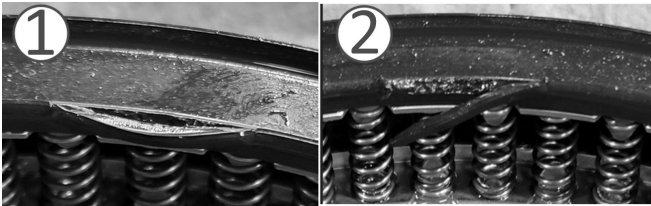
| | <div></div> <div>6712761</div> <ul style="list-style-type: none"><li>• The 4-5-6-7-8-9-10-Reverse Clutch (C6) may have experienced a de-bond (1) or tear (2) condition of the C6 Apply Piston (534).</li></ul> |
