GROUP	MODEL
Voluntary Emissions Service Campaign	2021-2024MY K5 (DL3a) w/1.6L T-GDI
NUMBER	DATE
SC288 (Rev 4, 10/25/2024)	April 2024

FUEL TANK AND/OR PCSV CHECK VALVE

INSPECTION/REPLACEMENT + ECU SW UPGRADE (SC288)

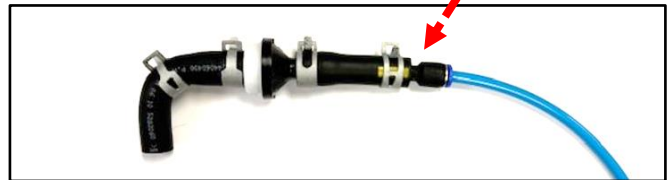
- 3b. Connect the PCSV check valve (B) to the pressurization adapter (D).
- 3c. Connect the shop air supply hose to the air supply valve (E).
- 3d. Open shop air supply valve (E).

The pressurization adapter (D) **MUST** be connected to the PCSV check valve (B) in the direction shown. If the pressurization adapter is connected incorrectly, the inspection cannot be properly conducted due to incorrect airflow to the check valve.

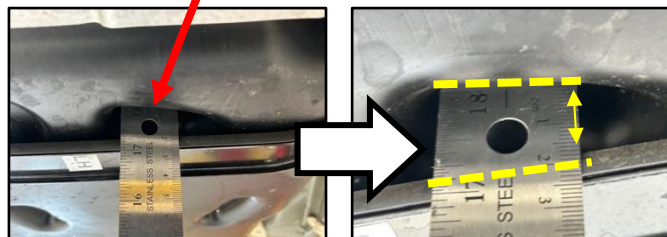
AWD/4WD

- 2b. Left Hand Fuel Tank Band

- If the gap measures 21mm or LESS (OK), proceed to measure the right hand fuel tank band.
- If the gap measures 22mm or MORE (NG), attach one clear photo using KDS Tablet Warranty Claim Attachment Tab of the **NG** measurement, then proceed to step 3.

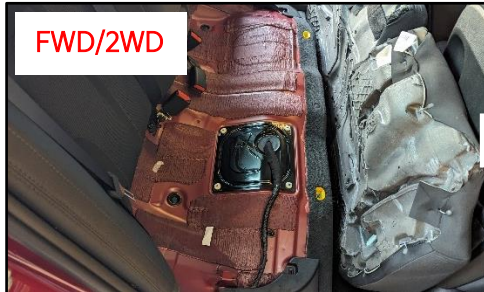
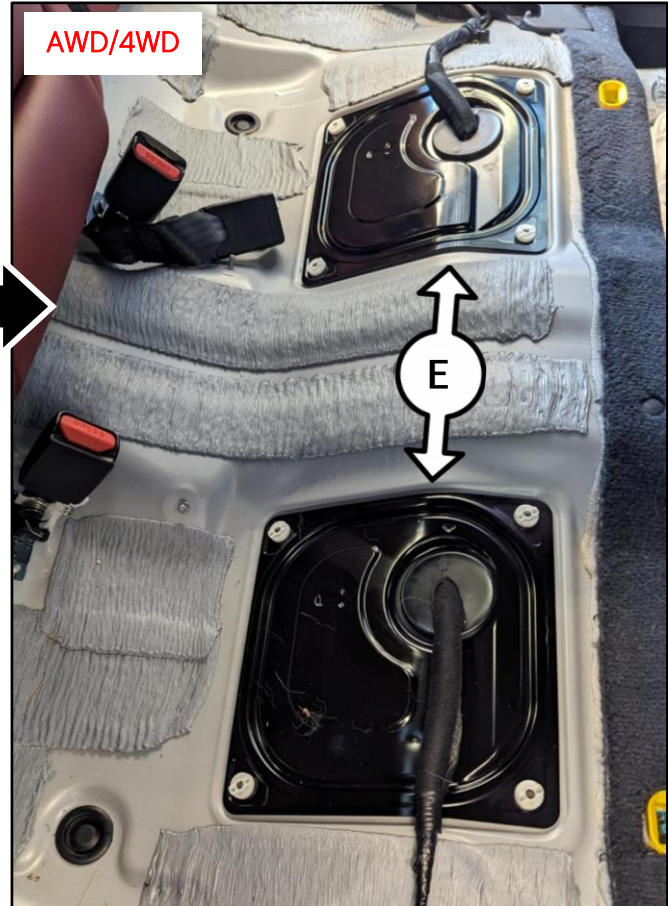
Note: AWD model shown on the right for reference, the FWD models shown below feature a single fuel tank service cover access.

4. Inspect the seat floor to fuel pump service cover (E) (4 sides) for any gaps:

- If a gap is NOT present (OK), the cover is seated flush with the seat floor panel, then proceed to replace both the PCSV check valve and Fuel Tank (page 12). After completing the two replacements, perform the 'ECU Upgrade Procedure' (page 8).

- If a gap IS present (NG), the cover is lifted/detached from the seat floor panel, create a Techline Repair Assistance (RA) case, and attach one clear photo using KDS Tablet Warranty Claim Attachment Tab of the NG condition to the Techline case and Warranty Claim.

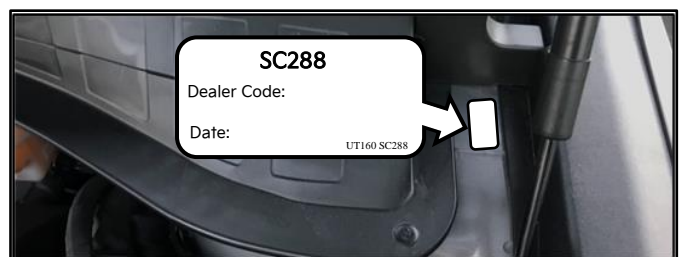
The dealer must fill in the Dealer Code and Date information fields on the Campaign Completion Label. Once complete, affix the campaign completion label under the hood of the vehicle, as shown below.

CA and S.177 States Only: Apply SC288 Campaign Completion Label onto the body in the area next to the shock tower, as shown. **NOTE: Be sure to clean the mounting surface to ensure proper label adhesion.**
