PERSONAL SERVICE LAB

Rear Exhaust Silencer Anomalies Diagnosis

ATTENTION! This bulletin supersedes both [MAS003867](#) and [MAS004115](#). Please discard/remove all copies of the previous bulletin.

SUBJECT: Noise from Rear Exhaust Silencer

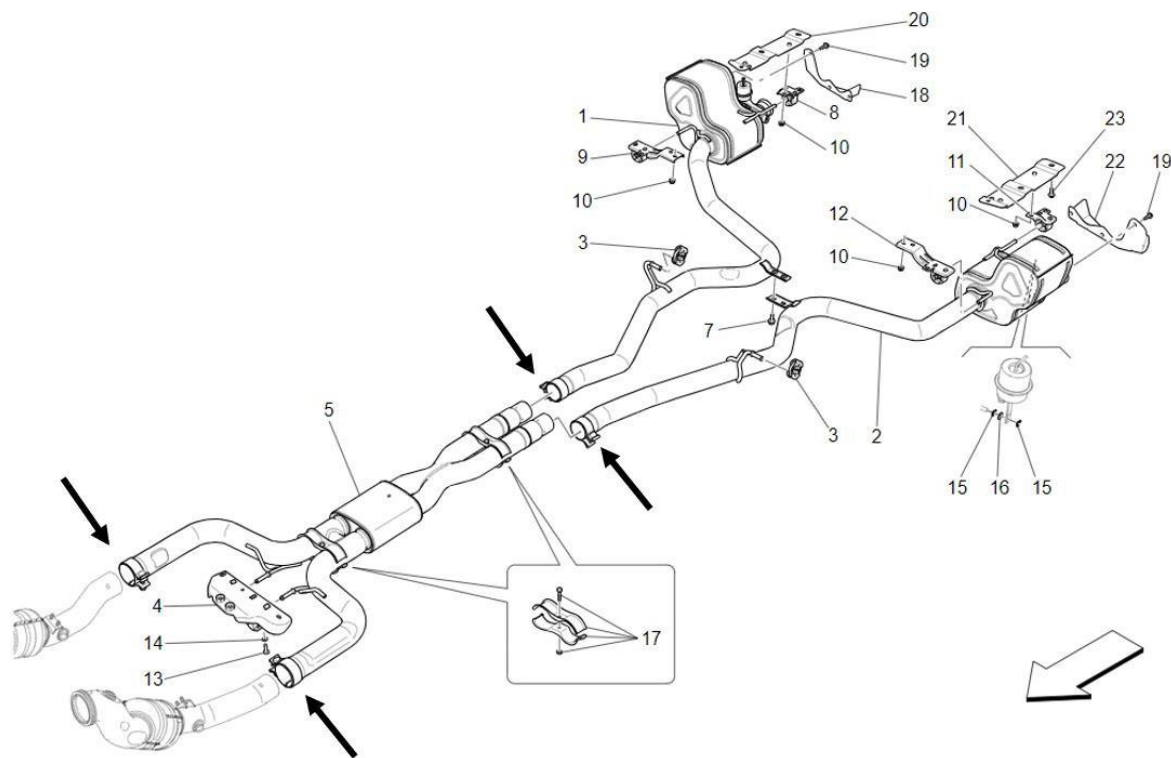
- 3a) Check the tightness and the conditions of the anti-vibration pads (items n. 8,9,11 and 12).
- 3b) Check the tightness of the collars (pipe clamps) indicated by the arrows, see the above picture.
- 3c) Check the tightness of the nuts of the central silencer support (item n.17).
- 4) Highlight any checks that are NOT OK in BOL (documenting with photos and/or videos) and check whether the problem persists even after correctly torquing. If so, proceed to step 5.
- 5) Remove the silencer and check whether there is incomplete closure of the by-pass valve in "Normal" mode which could cause vibrations/rattling (below, an example photo relating to poor closure of the valve):

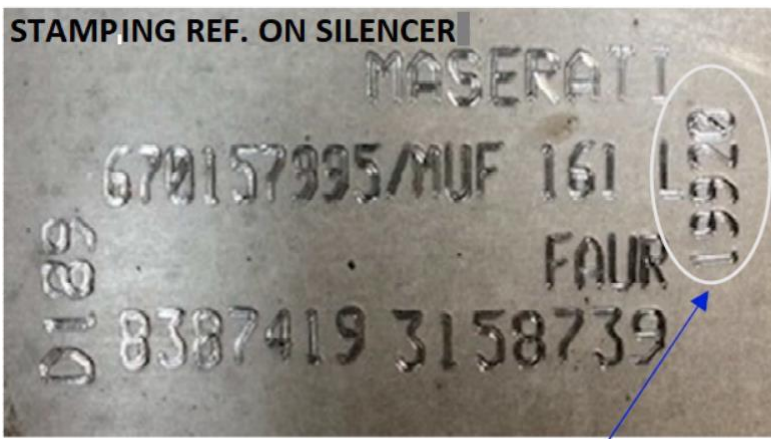
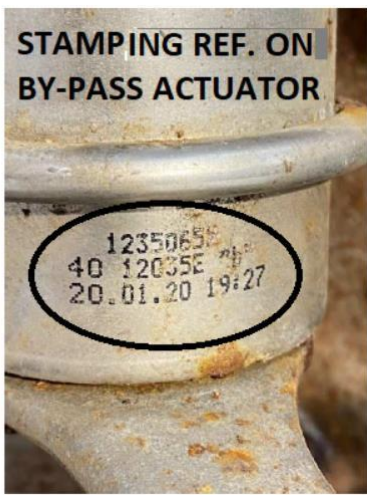
- 6) Provide the results of the checks carried out in BOL and attach a photo of the identification references stamped both on the rear silencer, which is suspected to be noisy, and on the relevant bypass valve. Below are some examples.

SUPPLIER PROD. DATE ← 17/07/2020

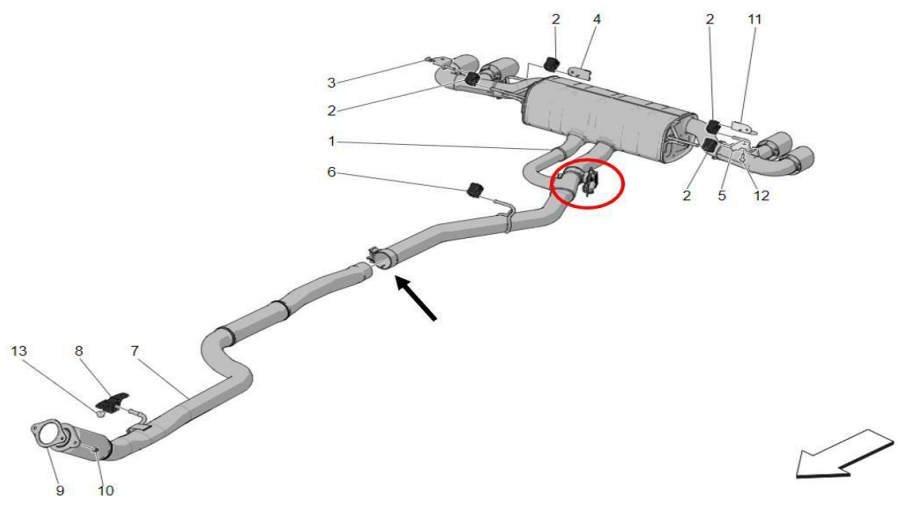
- 4a) Check the tightening and the conditions of the rear anti-vibration pads (items n. 2). 4b) Check the tightening of the collar indicated by the arrow, see picture.
- 4c) Check the tightening and the conditions of the central silencer support pad (item n. 8).

NOTE: do NOT dismantle the bypass valve actuator from its seat. See the red circle in the figure.

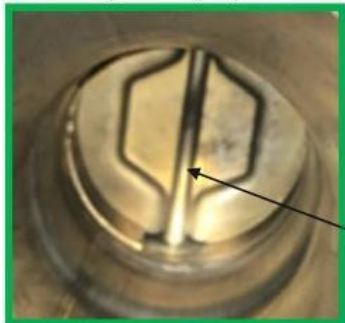
Shaft

7) Disconnect the rear silencer from the central silencer. With an endoscope, inspect the valve as shown in the images below. Document the condition of the valve with photos.

OK mounting of valve group show this visible shaft:

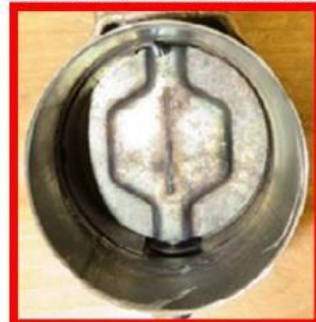
NOK mounting of valve group show this covered shaft:

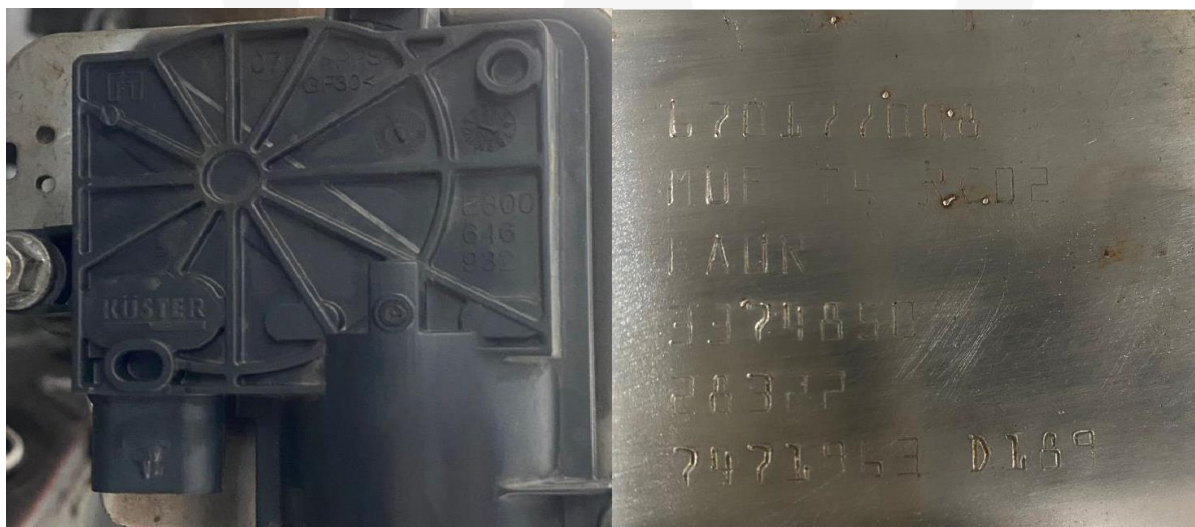
8) Provide the results of the checks carried out in BOL and attach a photo of the identification references stamped both on the rear silencer, which is suspected to be noisy, and on the relevant bypass valve. Below are some examples.

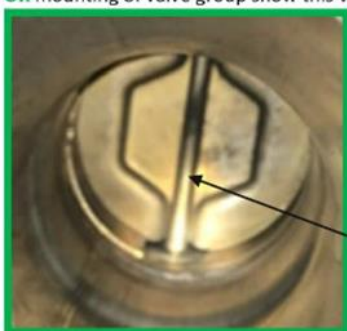
Shaft

- 2) Disconnect the rear silencer from the center pipe. Using an endoscope, inspect the valve as shown in the images below. Document with photos of the condition of the valve and any possible presence of rust/oxidation on the assembly or bore.

OK mounting of valve group show this visible shaft:

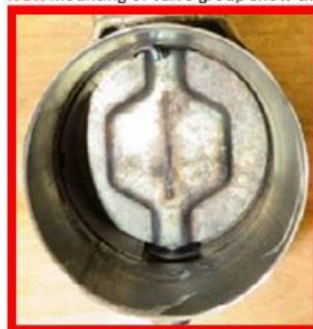
NOK mounting of valve group show this covered shaft:

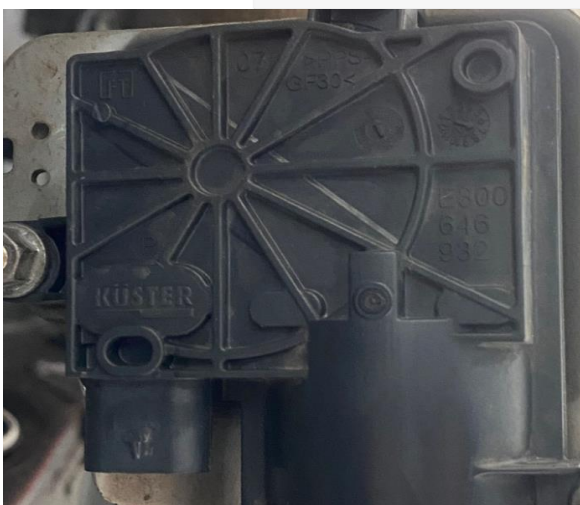
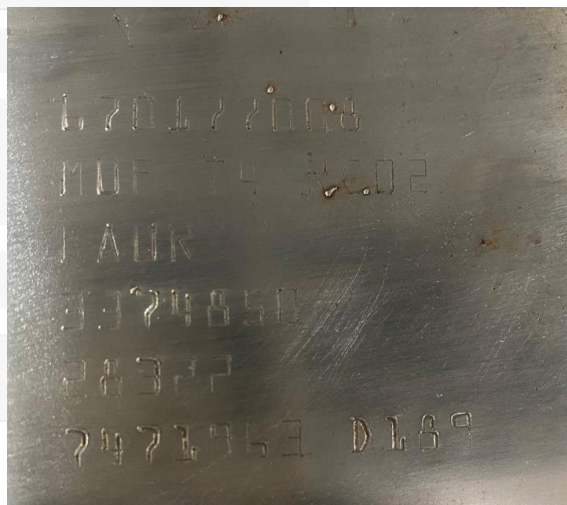
- 4) Attach a photo of the identification references stamped on the rear silencer.
