Diagnostic Sheet

Grecale –Axle Shaft Clicking Noise - Tech Tip

MODELS: M182 Grecale ICE ONLY (All MY). **Not applicable to BEV versions.**

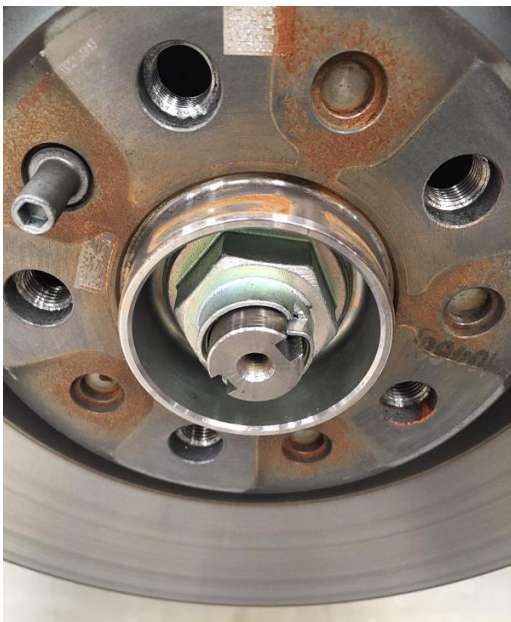
Picture 1

CONCERN: Front/rear clicking noise while maneuvering the vehicle.

1. Remove the M24 axle nut (Pic.1) and thoroughly clean the grooves and hub thread with brake cleaner (Pic. 2).
2. Apply Molykote copper paste as illustrated – (Pic.3).
3. Replace the axle nut (component #12 in spare parts table 03.22-2 FRONT WHEELS TRANSMISSION).
4. Torque the axle shaft nut to specifications in the workshop manual.
