**SERVICE CAMPAIGN 75-02 ALTERNATOR CABLE ROUTING  
AFFECTED MODELS: 2019 - 2025 TRAVATO**

# Alternator Cable Routing Travato Lithium

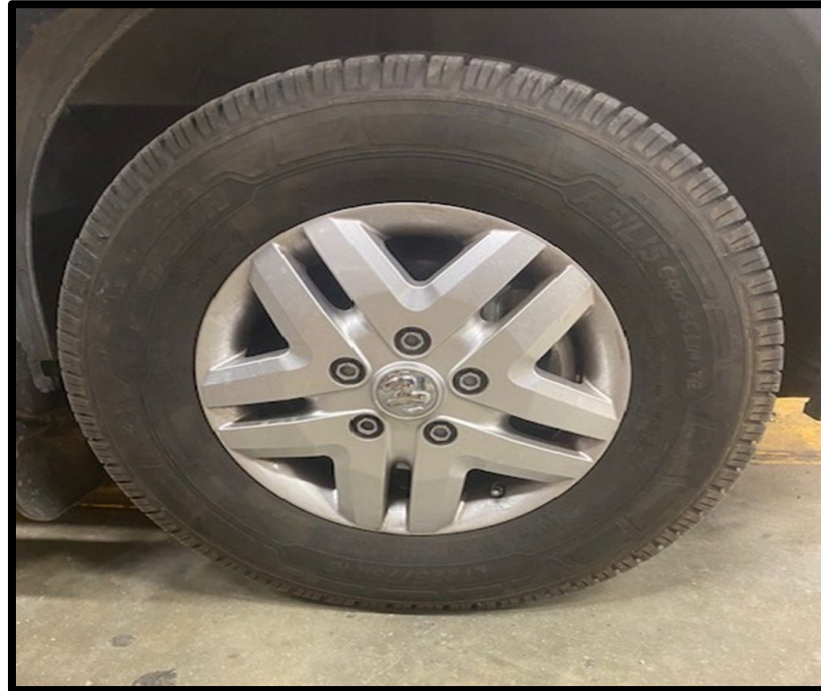
# Step 1 – Remove Right Front Wheel

1. Remove right front wheel, 22mm socket.

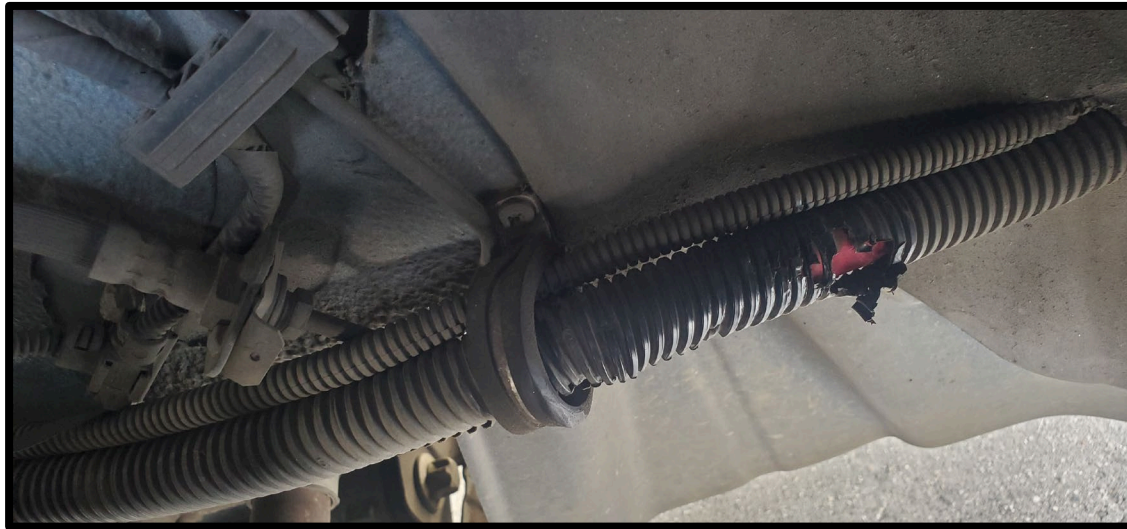
# Step 2 – Inspect Cable and Shielding

1. Inspect cable and convoluted shielding for any sign of damage. If convoluted shielding is damaged, replace affected area. If there is damage to the cable, contact Winnebago Technical Service at 866-653-4329.

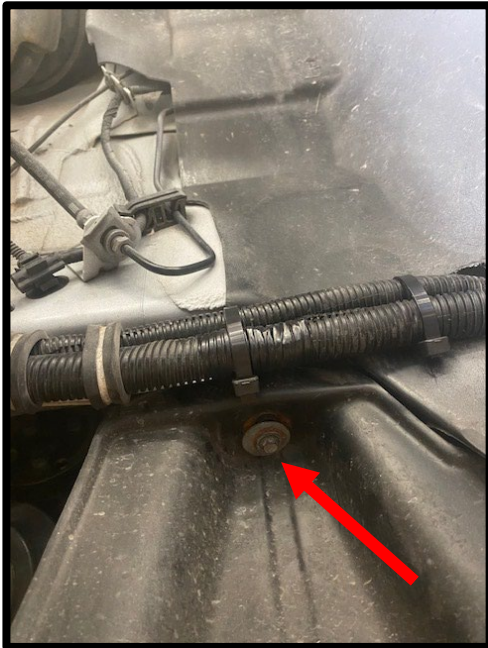
Splash shield fastener  
under wheel well panel

1. Remove fastener for splash shield under chassis tube (8mm). Will be reinstalled later.
2. Remove fastener from wheel well shroud (8mm). Will be reinstalled later.

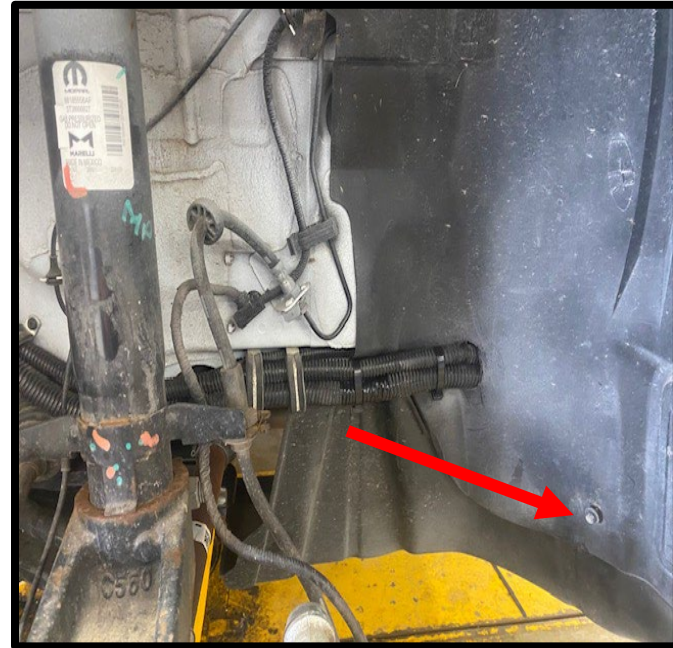
Fastener in wheel well  
shroud

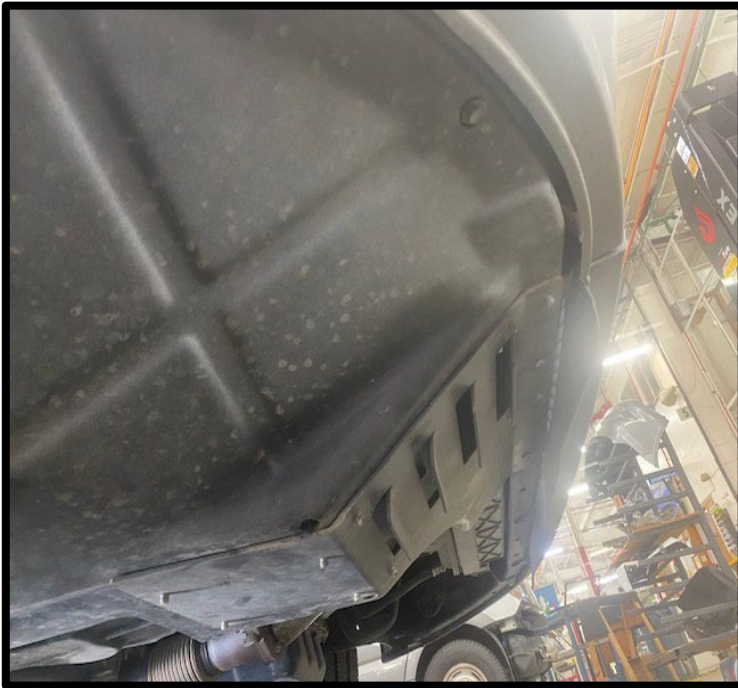
Splash shield

1. Reinstall splash shield and wheel well panel using original fasteners from Step 4.

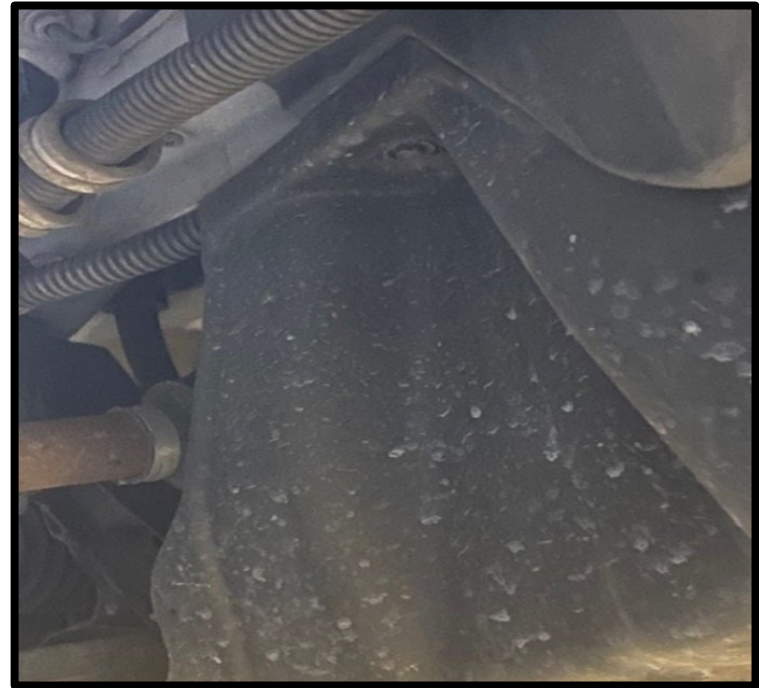
Wheel well panel

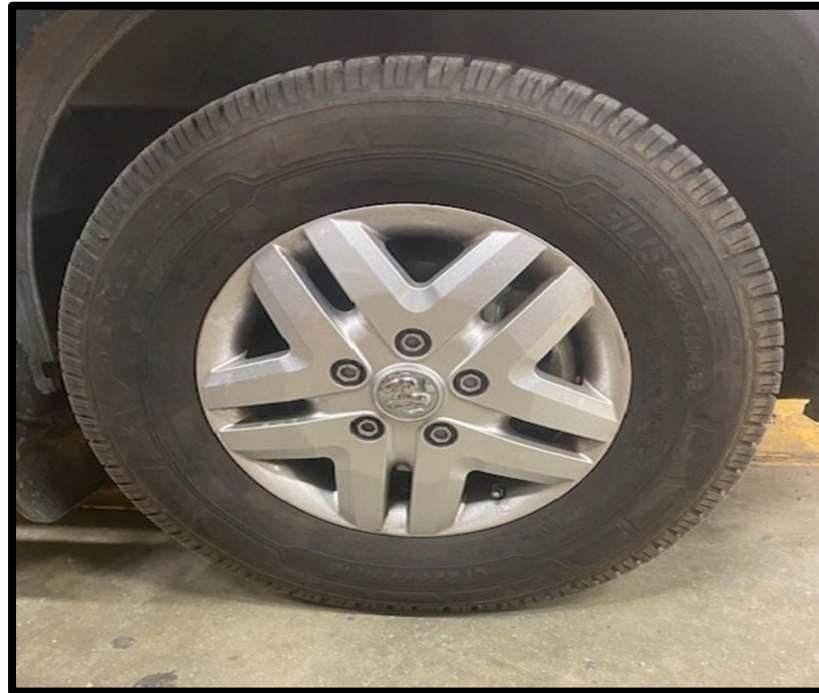
# Step 11 – Reinstall Right Front Wheel

1. Reinstall right front wheel, 22mm socket, 140 ft lbs.
2. Turn wheel full travel left and check clearance to wire harness at front of tire, should be over 1”.
3. Turn wheel full travel right and check clearance to wire harness at rear of tire, should be over 1”.
