Service Alert

Subject: TRANSMISSION DESIGN CHANGE (PART SUPERSESSION)	Service Alert No.: SA-002/24
	Last Issued : 10/23/2024

2025 CX-70 (H3T)

2024-2025 CX-90 (H3T)

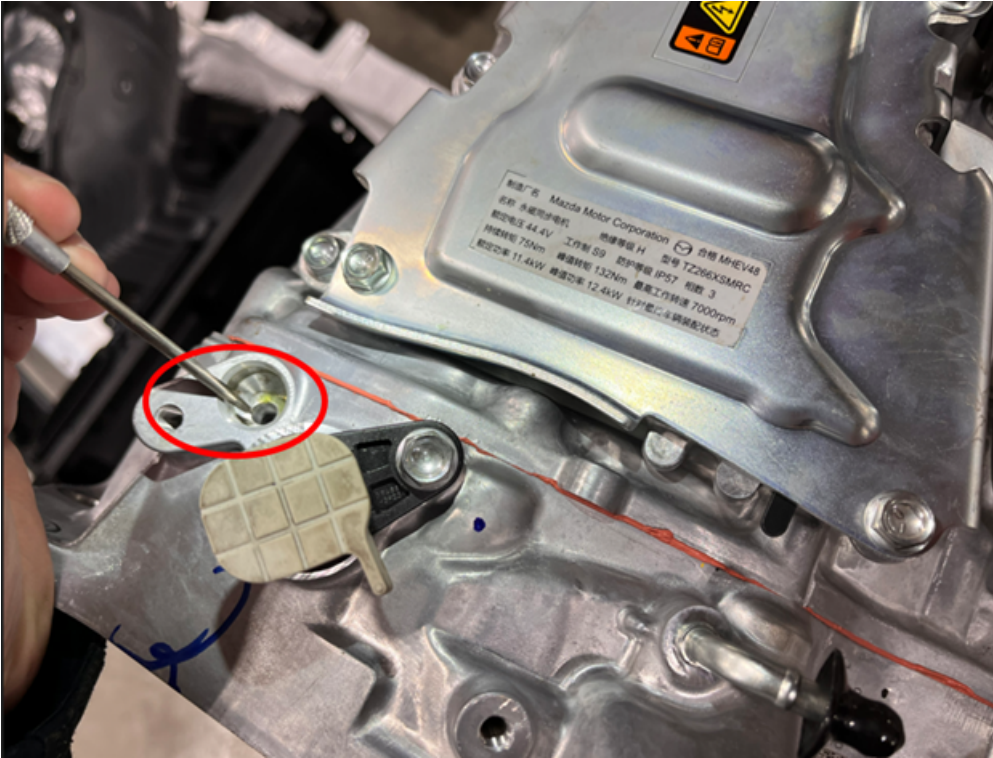
Original Design (Transmission Hole Drilled)

Old design originally required a coolant line running to the top of the bell housing, the new design has omitted the hole and need for the coolant line.

The new/superseded design can be used in place of the old/original design and the coolant hose is no longer needed to be used.
