McLaren Artura Engine Oil Leak Diagnosis Guide – Oil Cooler

Location: Powertrain

Topic: McLaren Artura Engine Oil Leak Diagnosis Guide - Oil Cooler

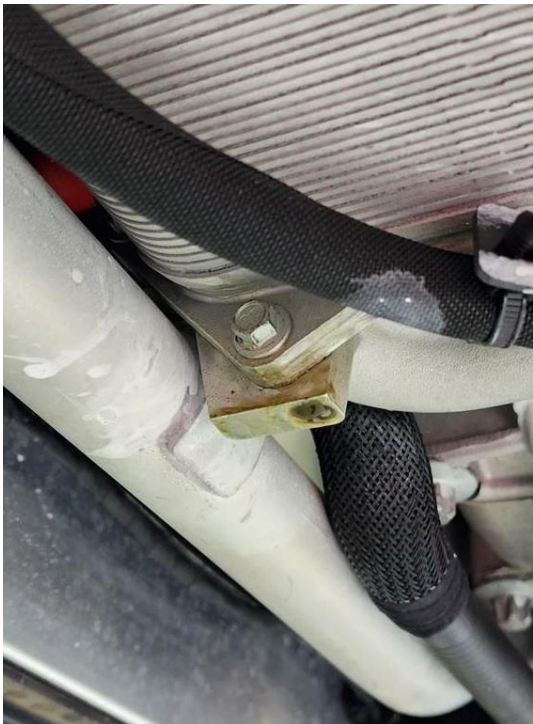
If an Artura is found to have a leak from the oil cooler area (oil or coolant), Please follow the steps below

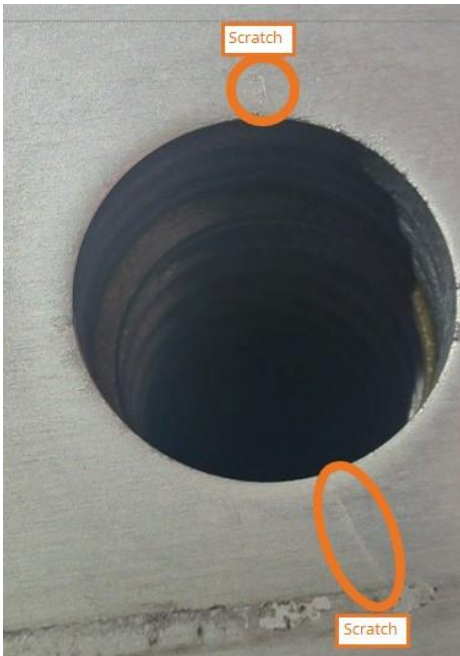
17. Inspect oil cooler face, and through holes escalate any concerns for review on TR providing images Example:

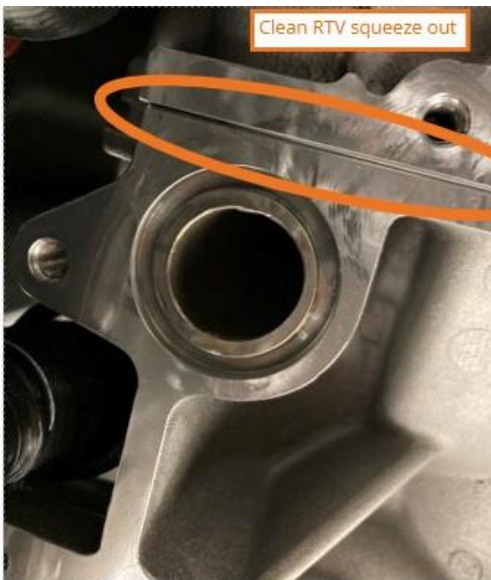
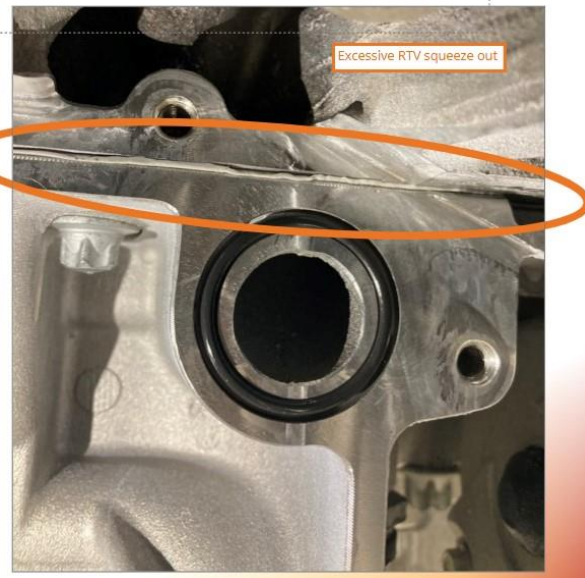
18. Inspect block interface for RTV Squeeze out, escalate if concerned with squeeze out on TR to the Technical Support team

Example of clean face vs high squeeze out:

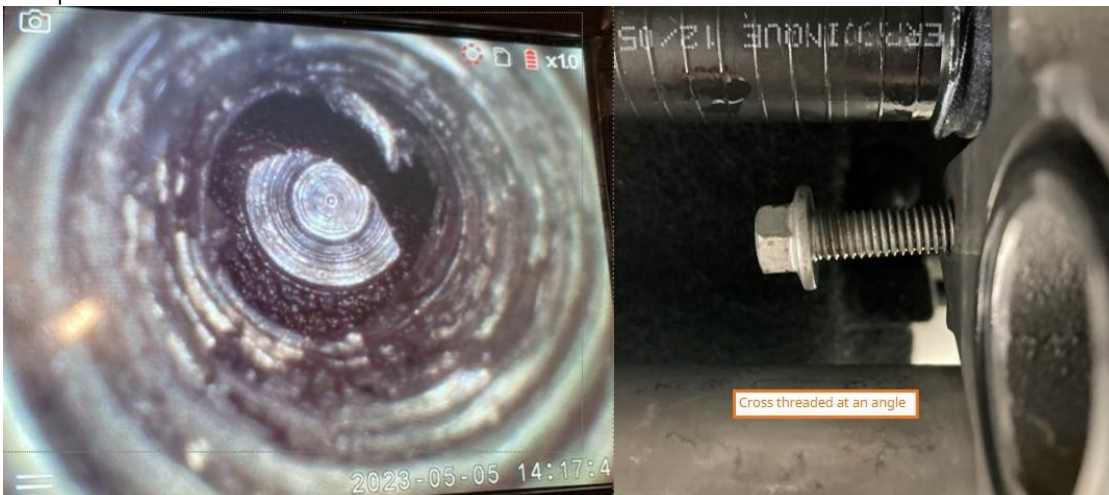
19. Check the block threads, are these clean and the bolts have not been fitted cross threaded/damaged?

Example:
