Preview Solution CBR-2330-3

## **Volvo Chassis - 13L TC Engine Turbocharger Wastegate Shaft To Housing Leak - VN (4) Chassis**

Valid for 2024 to 2027 13L TC engines

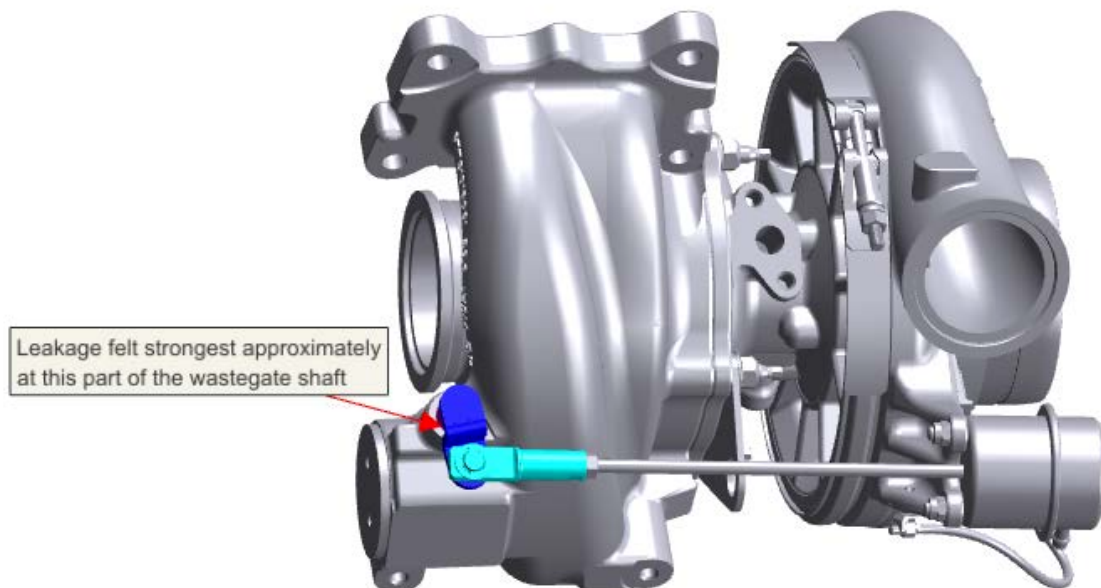
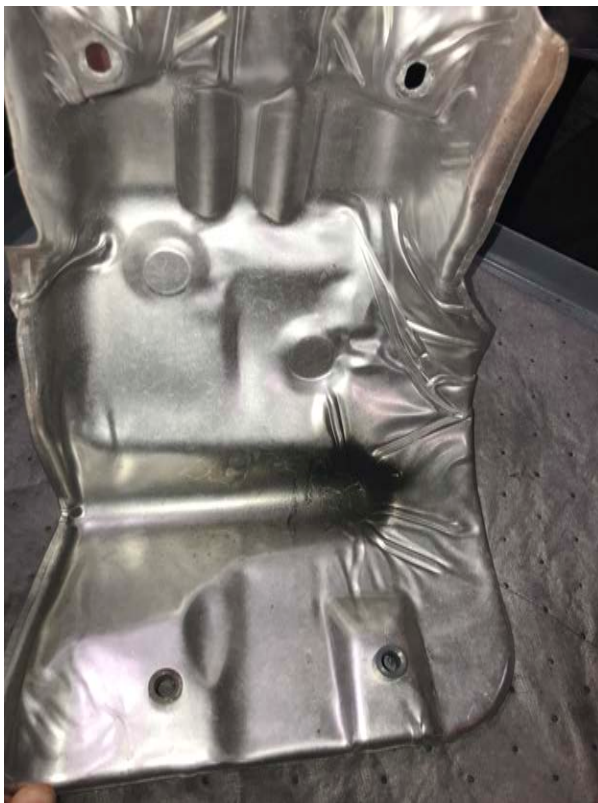
Mechanical components with moving parts designed for high-temperature environments – such as the turbo wastegate used on the 13L TC engines – are susceptible to certain kinds of leakages due to their design requirements. This may result in soot buildup on the inside of the turbo heatshield under certain operating conditions.

This is a known issue. **Do not** use soot build up on the inside of the heat shield as the primary reasoning for replacing the turbo. Clean any soot or debris build up from the heatshield and reinstall.
