TO: All U.S. Ford and Lincoln Dealers
SUBJECT: **Customer Satisfaction Program 24N01 - Supplement #1**
Certain 2020-2022 Model Year Explorer Vehicles
Rear Axle Bolt Fractures
REF: **Customer Satisfaction Program 24N01**
Certain 2020-2022 Model Year Explorer Vehicles
Dated July 3, 2024

CERTAIN 2020-2022 MODEL YEAR EXPLORER VEHICLES — REAR AXLE BOLT FRACTURES

NEW ! SERVICE PROCEDURE

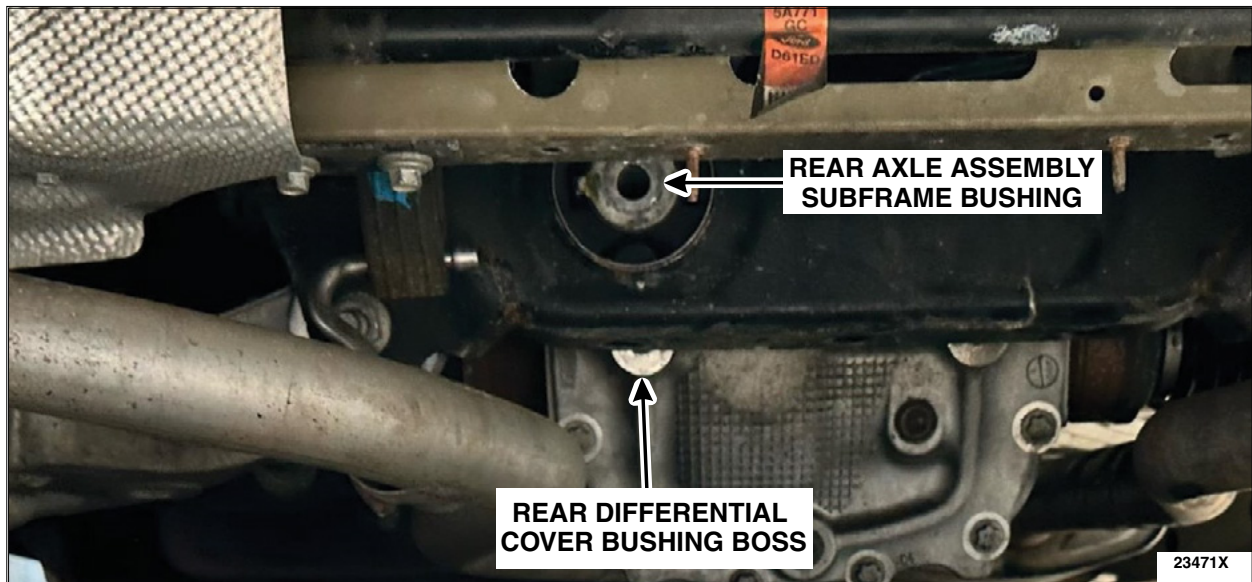
FIGURE 1

1. With the vehicle in NEUTRAL, position it on a hoist. Follow the WSM procedures in Section 100-02.
2. Ford has requested photo evidence of a broken or missing rear axle bolt for this Customer Satisfaction Program. Visually inspect the Rear Differential Unit (RDU) for a broken or missing RDU fastener. Is the RDU bolt to axle cover bushing boss broken or missing? *See Figure 1 on Page 2.*

YES - Does Not Pass inspection. Submit photos of the broken or missing RDU axle bolt, refer to the Photo Request Submission on Pages 14 and 15. Wait for the Special Service Support Center (SSSC) approval to begin any repairs. Then, proceed to Step 3.

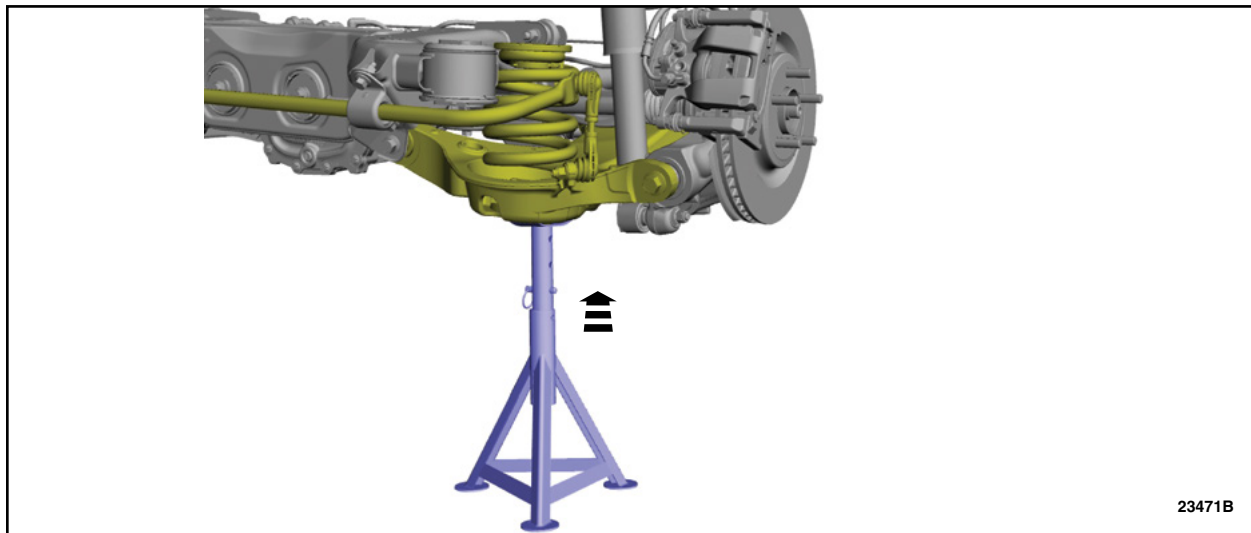
FIGURE 2

6. On the rear LH side of the vehicle, use a suitable jack to raise the suspension until the distance between the center of the hub and the lip of the fender is equal to the measurement taken in Step 3, (curb height). See Figure 2.

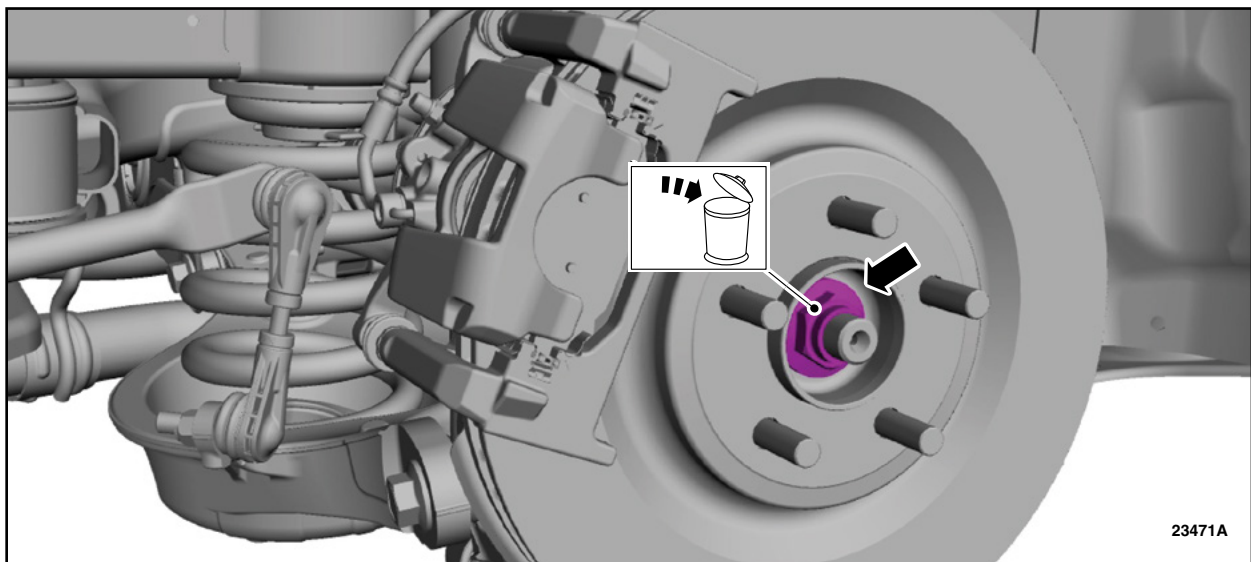
FIGURE 3

7. Remove and discard the LH rear wheel hub nut. See Figure 3.

• Torque: 221 lb.ft (300 Nm).

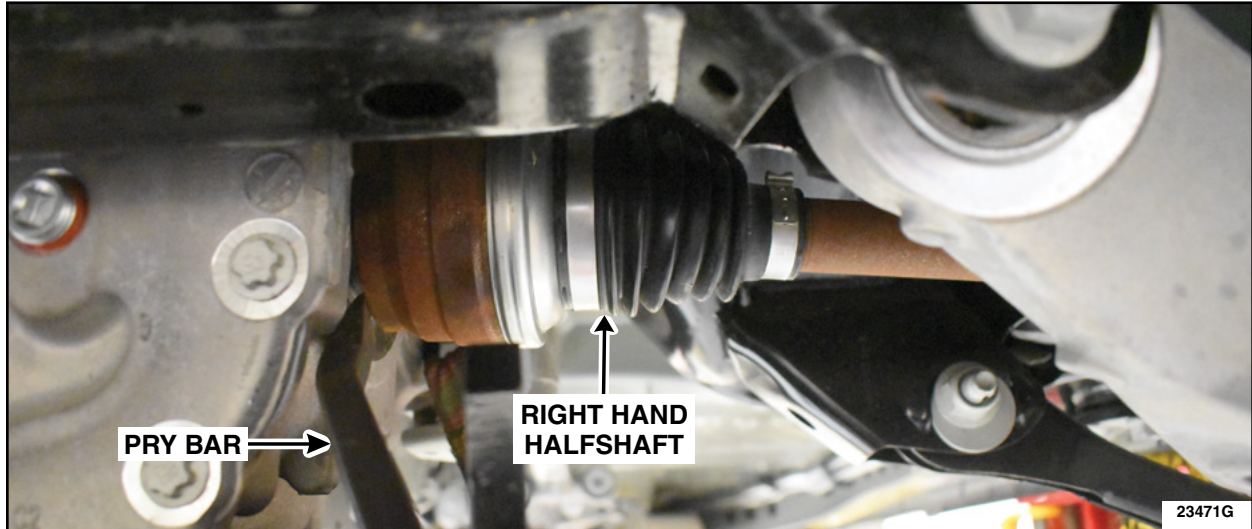
FIGURE 8

15. Using a pry bar, disengage the RH rear halfshaft inner cir-clip from the rear axle assembly.
See Figure 8.

NOTE: It is not necessary to remove the RH rear halfshaft from the vehicle.

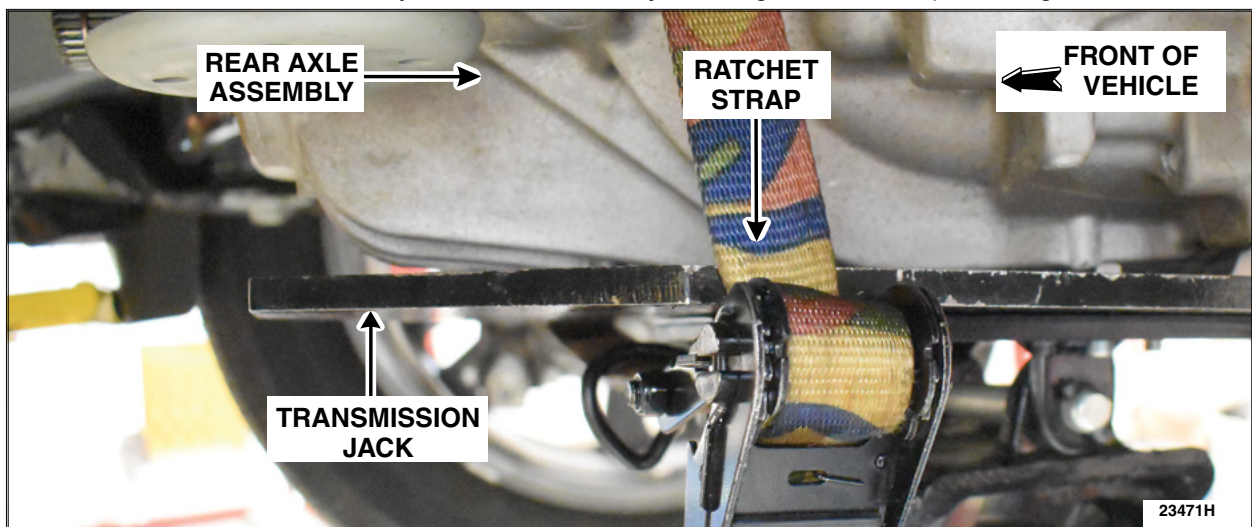
FIGURE 9

16. Secure the rear axle assembly to the transmission jack using a ratchet strap. See Figure 9.

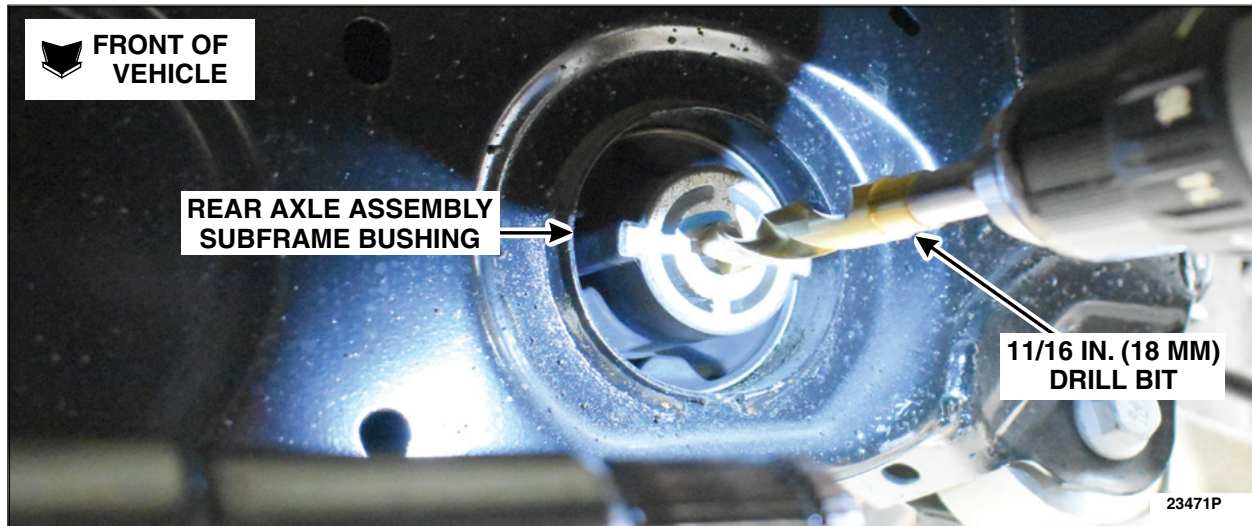
FIGURE 15

22. Install only a *new* differential housing cover (Do Not install the rear axle assembly at this time). Follow the WSM procedures in Section 205-02.
23. Using an 11/16 in. (18 mm) or larger drill bit, drill out the rear axle assembly subframe bushing bolt hole. See Figure 15. Click on the video link to see the drilling process: [▶](#)

NOTE: The use of a corded, high power drill and a good quality/sharp drill bit along with the use of cutting oil will aid in drilling out the rear axle assembly subframe bushing bolt hole.

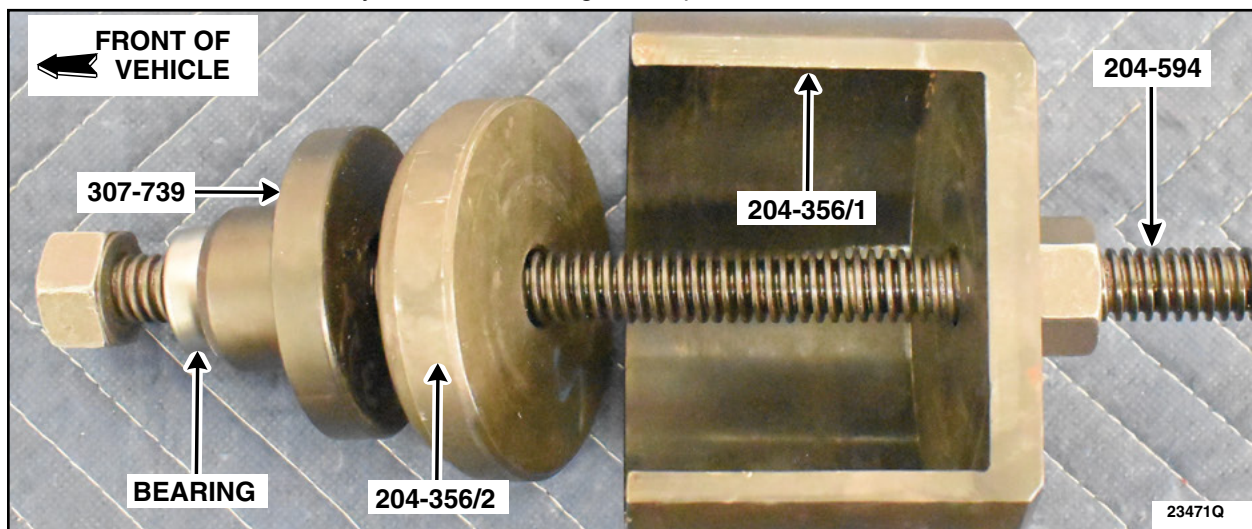
FIGURE 16

NOTE: The bearing, 307-739 Installer, R3 Bearing and 204-356/2 Remover/Installer, Radius Arm Axle Bushing go towards the front of the vehicle.

NOTE: The rear axle assembly subframe bushing will be pressed out towards the rear of the vehicle.

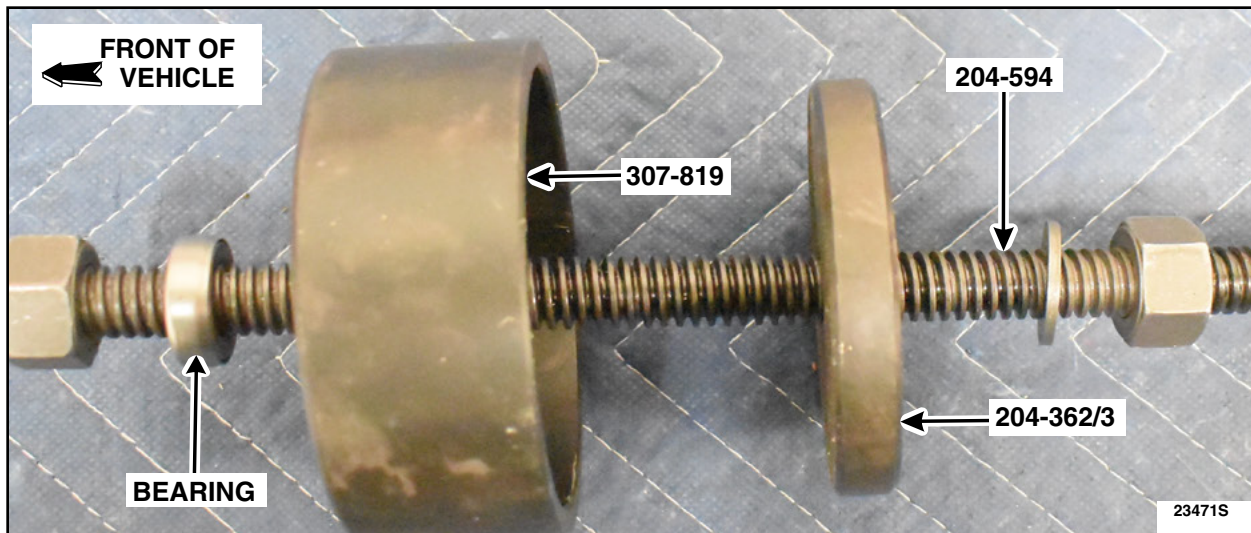
FIGURE 18

25. Using the ESST tools listed below, install the *new* rear axle assembly subframe bushing. See Figures 17 and 18.

NOTE: The bearing and 307-819 Cup, Receiver, go towards the front of the vehicle.

NOTE: The *new* rear axle assembly subframe bushing will be pressed in from the rear of the vehicle.

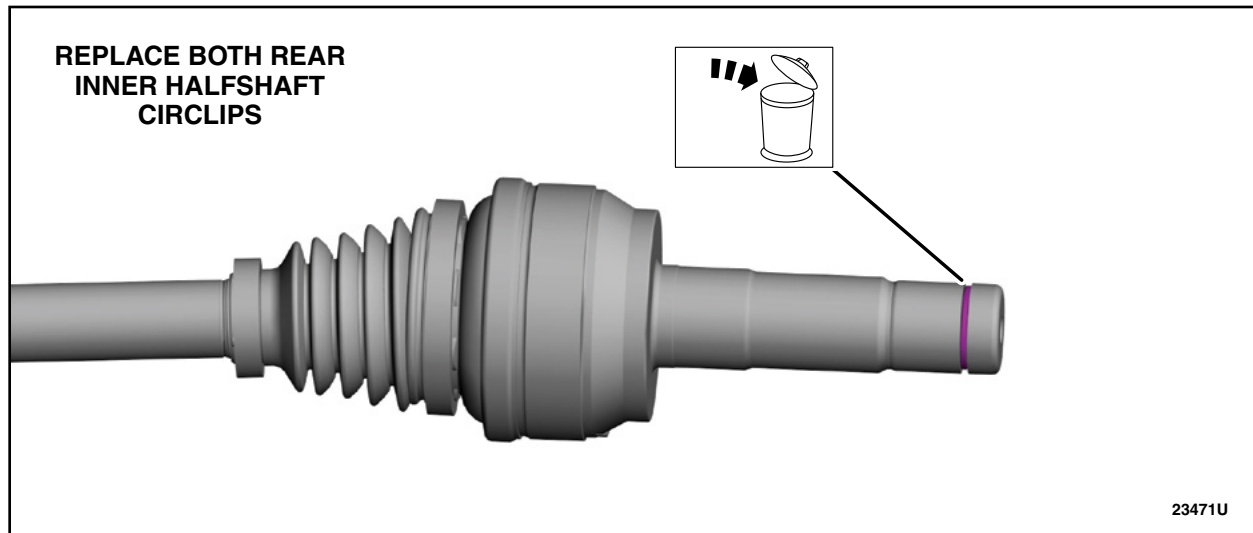
FIGURE 19

NOTE: In the next Step, make sure both rear halfshaft circlip openings are located at the bottom or 6 o'clock position to allow for easy installation when directed to install them.

27. Remove and discard both rear inner halfshaft circlips. Then, install *new* circlips onto both rear inner halfshafts. See Figure 19. Then, proceed to the next Step.

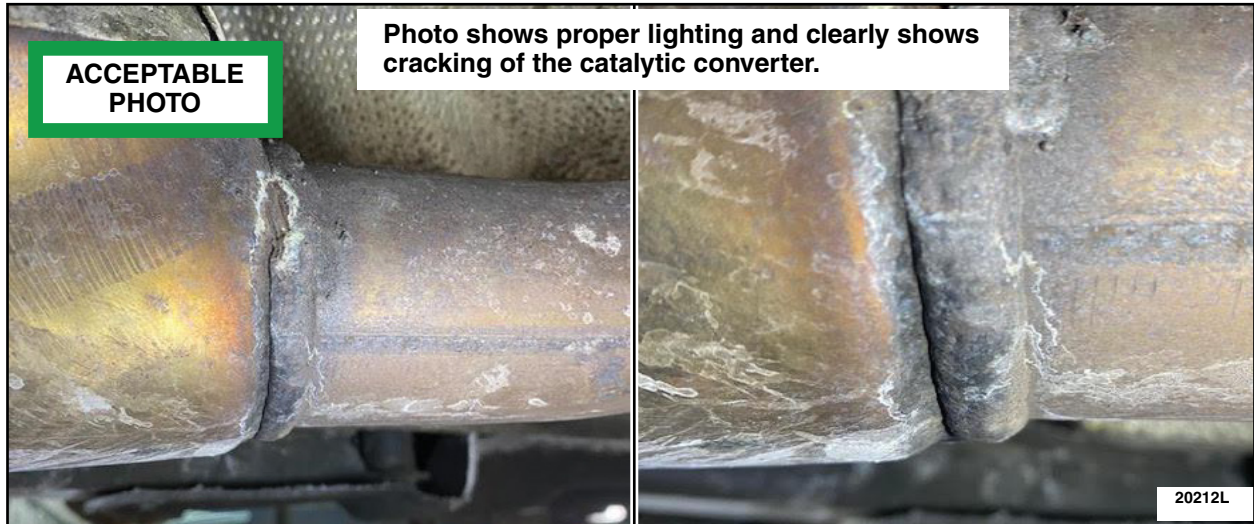
FIGURE 20

Acceptable Photos: Clearly shows the area of damage or failure related to this recall.

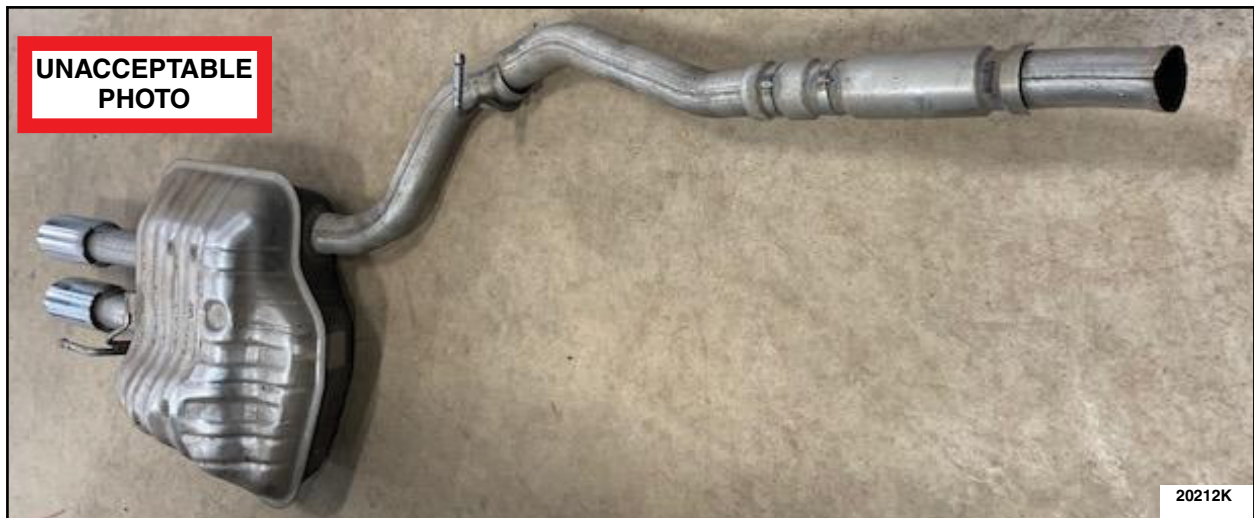
FIGURE 21

Unacceptable Photos: Is not clear or does not show the area of damage or failure related to this recall.
