WPK9 - Check Crankcase Ventilation Plug Connection (Workshop Campaign)

Model Line: **Panamera (971)
Macan (95B)
Cayenne (9YA / 9YB)**

Concerns: **Crankcase ventilation line plug connection**

Cause: **There is a possibility that the plug connection of the crankcase ventilation is not locked correctly on the affected vehicles.**

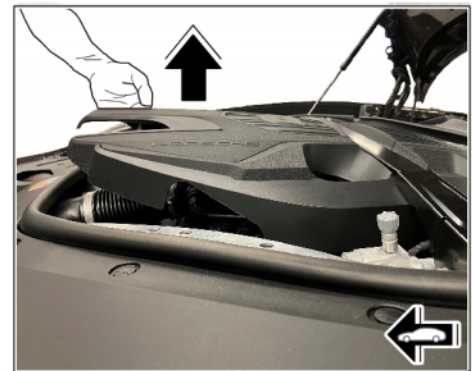
Access point for plug connection for crankcase ventilation

The dome strut is not removed, it is sufficient to only lift the engine compartment cover. ⇒ *Access point for plug connection for crankcase ventilation*

- 1 Loosen and lift motor cover (design cover).
For procedure, see: ⇒ *Workshop Manual '108319 Removing and installing engine cover (design cover)'*

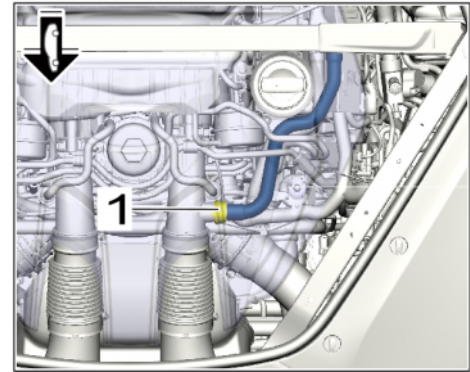
Plug connection for crankcase ventilation

If this is the case, the tightness of the crankcase ventilation cannot be guaranteed.

- 2 Check crankcase ventilation plug connection for tightness ⇒ *Plug connection for crankcase ventilation -1-* by countering it and lock it correctly if necessary.
- 3 Fasten engine cover (design cover).
For procedure, see: ⇒ *Workshop Manual '108319 Removing and installing engine cover (design cover)'*
- 4 Attach **Recall Proof of Completion label** to the front lid (**California Porsche Centers only**).
