# Technical Service Bulletin

## 10 Oil is lost from the filler cap

10 24 28 2059446/7 October 8, 2024. Supersedes Technical Service Bulletin Group 10 number 23-25 dated January 24, 2023 for reasons listed below.

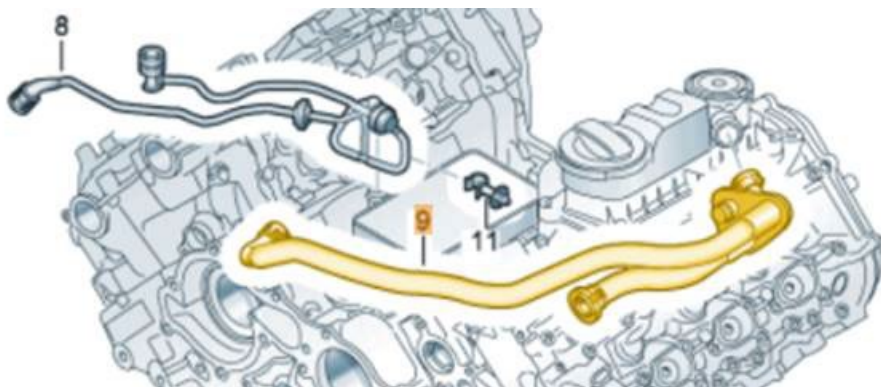
**Figure 1.** Breather line for the Turbocharged V6.

Replace the breather line (different variants available, only order by VIN) by following the Elsa repair manual (Figures 1 and 2).

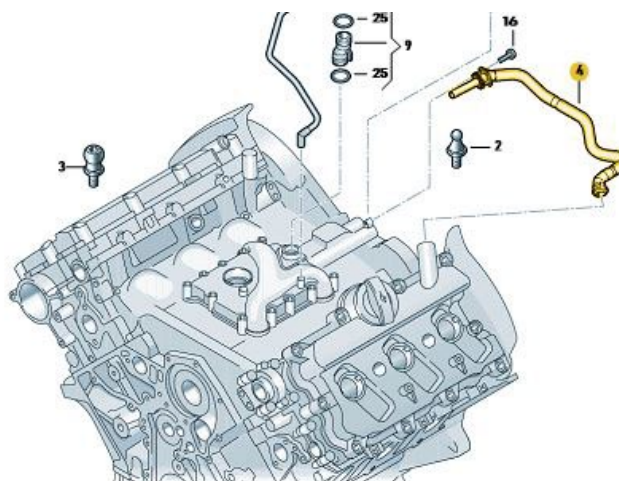
**Figure 2.** Breather line for the Supercharged V6 (EVO).
