Technical Service Bulletin

87 Display on air conditioner operating unit for setting temperature - pixel fault/black

87 24 91 2075688/1 October 21, 2024.

Model(s)	Year	VIN Range	Vehicle-Specific Equipment
Q5, Q5 e quattro, Q5 Sportback, SQ5, and SQ5 Sportback	2022 – 2024	All	Not Applicable

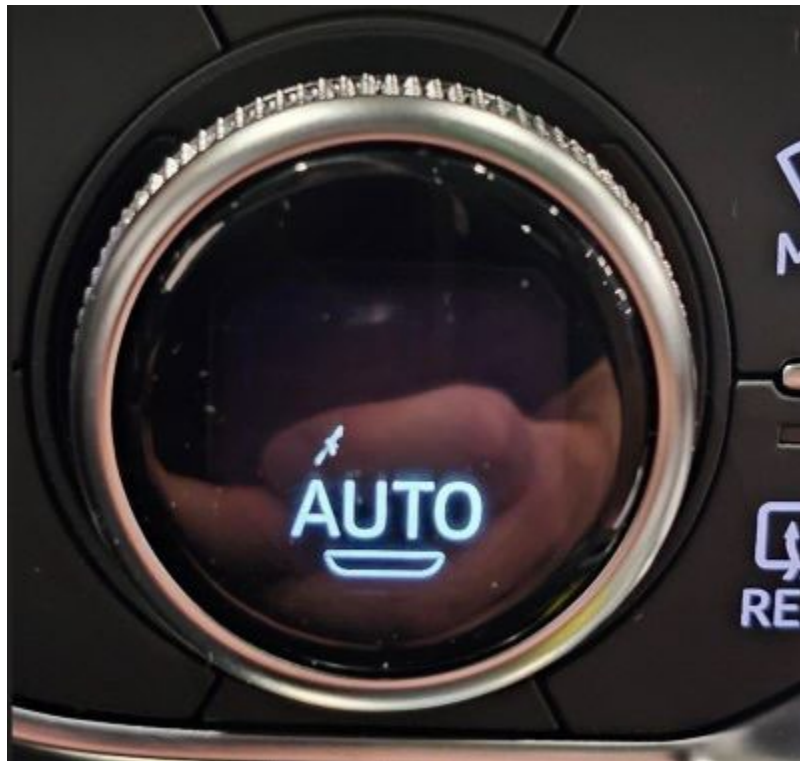
Figure 1. Display with missing temperature value.

Figure 1 shows a display with a missing temperature value, but the setting status is visible.

Component voltage can cause internal pressure on the LCD panel, which can lead to a faulty display.

If the display on the air conditioner operating unit behaves as described above under workshop findings, remove the entire unit from the vehicle and unplug it. Then, reinstall the same air conditioner operating unit in the car. If the complaint continues to occur after this process, then the air conditioner operating unit is defective, and we recommend replacing it.

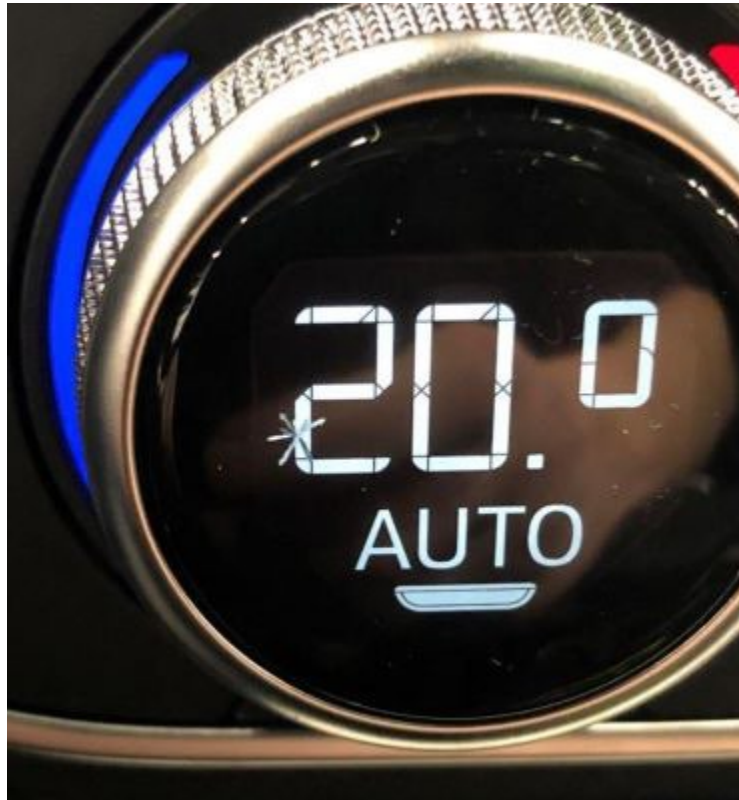
Figure 2. Display with distorted pixels.

Figure 2 shows an active display, but with distorted pixels.
