Topic	Black 'S' Front door badge missing from Black Edition specification vehicles (SC24/30)
Market area	Germany E02 Bentley rest Europe (6E02),United Arab Emirates E06 Bentley Middle East and Africa (6E06),United Kingdom E01 Bentley UK (6E01),United States E05 Bentley USA and rest America (6E05)
Brand	Bentley
Transaction No.	2075748/1
Campaign number	ED23
Note	
Type	
US code

Bentayga Series - Black Edition

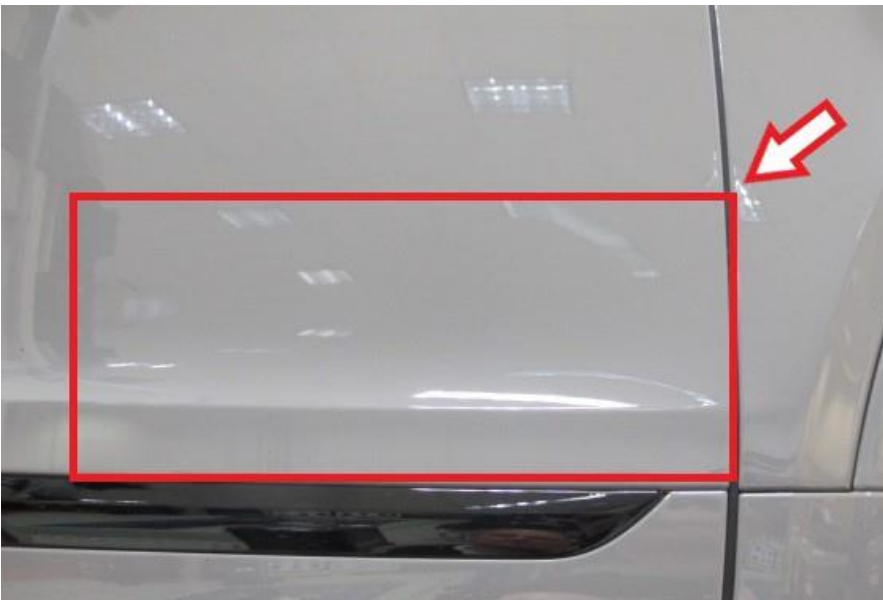
1) Clean the area shown in Figure 1 using a non-wax wash solution

- Once clean the operative must dry the area thoroughly

The surface on which the badge is to be bonded must be free of all anti adhesive impurities, such as dirt, dust and grease - Clean the mating surface with 3M Isopropanol cleaner (or similar)

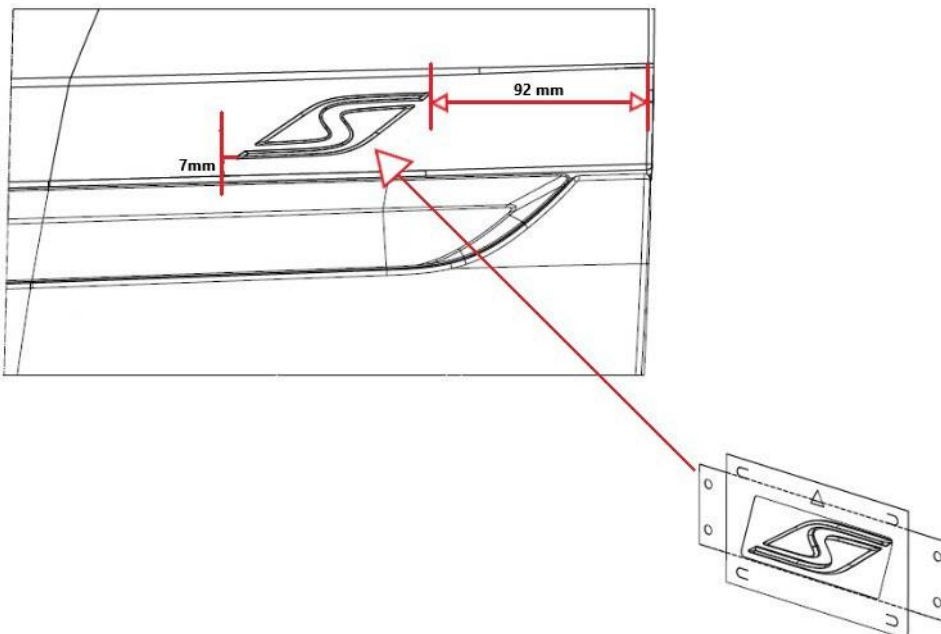
2) Referring to Figure 2 - Apply / stick the black 'S' front door badges at the location shown on the front left door and front right door

For clarity the measurements are as follows:

- 92 mm from the front door edge to the upper tip of the 'S' badge
- 7 mm upwards from the lower door edge

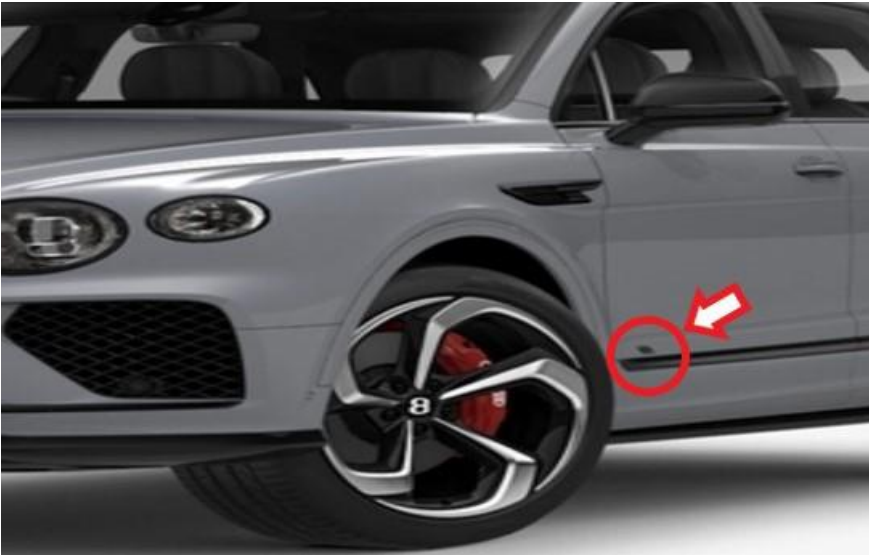
Figure 3

Fitment of the left (Figure 3) and right (Figure 4) black 'S' front door badges confirms completion
