# Super White 040 Paint Peeling from Affected Panel(s)

YEAR(S)	MODEL(S)	ADDITIONAL INFORMATION
2016 - 2022	Tacoma

Some 2016 – 2022 model year Tacoma vehicles with Super White (040) paint may exhibit paint peeling along the exterior window door frames and/or inner fender edges under the hood. The affected panel(s) require repainting to address this condition. The paint repair may need to be sublet to a body shop. Follow the Confirmation Procedure in this bulletin to verify the presence of this condition.

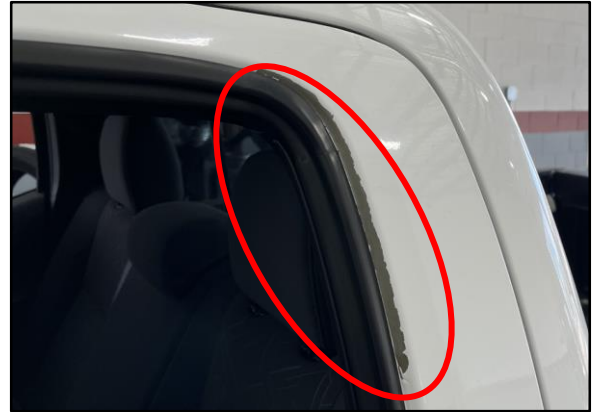
**Figure 1. Paint Peeling on Door Frame**

1. Confirm the condition exists.  
 Inspect the vehicle to determine if it exhibits paint peeling along the exterior window door frames and/or inner fender edges under the hood, as shown in Figures 1 – 3.
  - A. Is the location of the paint condition on the door window frames and/or inner fender panels?
    - **YES** — Continue to substep B.
    - **NO** — This bulletin does NOT apply. Continue diagnosis using the applicable Repair Manual.
  - B. Is the paint peeling?
    - **YES** — Continue to substep C.
    - **NO** — This bulletin does NOT apply. Continue diagnosis using the applicable Repair Manual.
  - C. Is there evidence of outside influences on the affected panel(s) that may have caused the condition?

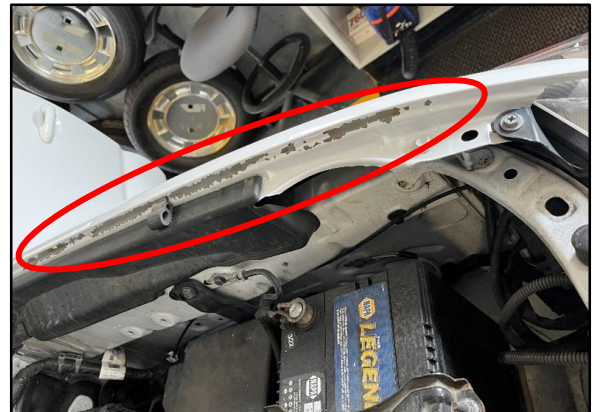
**Figure 2. Paint Peeling on Inner Fender**

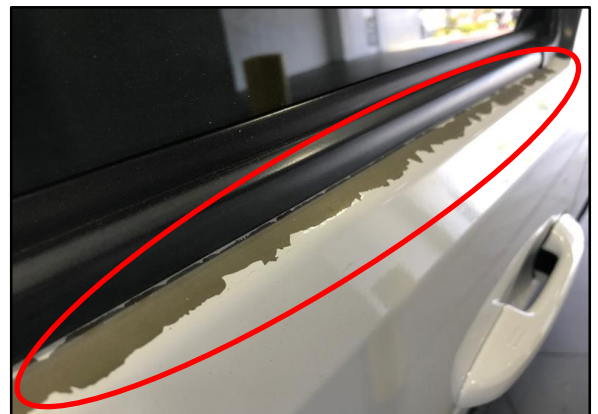
**Figure 3. Paint Peeling on Door Frame**
