2016MY  
Forte, Forte Koup (YD)  
w/Nu 2.0L GDI

PI2105Y/Z (Rev 1, 11/07/2024)

ENGINE REPLACEMENT INSTRUCTIONS  
FOR DTC P1326 (PI2105Y/Z)

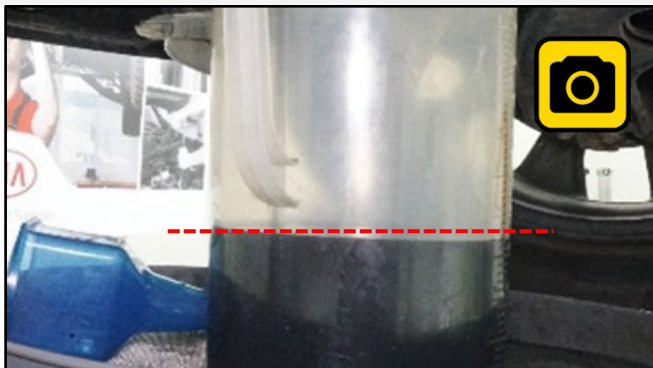
**Oil Level Measurement: (Main Flowchart → PWA Request) NO OIL READING ON DIPSTICK**

1. Remove oil filler cap, remove oil drain plug and drain oil into the measuring container SST067BUCK and check oil level.
2. Record oil level reading on the RO.
3. Take photo of the drained oil container using KDS and attach to warranty claim PWA request.

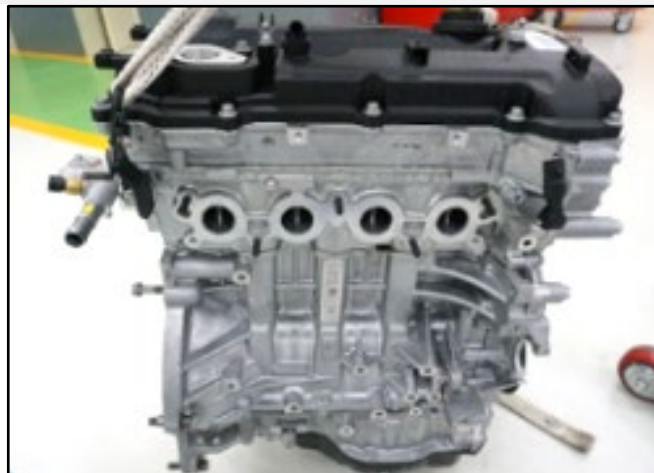
**ENGINE REPLACEMENT INSTRUCTIONS FOR DTC P1326 (PI2105Y/Z)****Engine Replacement Procedure:**

1. Replace the engine assembly by referring to the "Engine Mechanical System → Engine And Transaxle Assembly → Engine And Transaxle Assembly → Repair procedures" chapter in the applicable Shop Manual on KGIS.

2. After removal of the engine from the vehicle, remove all components that will need to be transferred by referring to the applicable Shop Manual on KGIS.
3. **Install all removed components from the old engine block onto the new engine block utilizing all parts from Service Kit(s).**

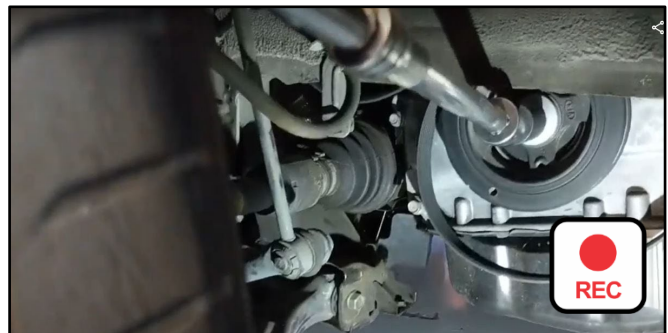
**Prepare the vehicle prior to the video by removing the spark plugs and drive belt as well as setting the torque wrench to 94 lb.ft.**

5. Show the removed drive belt and attached torque wrench to crank bolt.
