# Service Bulletin

Bulletin No.: 12-08-51-002Q

**Subject:** Spray-in Bed Liner General Information and Repair Procedures

**Models:** 2013-2014 Chevrolet Silverado HD 2500/3500 Series  
2014 Chevrolet Silverado 1500  
2015-2025 Chevrolet Colorado, Silverado  
2013-2014 GMC Sierra HD 2500/3500 Series  
2014 GMC Sierra 1500  
2015-2025 GMC Canyon, Sierra  
2022-2025 GMC HUMMER EV Truck  
2020 Holden Colorado  
Equipped with Spray-in Bed Liner (RPO CGN, PDL)

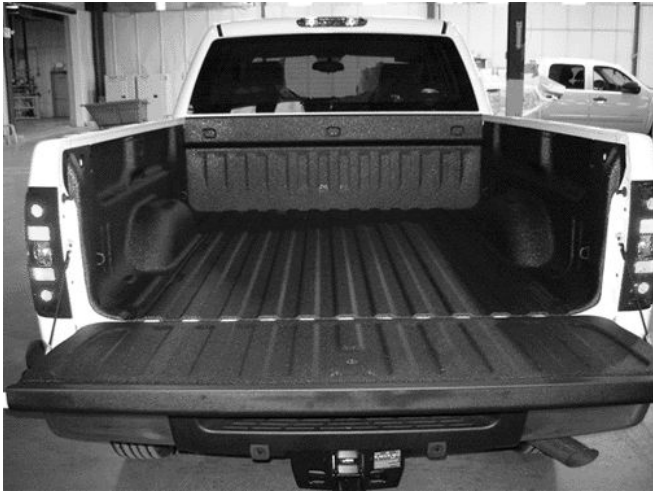
2968662

Entire bed

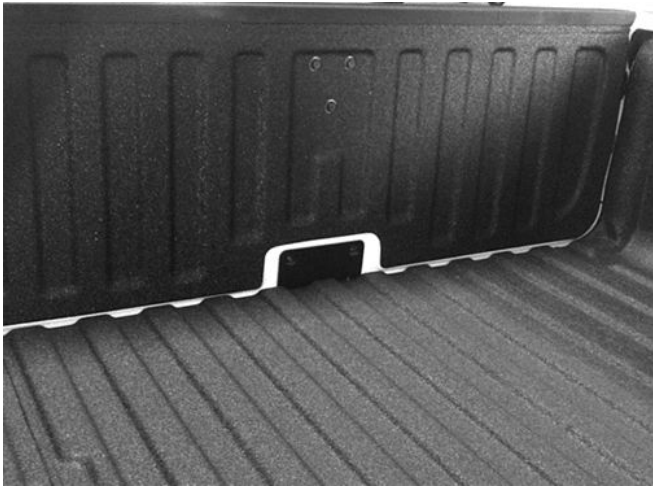
2968668

Tailgate with Rear Vision Camera (gate in closed position)

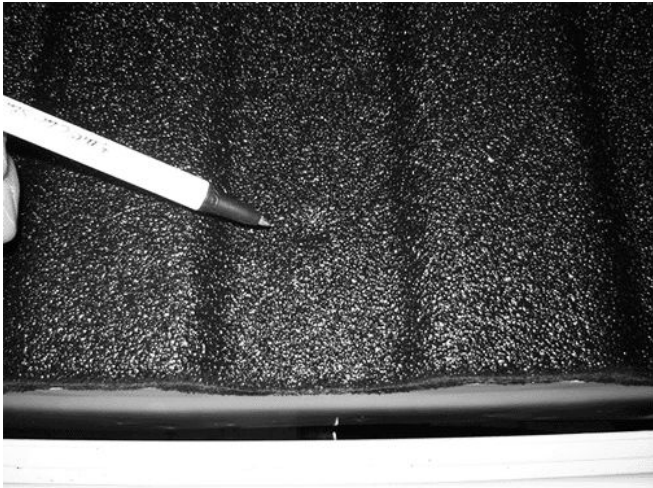
2968675

Because the bed liner material is sprayed on evenly, any variation in the bed such as seam sealer or spot welds in the sheet metal will show underneath the spray on coating. This is an expected condition. The coating does not completely fill in these variations.

Spot weld under bed liner example

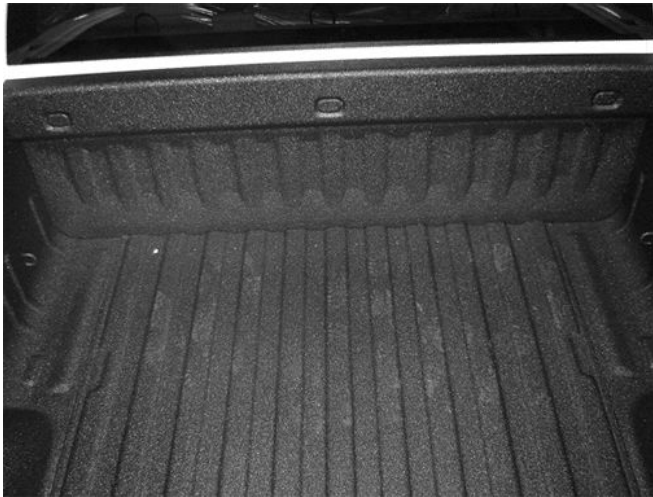
2968676

Bed header panel

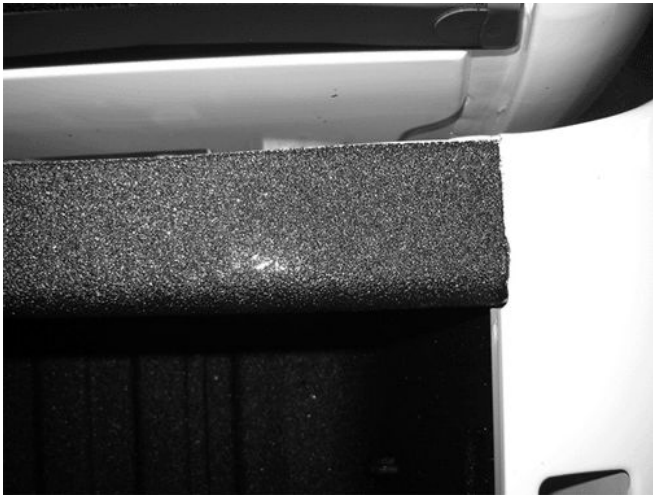
2968682

**Bed header panel/side panel joint**

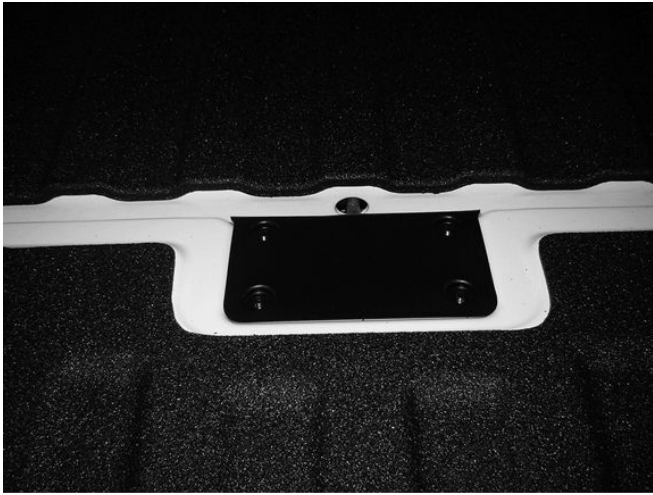
2968687

Bed floor (with rear camera access panel, gate open)

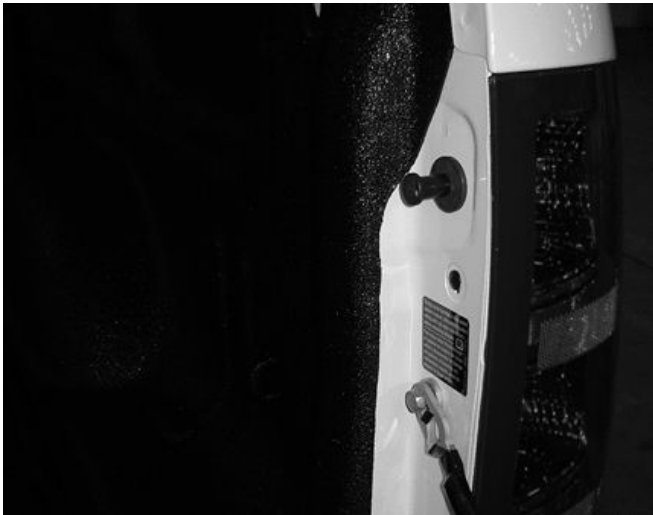
2968690

Tailgate opening view
