Service Bulletin

Bulletin No.: 23-NA-073

Subject: Evaporative DTCs P0442, P0446, P0455 or P0449, Caused by Dust Intrusion into the Evaporative Canister and Canister Vent Solenoid

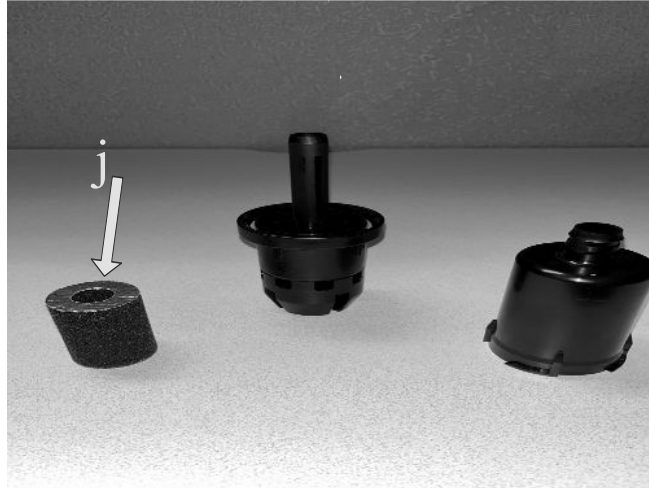
⁶³²⁵³¹⁸
Note: The retro-fit to add the filter is described in the Service Procedure below. For the retro-fit, the filter assembly P/N (with the 3 parts shown above) will need to be utilized along with a 3/4" to 5/8" hose connector that can be obtain for a local parts store. If a vehicle has already undergone the retro-fit and the vehicle returns after a period of time with the Condition reappearing, the filter assembly can be changed.

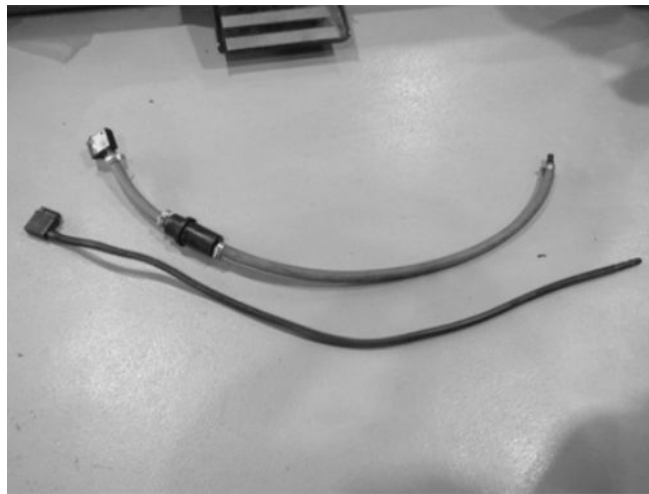
⁶³²⁷⁰¹⁵
 A filter may be installed between the EVAP canister and air inlet, to correct this Condition. An example of the original, and the retro-fit, evaporative emission canister vent hose are shown in the graphic above.

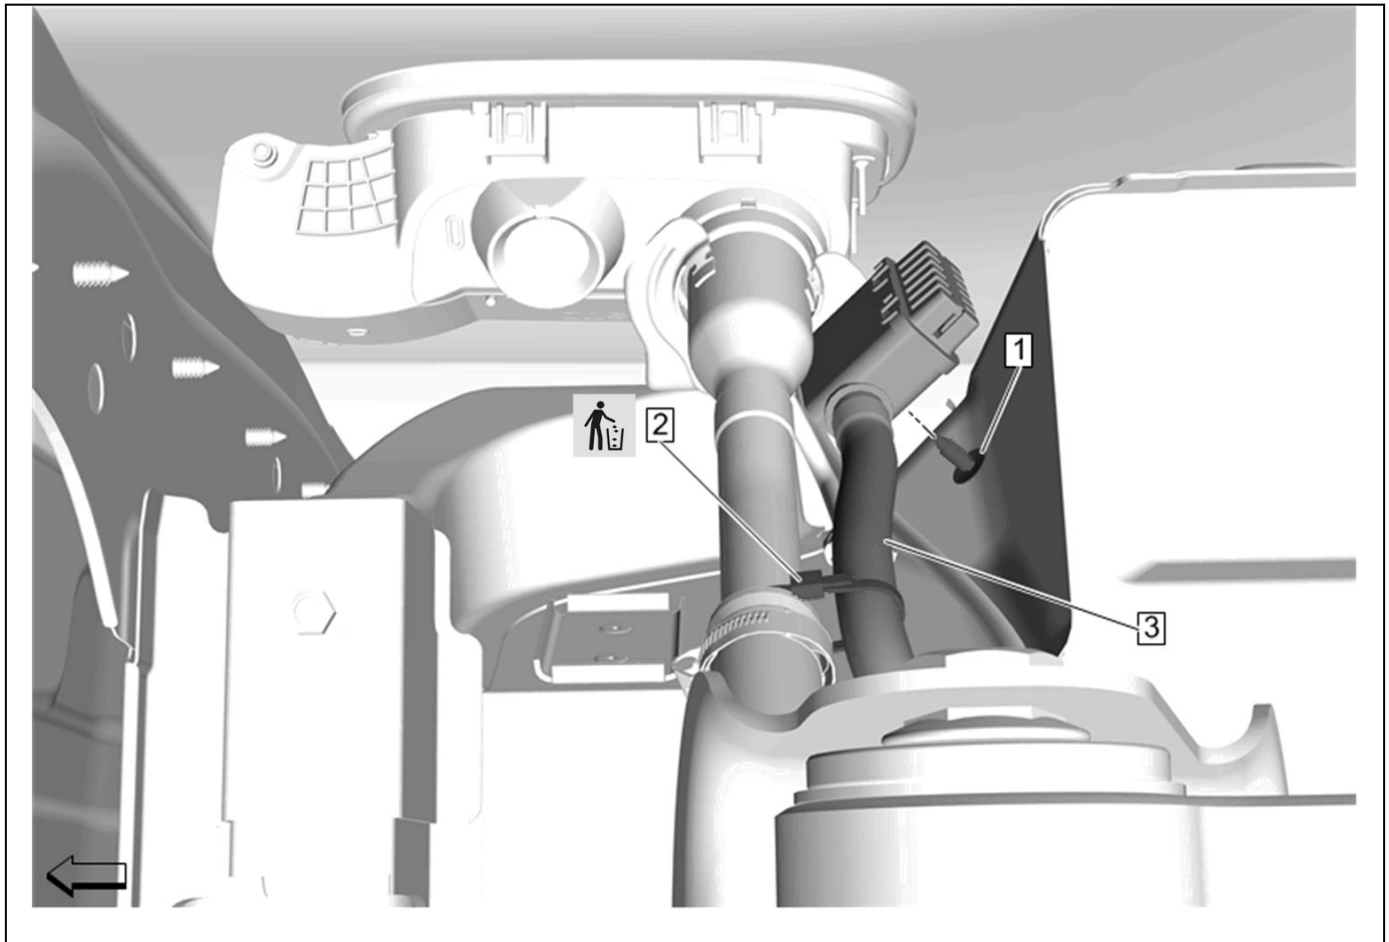
5041593

2. Remove the evaporative emission canister vent hose (3). Refer to the appropriate *Evaporative Emission Canister Vent Hose Replacement (Filler Pipe to Pipe)*, in SI.

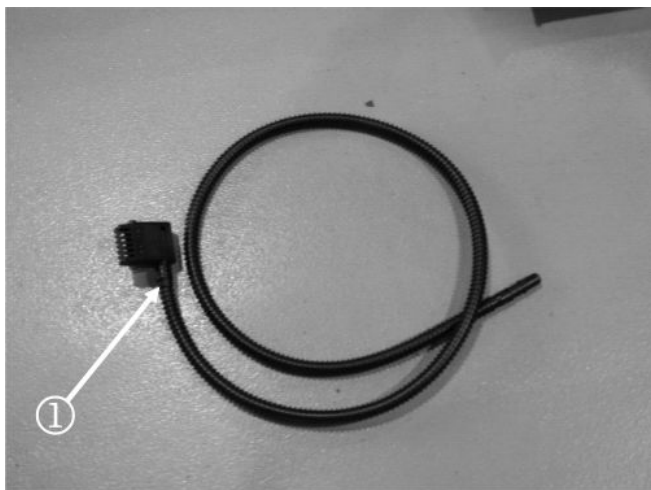
6325322

3. Cut the vent hose at the end of barbed fitting on the pre filter (1).

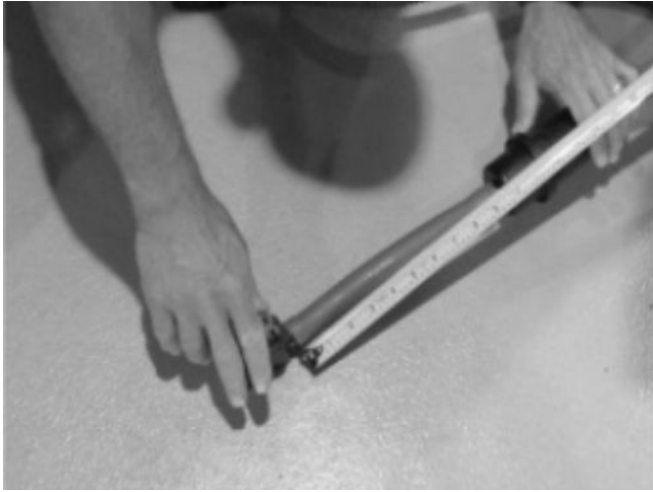
6325324

4. Cut a 12 inch (30.5 cm) length of 3/4 in. diameter heater core hose.

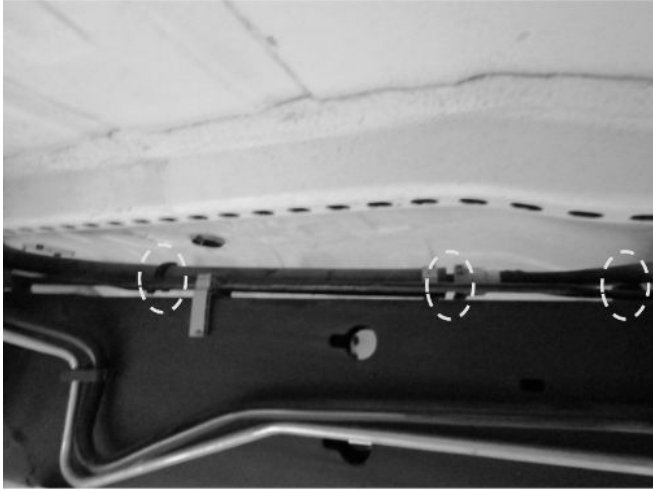
6325329

11. Using existing hose clips, and tie straps, clip new hose at same location as previous line.
12. Lower the vehicle.
