# TECHNICAL SERVICE BULLETIN

<b>ISSUE DATE:</b>	8/2/2022
<b>SERVICE BULLETIN SUBJECT:</b>	Lift-U ADA Ramp Bracket 6 to 1 Retrofit
<b>VINs or MODELS AFFECTED:</b>	Service Specified Buses
<b>COMPLETE BY:</b>	Next Service Opportunity
<b>SERVICE BULLETIN #:</b>	SC-22-97
<b>LABOR OPERATION CODE:</b>	AR47Z

## LIFT-U ADA RAMP BRACKET SIX TO ONE RETROFIT

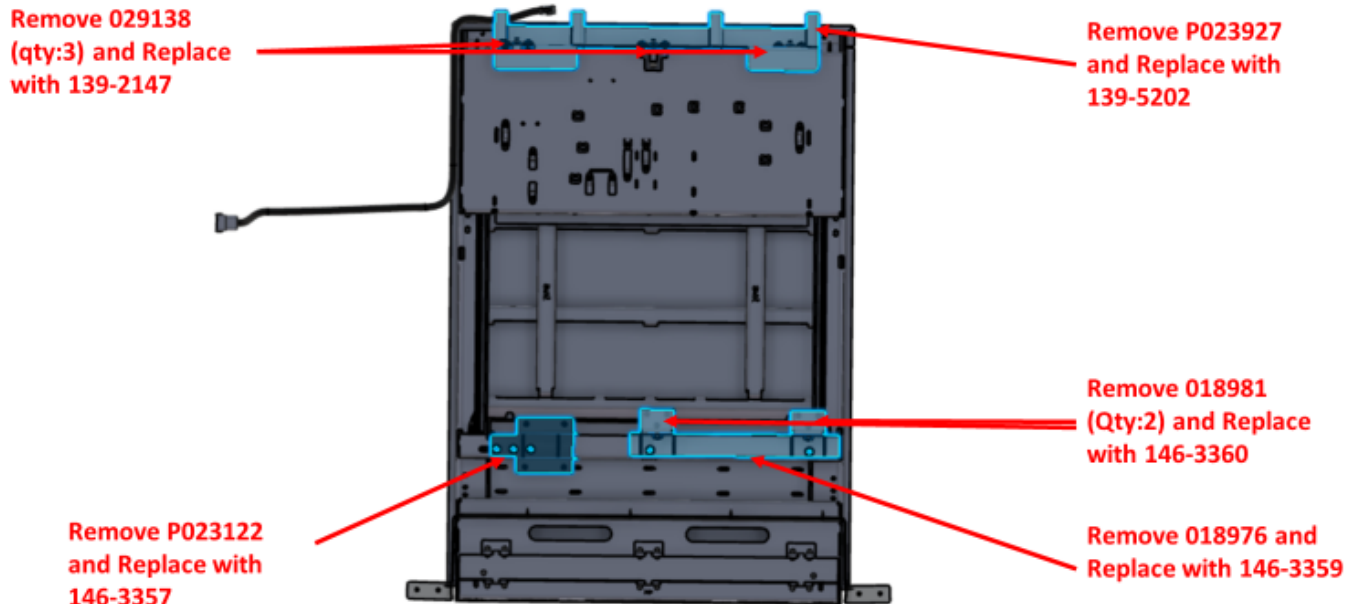
1. Complete the Proterra approved Lockout/Tagout procedure to make the bus safe for work.
2. Using the procedure in the Maintenance and Repair Manual, remove the ADA Ramp and set it aside for later use.
3. Using a Heat Gun and Slip-Joint Pliers, remove the brackets highlighted in blue in the following illustration. Heat each bracket until the Plexus Adhesive that secures the bracket to the bus softens. Apply pressure to each bracket with Slip-Joint Pliers until the Plexus softens. Continue applying pressure until the bracket loosens.

4. Continue applying pressure until the bracket becomes detached from the body.
5. Repeat the process to remove all the brackets shown in the illustration.
6. Using a Heat Gun and a Putty Knife, remove any remaining Plexus Adhesive from the bus body in the ramp area.
7. Using Isopropyl Alcohol and Shop Towels, clean the surfaces where the Plexus was removed.
8. Using a Power Drill with a 36-Grit Sanding Disk, scuff the areas on the body needed for installing the new Brackets.
9. Using Isopropyl Alcohol and Shop Towels, clean the scuffed surfaces on the bus body.
10. Using a Power Drill with a 36-Grit Sanding Disk, scuff the bonding surfaces of all the brackets from the kit.
11. Using Isopropyl Alcohol and Shop Towels, clean the scuffed surfaces of the brackets.
12. Using a Shop Towel, apply Plexus Primer (**020990**) to the scuffed areas.

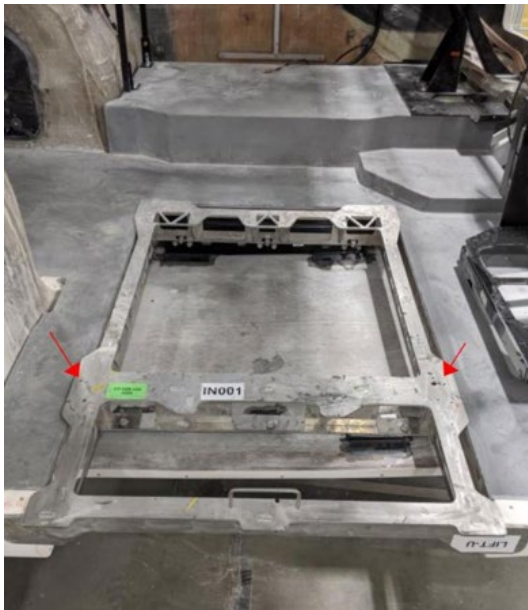
13. Install the LIFT U LU11 Fixture into the bus as shown in the following photograph.

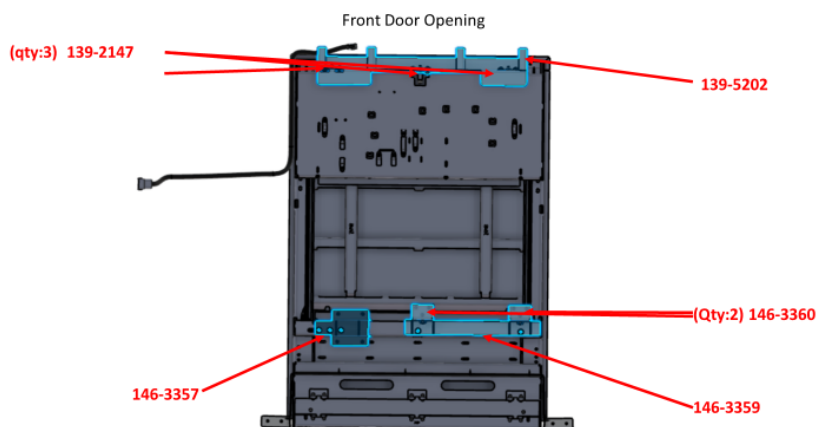
14. Using the LIFT U LU11 Fixture and a Plexus Gun with Plexus (**018362**), install the Brackets shown in the following illustration.

15. Allow the Plexus (**018362**) to cure. Approximately 160 minutes is required for temperatures between 65 and 85-degrees Fahrenheit.
16. Using a Power Drill with a 10mm Drill Bit, drill holes through the body using the weld-nut holes in the ramp brackets as a guide.
17. Using four Wheel Lifts, raise the bus to access the bottom of the ADA Ramp area.
18. Using four Jack Stands, support the bus for safety.
19. Using a Power Drill with a 21/32 Inch Counterbore, enlarge the nine holes previously. Drill up from underneath the bus. Stop drilling when the hole saw contacts the bracket.
20. Using a Vacuum Cleaner, remove any dust and debris from the holes.
21. Using a Tongue Depressor, mix 0.2 Ounces of Resin (**009479**) with five milliliters of MEKP

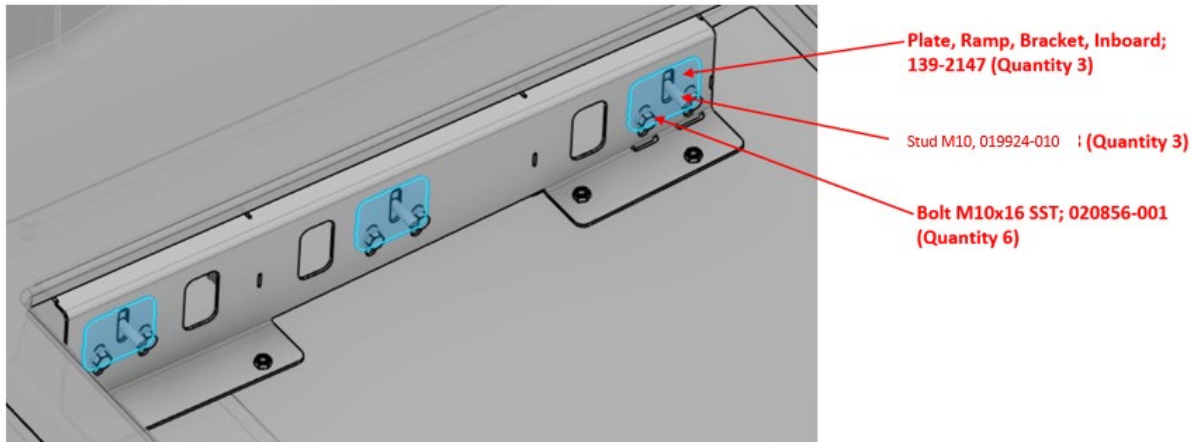
38. Using the following illustration as a guide, install the three Ramp Bracket Plates (**139-2147**) onto the bus.

39. Secure the Ramp Bracket Plates (**139-2147**) using six M10 Bolts (**020856-001**).
40. Using a Calibrated Torque Wrench with a 15mm Socket, **torque the bolts to 32.5 foot-pounds.**
41. Using Orange Torque Stripe Paint, mark the properly torqued fasteners.
42. Using a Ratchet with an 8mm Allen Socket, install the three M10 Studs (**019924-010**) into the bracket.
43. Using a Calibrated Torque Wrench with an 8mm Allen Socket, **torque the M10 Studs (019924-010) to 15 foot-pounds.**
44. Using Orange Torque Stripe Paint, mark the properly torqued fasteners.
45. Using the following illustration as a guide, install the ADA Ramp Bracket (**146-33590**) using two M10 Bolts (**020856-001**).

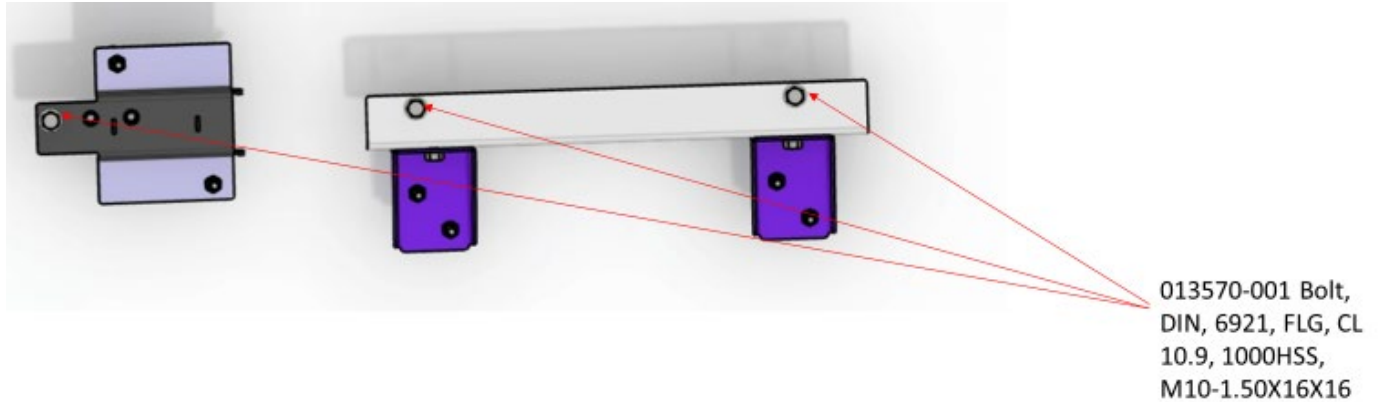
48. Using a 15mm Ratchet/Socket, secure the ADA Ramp to the bus as shown in the following illustration using M10 Bolts (**013570-001**).

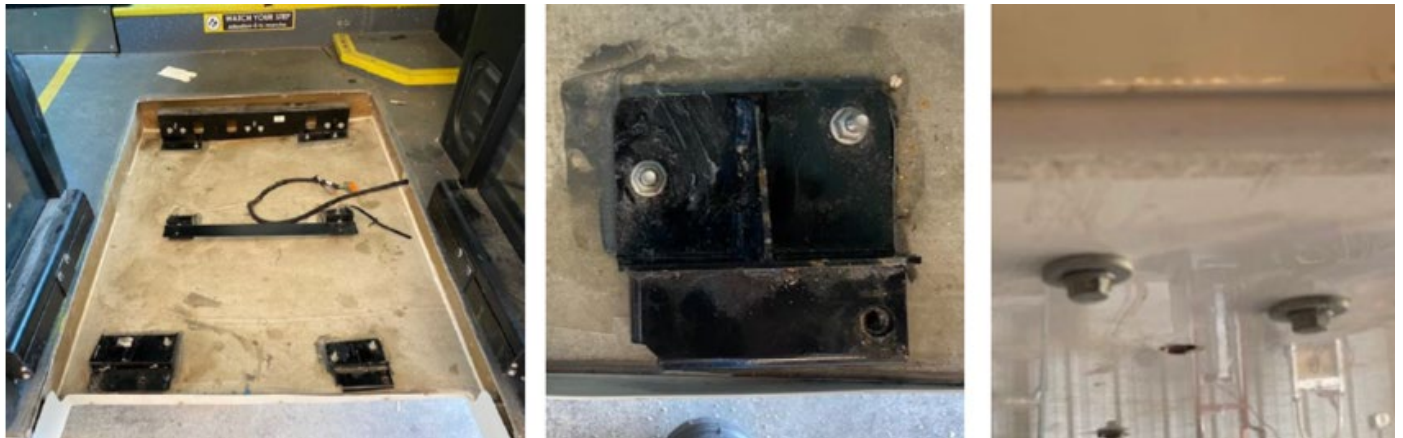
49. Use the Maintenance and repair manual for any additional details that are needed for installing the Ramp. The following photographs show the completed installation.

50. Remove the Lockout/Tagout devices and power in the bus.
51. Test the ADA Ramp for proper operation before returning the bus to service.
