TECHNICAL SERVICE BULLETIN

Chatter/Shudder During Low Speed Turning Events

24-2386

18 November
2024

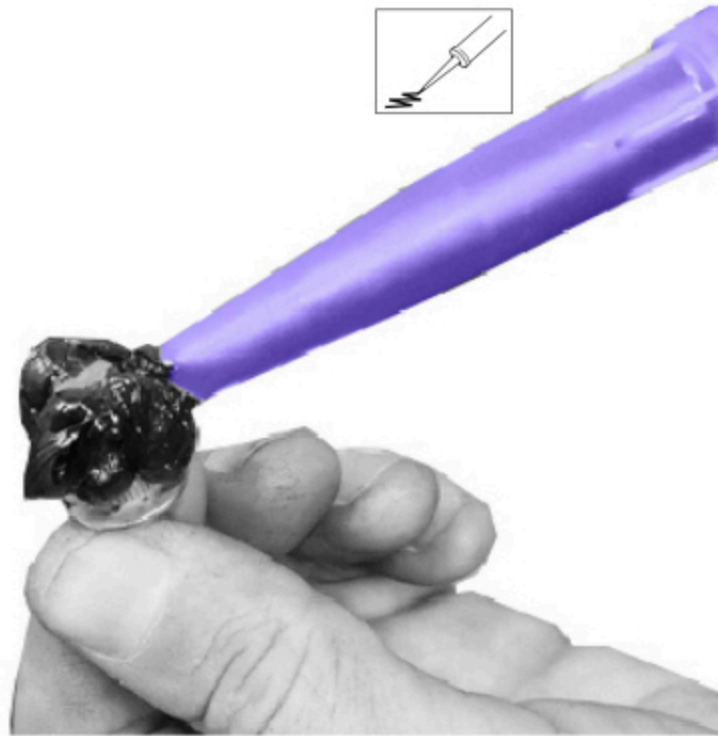
Figure 12

22. Apply a generous amount of sealant to the body side of the stud rivet. (Figure 12)

⚠ CAUTION: Failure to properly seal the stud rivet could lead to water entry into the passenger area.
