SERVICE ADVISORY # 24-458

Winterize Filter Line

It has been determined that the below units cannot be winterized without an external pump to push antifreeze into the unit. The following procedure describes how to identify and reconfigure water lines.

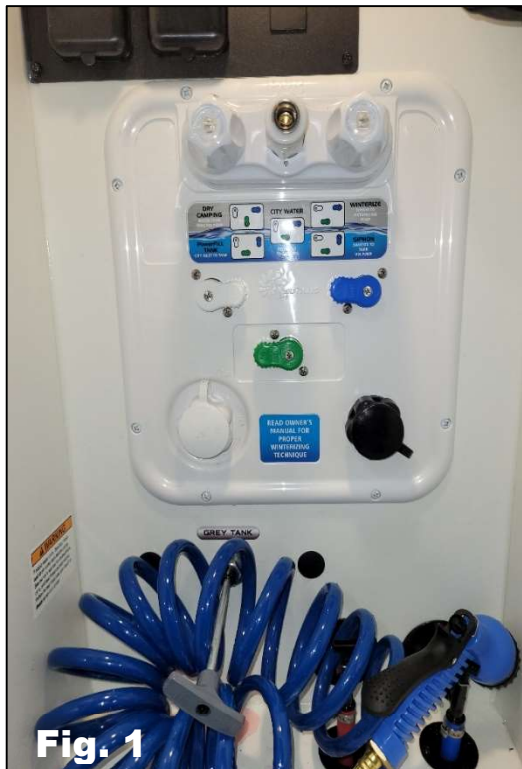
The remedy is to locate the convenience center city water connection on the back of the convenience center and verify or correct the configuration of water lines. See Figure 1.

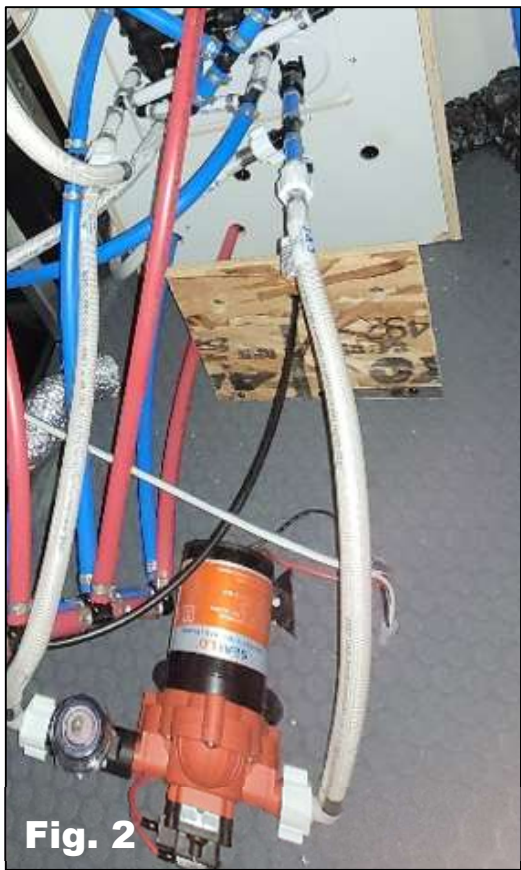
Remove the flexible water line coming from the water pump to the city fill connection and lay it aside. See Figure 2.

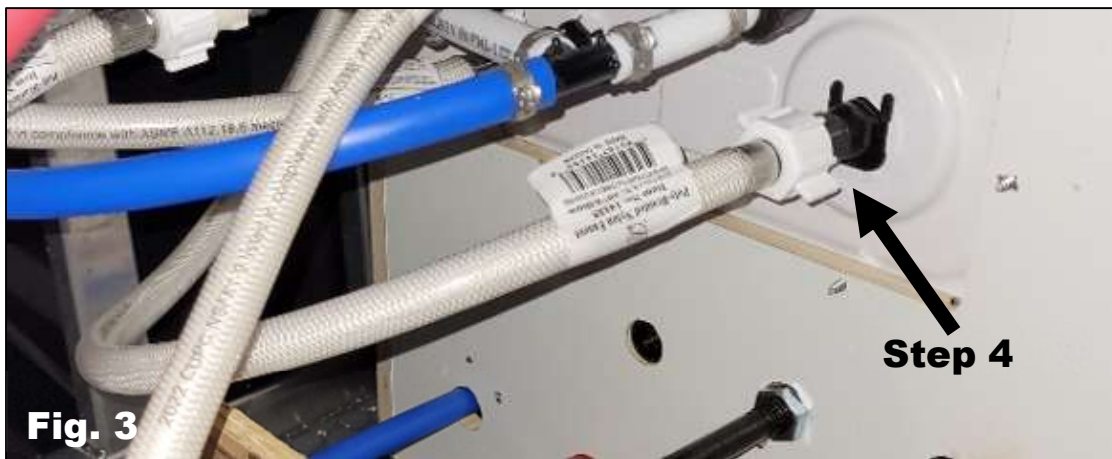
Fig. 3

Take flexible water line from this manifold and install it on the city fill connection. See Figure 3.

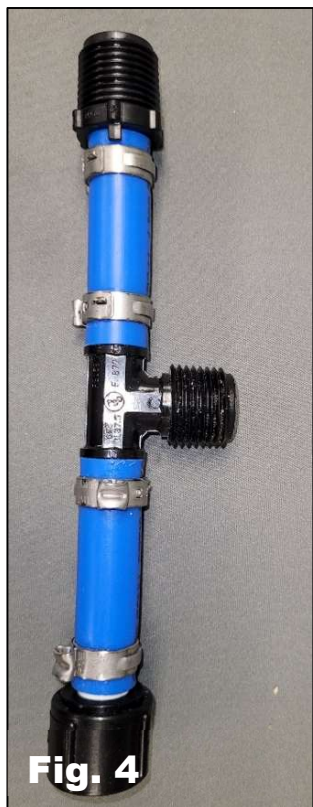
Discard this manifold. See Figure 4.

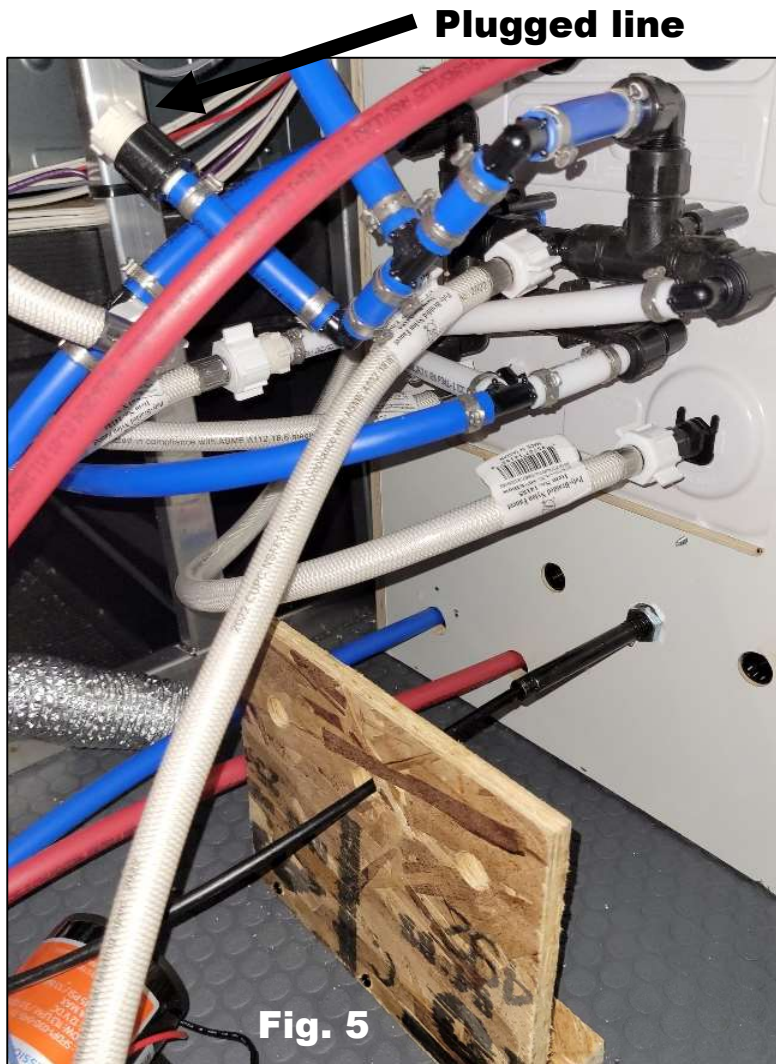
Unhook the blue water line from the center of the mixing valve and add plug (KRV # 295561) to seal off the removed line. Now turn this line up and out of the way. Then install flexible water line coming from the water pump in its place. Okay to move water pump over if flexible water line will not reach. See Figure 5.
