## Technical Service Bulletin

**24-01-020H**

**SONATA  
(DN8/DN8A)**

**SUBJECT:** ECU UPDATE & CHECK VALVE/FUEL TANK INSPECTION AND REPLACEMENT (SERVICE CAMPAIGN 9B1)

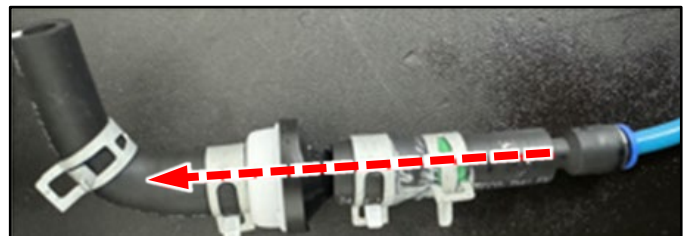
Direction of Air Flow

Be sure to connect the coupler to the check valve in the direction shown and clamp it.

Otherwise, this inspection **CANNOT** be conducted properly due to air flow of the check valve and/or a small leak at the connecting area.

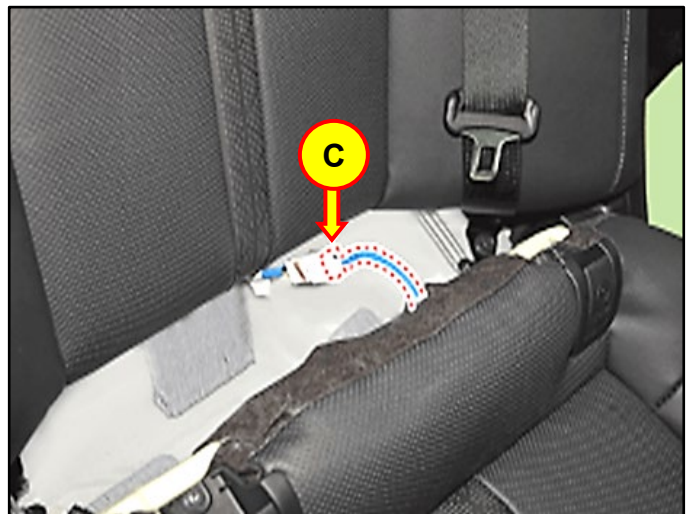
3. Disconnect the rear seat heater connector if equipped (C).

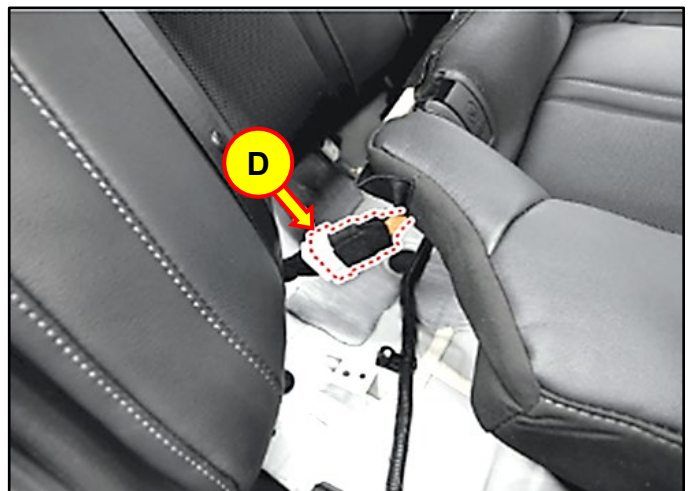
4. Disconnect the rear seat heater unit connector if equipped (D).

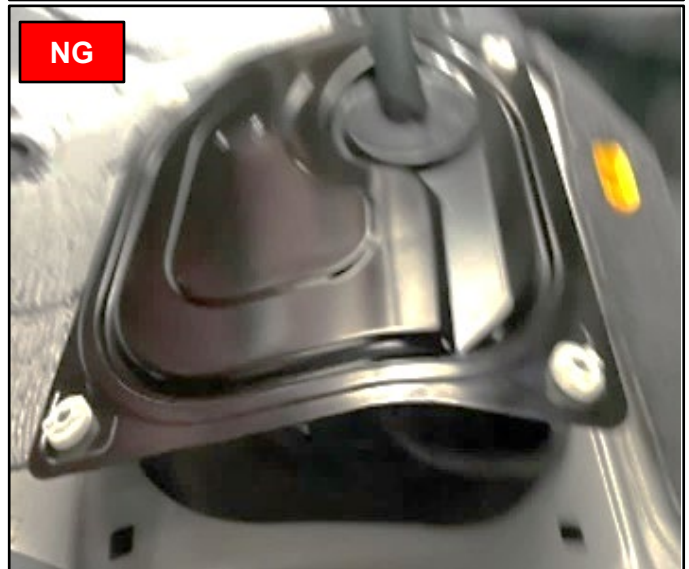
5. Inspect the fuel pump service cover (E).

- If a gap is **NOT** present (**GOOD**):
  - Replace the check valve.
  - Proceed to **step 8**.
- If a gap **is** present (**NG**)
  - Open RA Techline Case.
  - Continue to **step 6**.

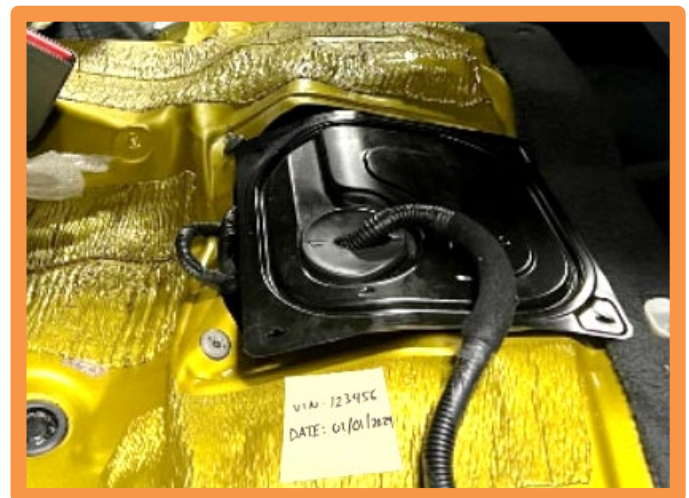
Using STUI, take a photo of the gap in the fuel pump service cover, with the last 6 digits of the VIN and the date of repair on a piece of paper.

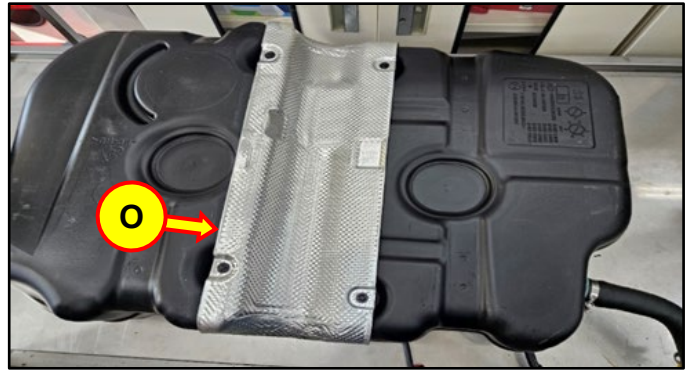
16. Remove the fuel tank band (M) and then the fuel tank (N) from the vehicle.

lb-ft	35
N.m	47

Replace fuel tank bands during installation.

Use a siphon pump to transfer fuel to supplied tank.

Attach the fuel tank heat protector (O) supplied to the new fuel tank.

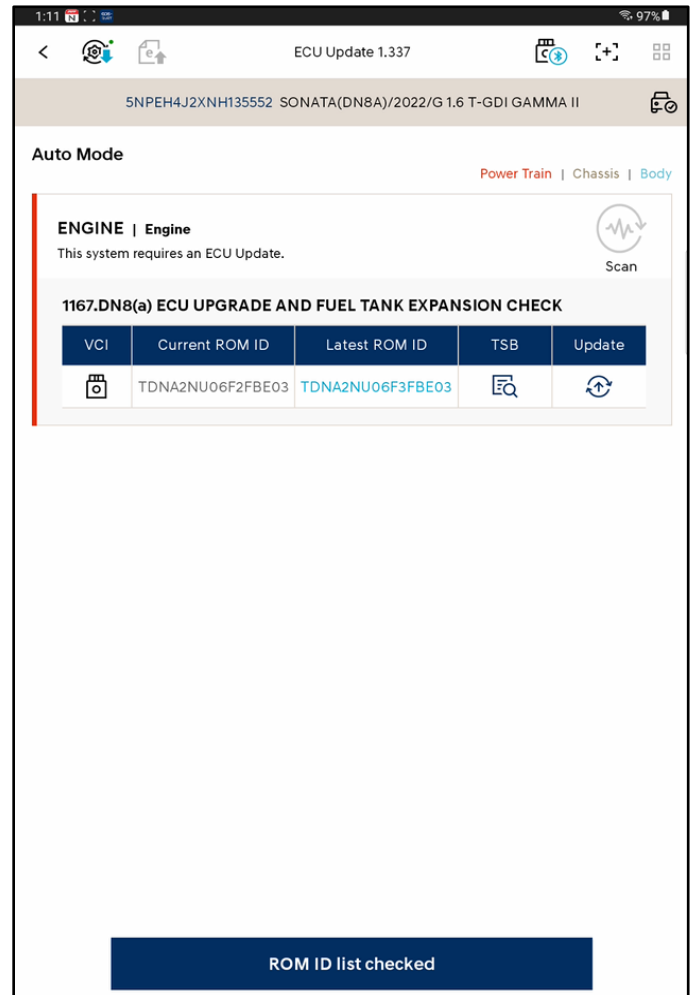
1. Perform the ECU update in Auto Mode.

Use the **ID Check** to verify the ROM ID before updating the software.

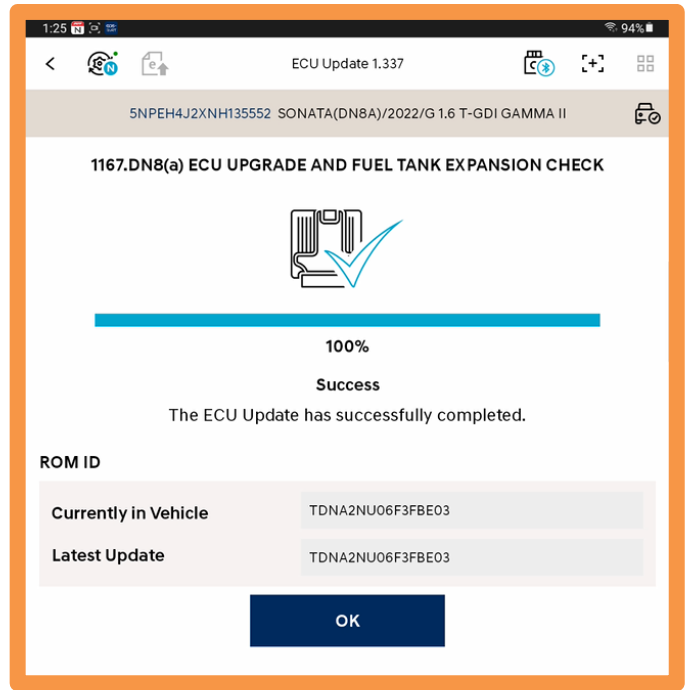
**Take a screenshot of the ECU update complete screen using your tablet and upload to STUI.**
