## TECHNICAL SERVICE BULLETIN

| SERVICE BULLETIN SUBJECT: | Steering Gearbox Valve Housing Torque Retrofit |
| SERVICE BULLETIN #: | SC-22-1 |

### STEERING GEARBOX VALVE HOUSING TORQUE RETROFIT

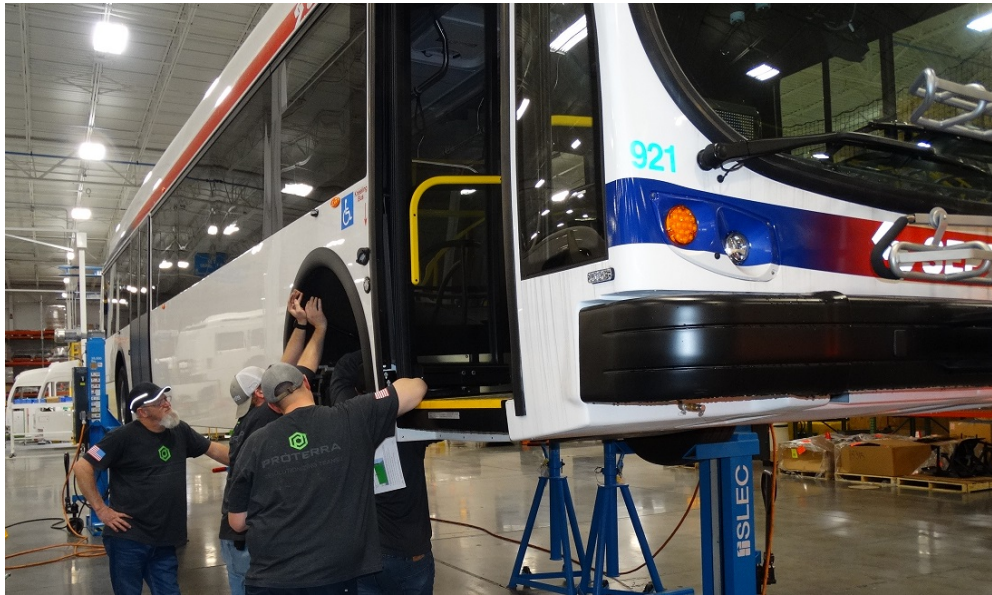
1. Perform the Proterra approved Lockout/Tagout process to make the bus safe for work.
2. Using four Wheel Lifts, raise the bus into the air. Using four Jack Stands, support the bus for safety.

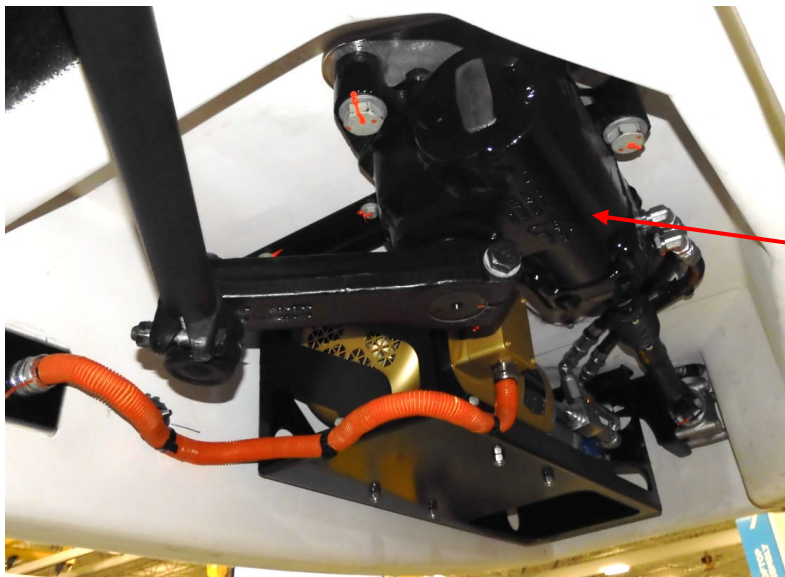
3. Working safely underneath the bus, access the Steering Gearbox Housing shown in the following photograph.

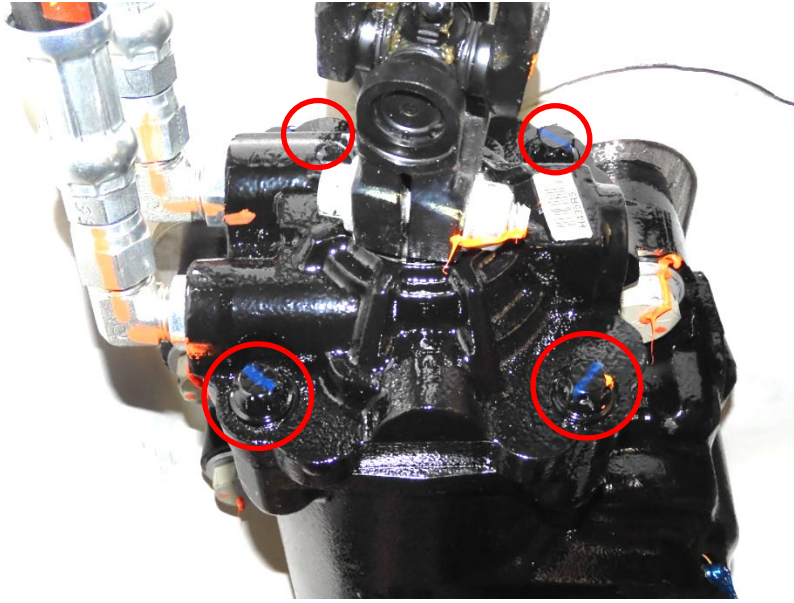
4. Using a Ratchet with an E18 Torx Socket, loosen one of the four Torx bolts shown circled in red in the following photograph.

5. Using a Calibrated Torque Wrench with an E18 Torx Socket, **torque the bolt to 118 foot-pounds.**
6. Using Orange Torque Stripe Paint, mark the properly torqued bolt.
7. Repeat the process to properly torque and mark the remaining three (3) bolts.
8. Remove the four (4) Jack Stands.
9. Lower the bus using the four (4) Wheel Lifts.
10. Remove the Lockout/Tagout devices and return the bus to service.
