LOADSPACE COVER HANDLE ASSEMBLY LOOSE

Range Rover

- 22 - 25MY Range Rover (L460)

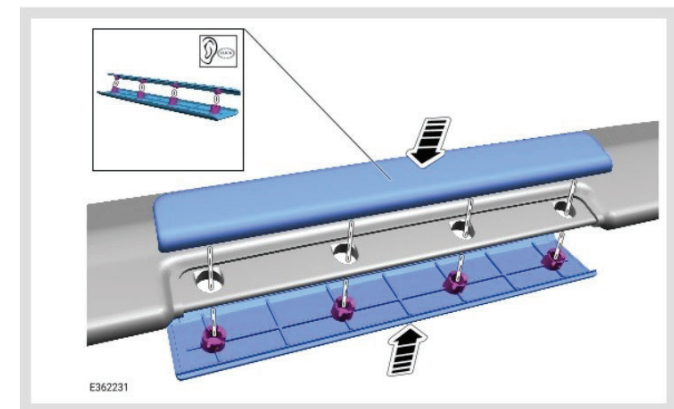
- The loadspace cover plastic handle on 5 seat or executive seat model variants may become loose.

- TSB JLRTB02130NAS1 has been published to provide repair instructions to address this concern.
- The loadspace cover should not be replaced for this concern..
