# TECHNICAL SERVICE BULLETIN

TECHNICAL SERVICE BULLETIN: 10-1871  
SERVICE CAMPAIGN: 001169  
EXPIRATION DATE: 12/1/2025

Forest River is alerting you to an issue involving certain 2025 Rockwood RLT2606WS and Flagstaff FLT26RBWS Travel Trailer Recreational Vehicles. Please see the information below, which describes the issue and provides you with details on the steps you should take to have your vehicle repaired.

The RVQ Grill Bracket may not be located in the correct location.

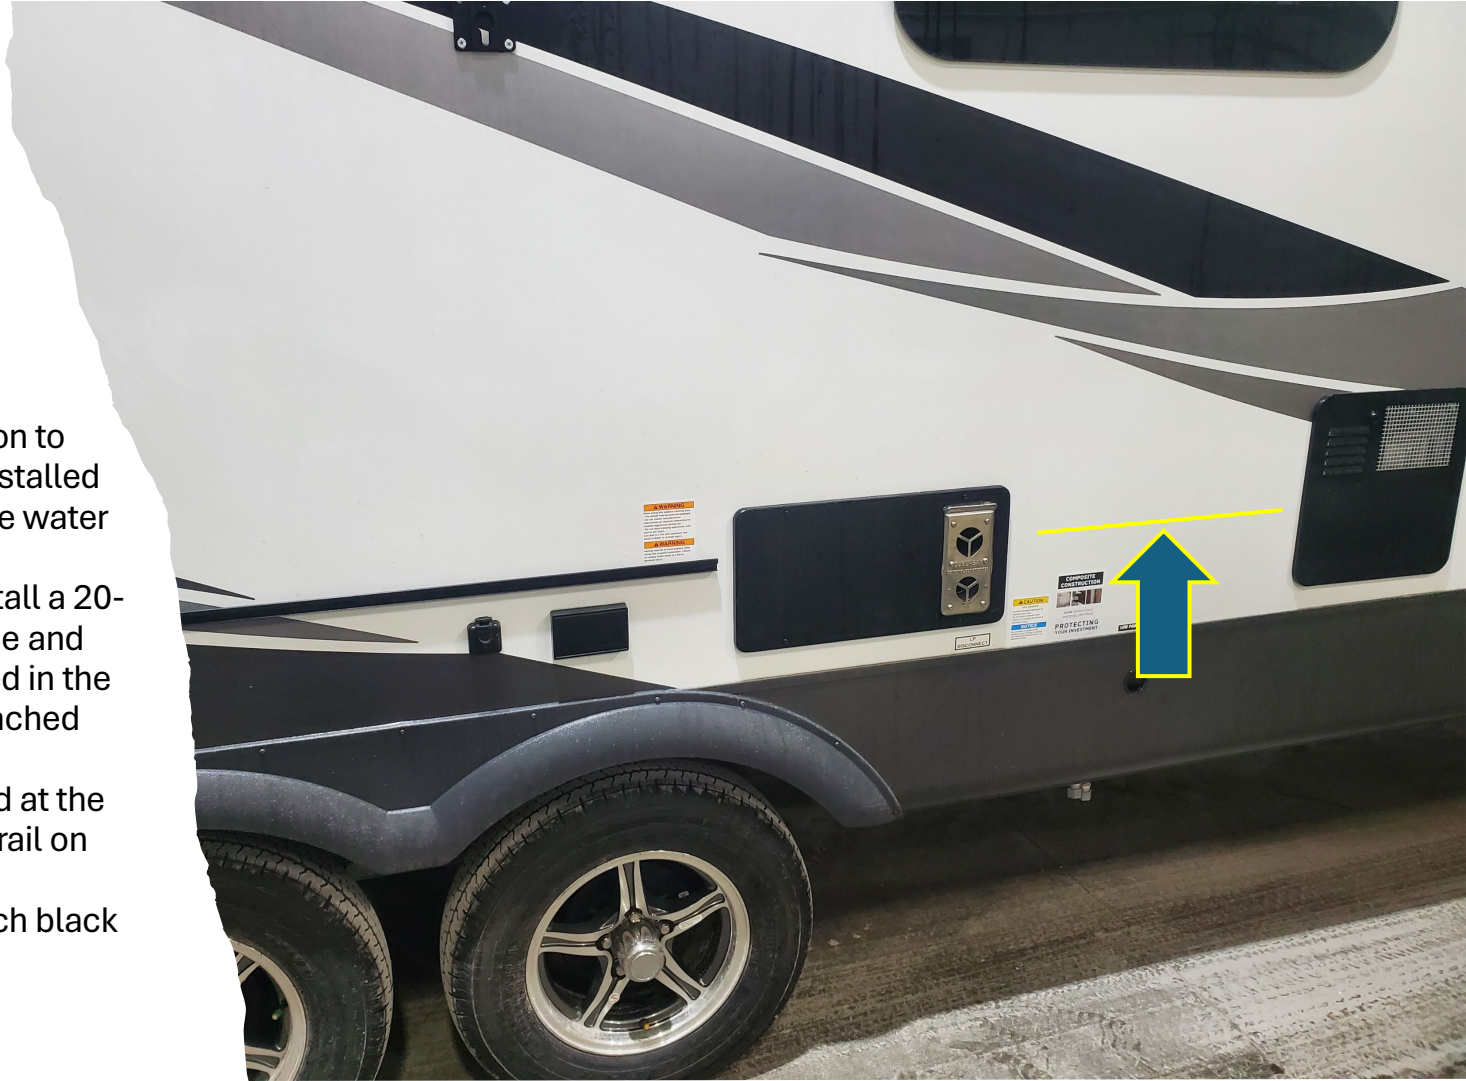
This is what it  
should look like  
once complete.

1. Inspect the unit in question to determine if there is a rail installed between the furnace and the water heater.
2. If a rail is not present, install a 20-inch rail between the furnace and the water heater as indicated in the provided reference (see attached image).
3. Ensure the rail is mounted at the same height as the existing rail on the unit.
4. Secure the rail using 1-inch black screws.

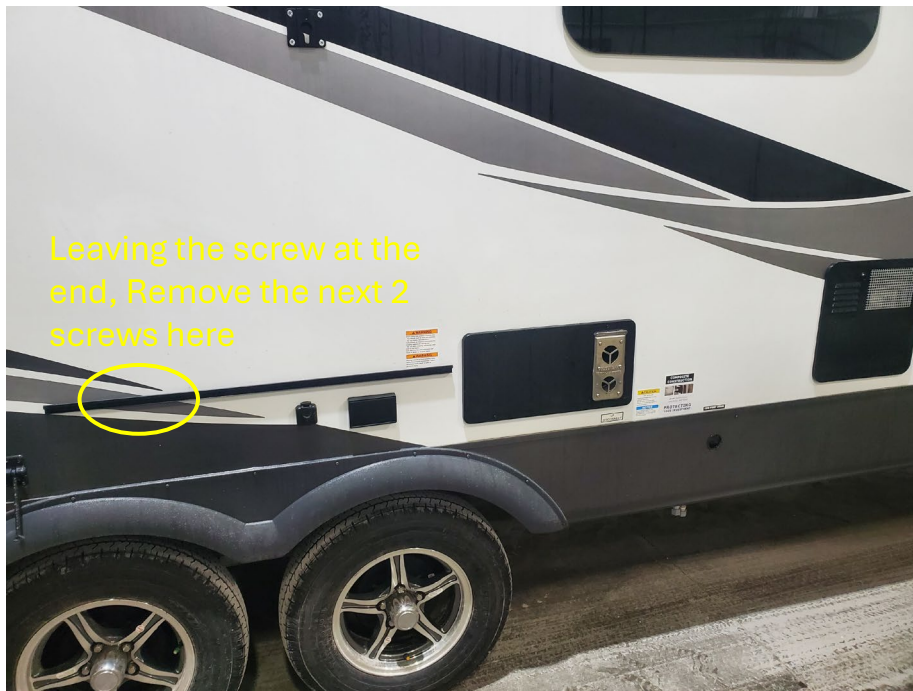
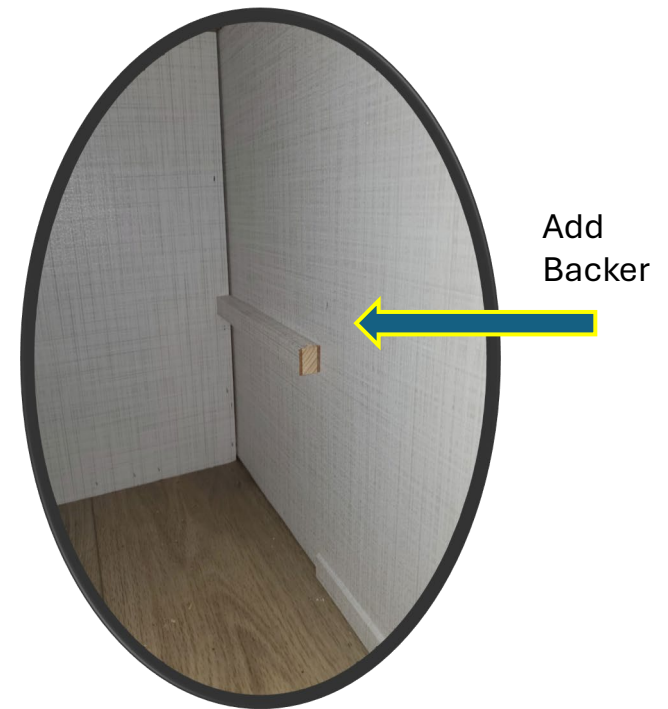
This is a picture of the Kit  
you will receive to  
complete this fix which  
includes:

- Rail with tape applied.
- Backer
- Screws

Kit #: F100684870
