SS 1032998 M2 mirror wind noise

M2 mirror wind noise

All M2 platform

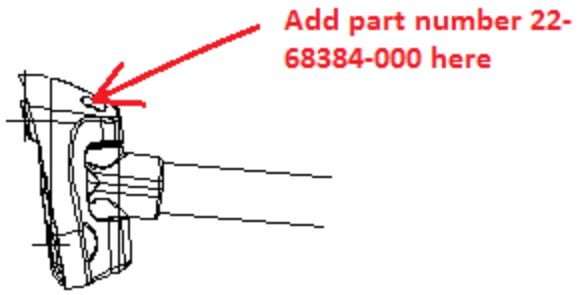
Wind noise across the upper mirror mounting bracket

Corrective action at this time is installation of part number 22-68384-000 into the upper mounting bracket drilling as per the attached document.

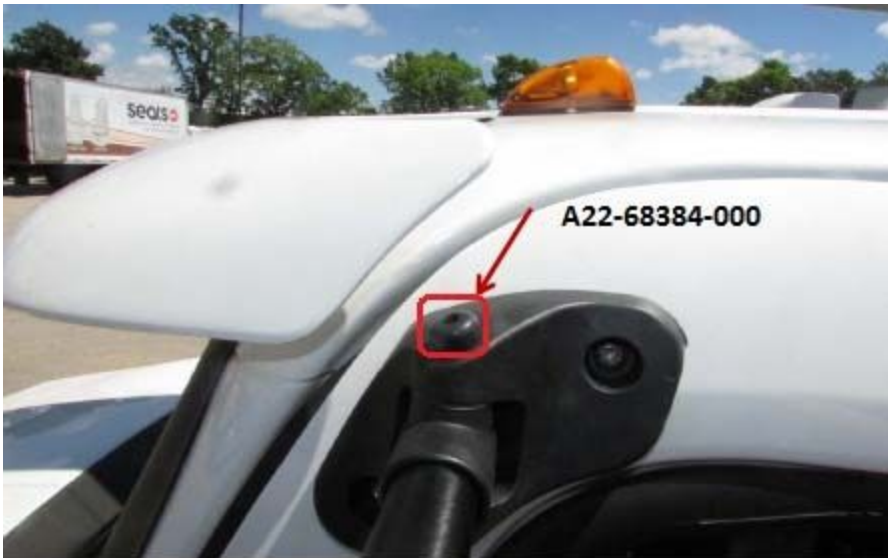
Part number 22-68384-000 cross sectional view
