Panamera E-Hybrid - "Remove Charger Plug" Message in Instrument Cluster

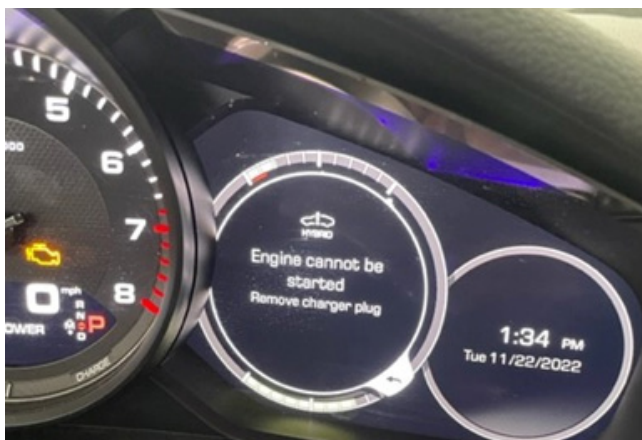
Figure 1

Following a replacement of the 3.6 kW On-Board Charger (OBC) part number PAB915682B, the workshop finds a white hybrid warning in instrument cluster as shown below. This message occurs on start-up even when no HV charging plug is connected. The following fault is present in the Instrument Cluster control unit:

B19DAF0 - Display of charger plugged in, no engine start, active
Fault **EA6639**.

This condition is due to a known production error in replacement 3.6 kW Onboard charger (OBC) parts with software level 6021. The issue has been investigated by PAG and the supplier and a root cause was identified.

Replacement parts are now available to correct this condition. They are designated with the same part number as before (PN PAB915682B). If a vehicle arrives and diagnosis leads to exchanging the OBC or the aforementioned symptom of faulty charger plug detection, then it is recommended to order an additional OBC part from the PDC according to standard procedures.

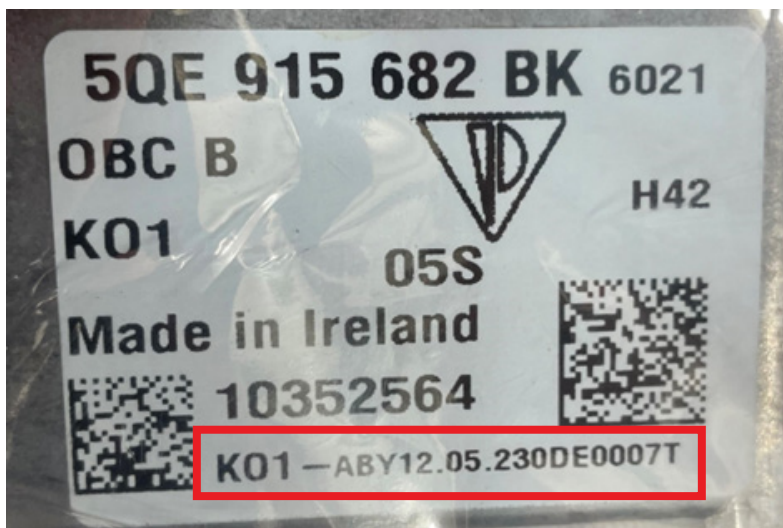
Figure 2

Until the stock of this part number is completely clean, it is recommended to check the serial number on the part's production label before installation. An example of this label with the production date highlighted in the serial number is shown in figure 2.

Part quality can be determined by the production date in the serial number before installation. Affected parts were produced before November 20, 2023 (20.11.23 on the label). In addition, some affected parts may have also been produced between November 20, 2023 and May 31, 2024. If a part produced between November 20, 2023 and May 31, 2024 is received, the serial number should be compared with the list. If the serial number is found in the list, the part should be returned instead of installed.
