87-18-12 - HVAC, Unpleasant Odor

Release date: 11/14/2024

Unpleasant odor is coming from Heating and Ventilation system. Odor mainly occurs after vehicle has been sitting (unused) at least 5 hours and within 20 to 60 seconds after vehicle is first started.

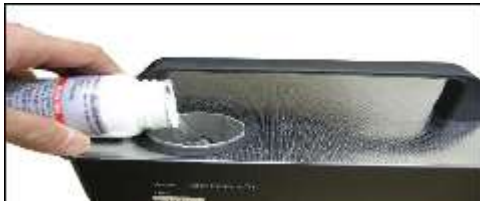
1. The vehicle should be cool, if necessary cool it down with the air conditioning to about 72°F
2. Dry the evaporator by running the ventilation (air conditioning "OFF") at the highest blower level for about 30 minutes.
3. Remove the activated carbon filter or pollen filter according to the repair manual. Close the cover on the AC duct without filter.
4. Open all vents, align them to the passenger compartment and select them with the control panel.
5. Leave the air conditioning switched off. Set the fan speed to level 1 and switch on the recirculation so air is not brought into the vehicle. Run the engine during the complete cleaning process or switch on the ignition and connect a battery charger.
6. Remove the neck (long black pipe) of air conditioning cleaner VAS 6189A / VAS 6189B and fill with a bottle of cleaning fluid part number 30208 (observe instructions on bottle).

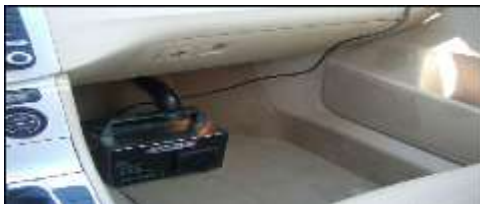
7. Place the air conditioning cleaner on the floor underneath the passenger glove box and point the neck towards the front of vehicle (see illustration).

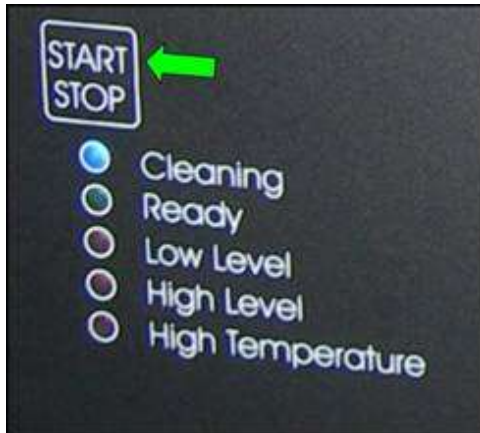
9. Start the cleaner (VAS 6189A / VAS 6189B), the warning light "Cleaning" comes on. Close all doors and windows.
