# Front Seat Outer Back Bolster Collapsed

**Service Category** Vehicle Interior

**Section** Seat

| YEAR(S) | MODEL(S) | ADDITIONAL INFORMATION |
|---|---|---|
| 2025 | Camry HV | |

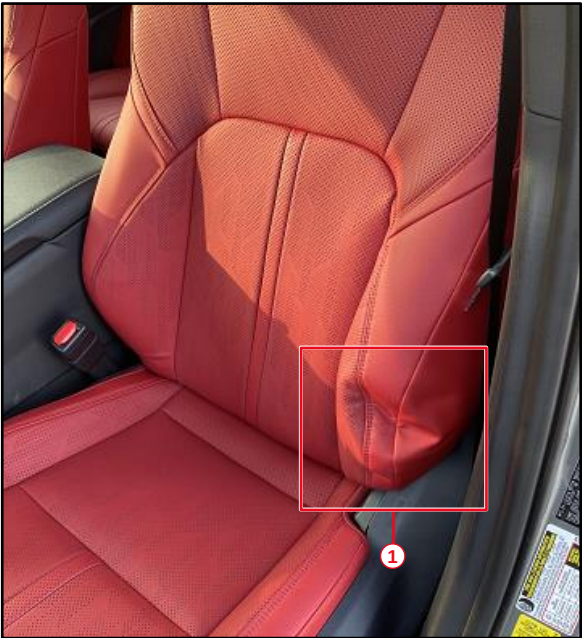
Figure 1. Example of Condition

Some 2025 model year Camry Hybrid vehicles may exhibit a condition in which a front seat outer back bolster has collapsed. The condition can occur on either or both the front driver and front passenger seats. A front seat back edge protector has been developed to reduce the likelihood of this condition. Follow the Repair Procedure in this bulletin to address this condition.

| 1 | Collapsed Front Seat Outer Back Bolster |

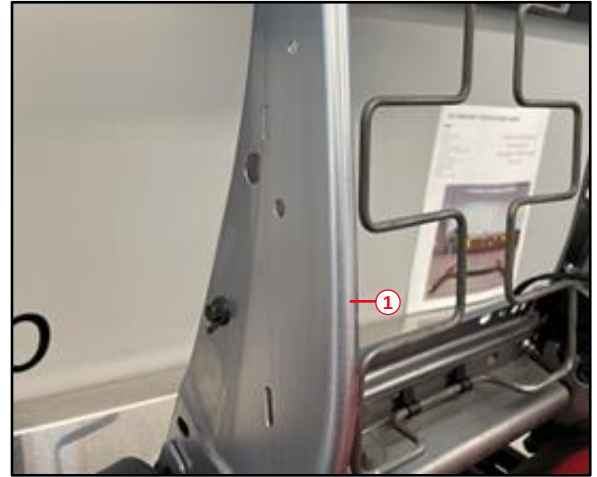
**Figure 2.**

| <b>1</b> | <b>Front Seatback Frame Sub-assembly</b> |

4. Wipe down the outer side of the front seatback frame sub-assembly with a clean towel/cloth and brake cleaner until it is free of any oil/debris.

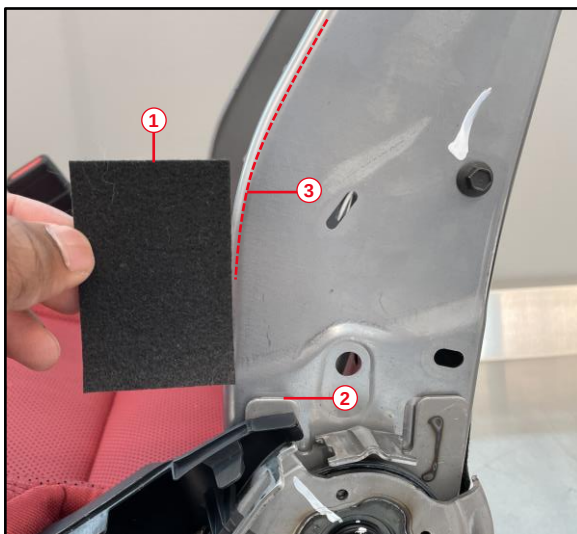
**Figure 3.**

| <b>1</b> | <b>Back Edge Protector</b> |
| <b>2</b> | <b>Top Edge of the Recliner Plate</b> |
| <b>3</b> | <b>Radius of the Frame</b> |

5. Align the bottom edge of the back edge protector to the top edge of the recliner plate, as shown in Figure 3. Apply the back edge protector along the edge of the front seatback frame sub-assembly. Make sure the protector wraps smoothly around the radius, past the edge, and adheres to the inner side of the radius inside of the frame, as shown in Figure 4.

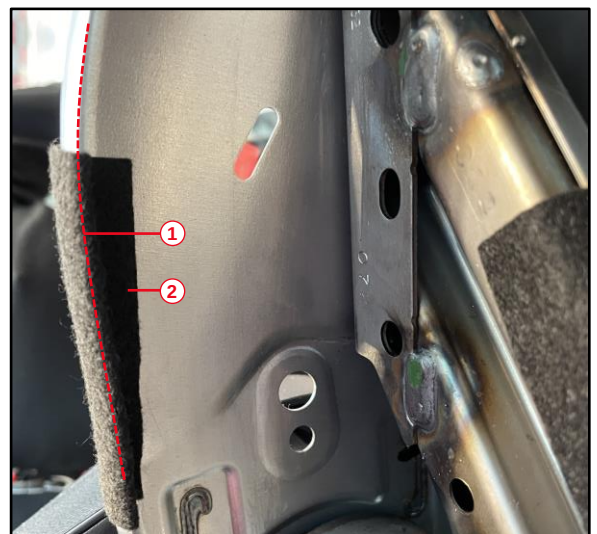
**Figure 4.**

| <b>1</b> | <b>Edge of the Frame</b> |
| <b>2</b> | <b>Protector Adhered to the Inside of the Frame</b> |

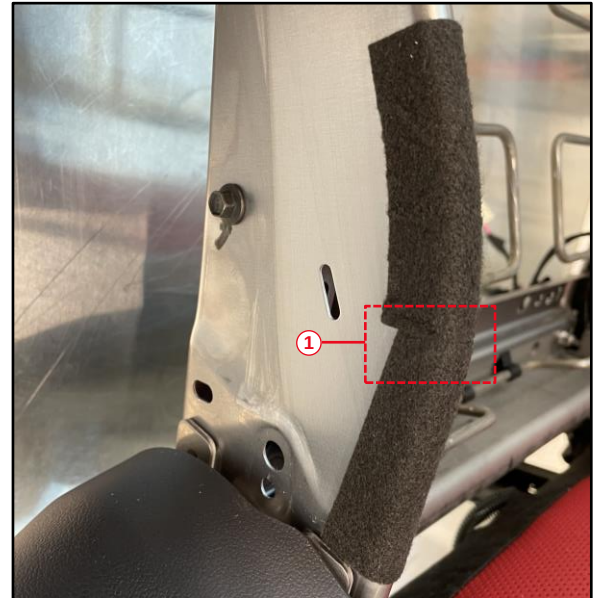
**Figure 5.**

No Gap or Overlap Between the Protectors

6. Apply the second back edge protector above the first and along the edge of the front seatback frame sub-assembly. There should be NO overlap or gap between the back edge protectors, as shown in Figure 5.

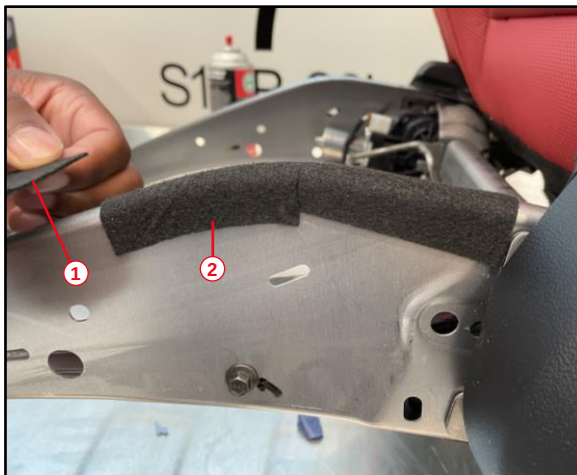
**Figure 6.**

Third Back Edge Protector

Second Back Edge Protector

7. Apply the third back edge protector above the second in the same manner as in step 6 while ensuring there is NO overlap or gap between the protectors, as shown in Figure 7.

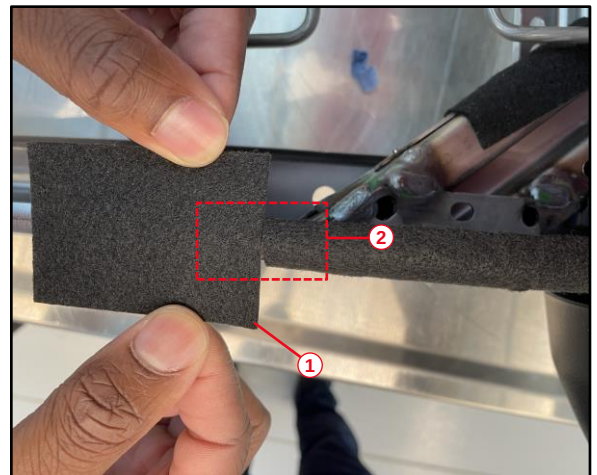
**Figure 7.**

Third Back Edge Protector

No Gap or Overlap Between the Protectors

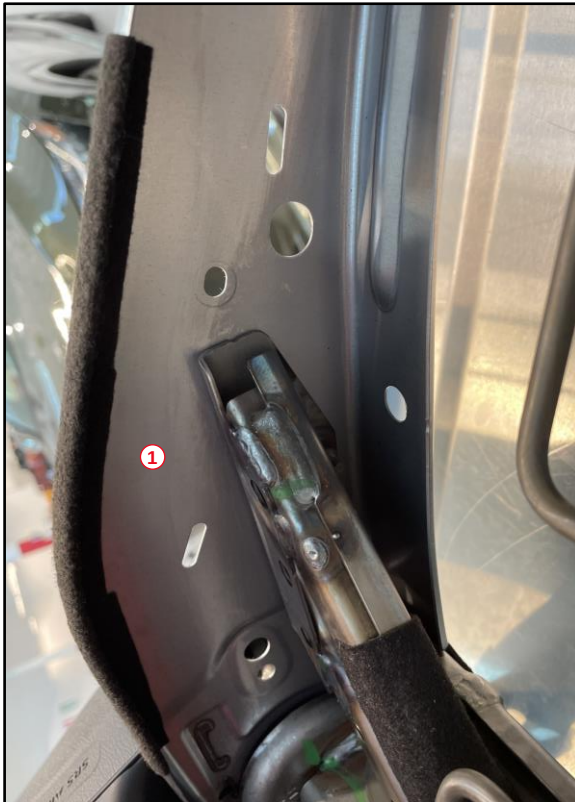
**Figure 8.**

| <b>1</b> | Inside of the Front Seatback Frame Sub-assembly |

8. Verify that all the back edge protectors are properly adhered to the frame with no gap or overlap between them, as shown in Figure 8 and 9.

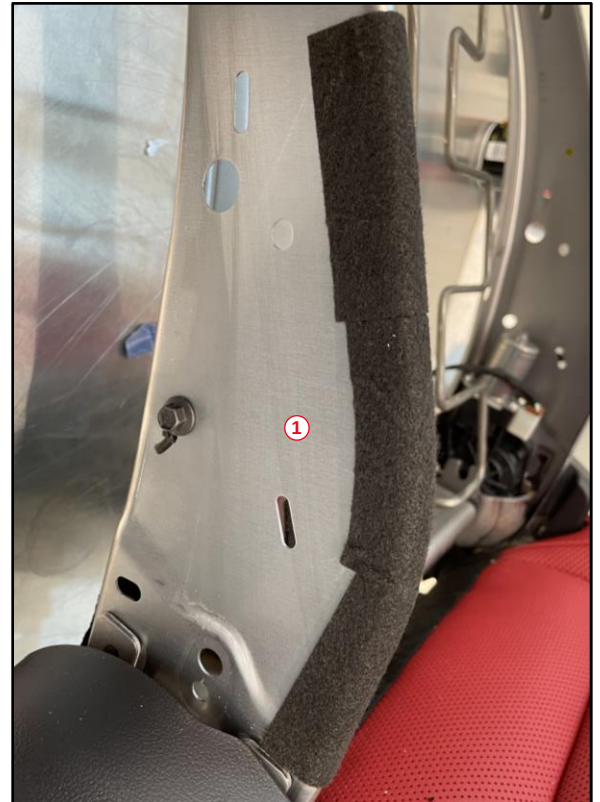
**Figure 9.**

| <b>1</b> | Outside of the Front Seatback Frame Sub-assembly |
