Topic	Rear armrest - Incorrect specification (SC24/31)
Market area	Germany E02 Bentley rest Europe (6E02),Japan E03 Bentley Japan (6E03),United States E05 Bentley USA and rest America (6E05)
Brand	Bentley
Transaction No.	2075974/1
Campaign number	ED24
Note	
Type	
US code

Bentayga Series

▼ **Repair instructions**

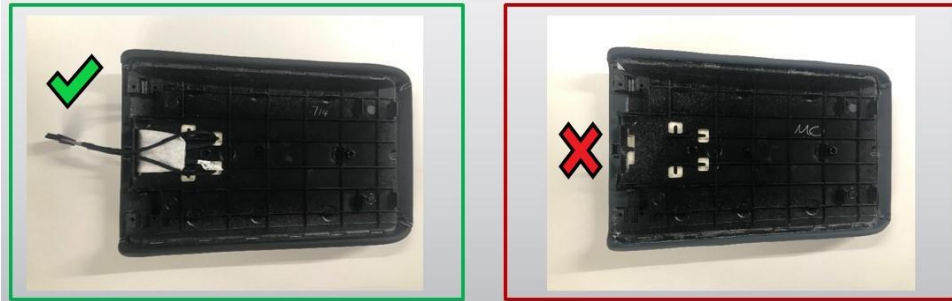
Figure 1

Incorrect rear armrest fitted during production, the correct part should include the heating pad (Figure 1)

The original rear armrest and lower armrest must be removed and replaced with the correct specification parts

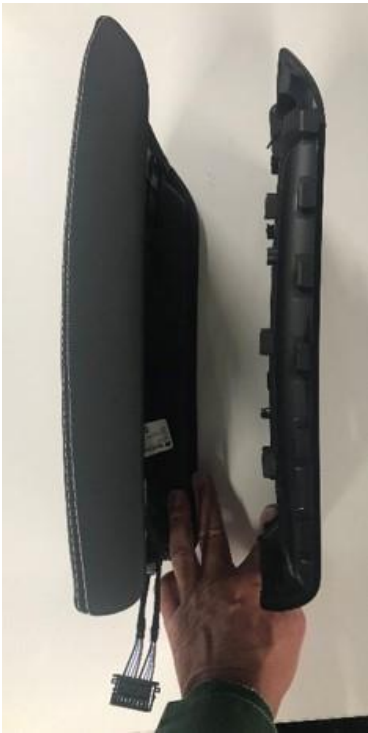
Figure 2

Armrest with heating pad and lower armrest (Figure 2) will be automatically distributed to each applicable retailer - Reference ED24 (SC24/31)

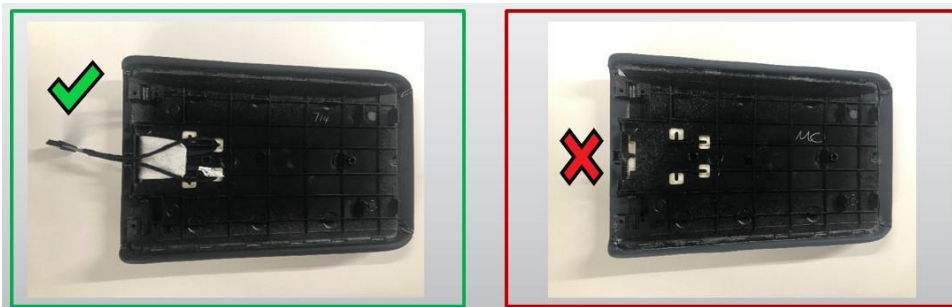
Figure 1

Incorrect rear armrest fitted during production, the correct part should include the heating pad (Figure 1)

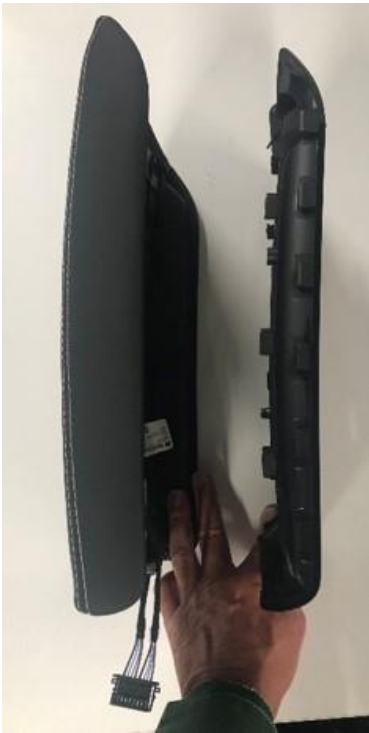
Figure 2

Armrest with heating pad and lower armrest (Figure 2) will be automatically distributed to each applicable retailer - Reference ED24 (SC24/31)

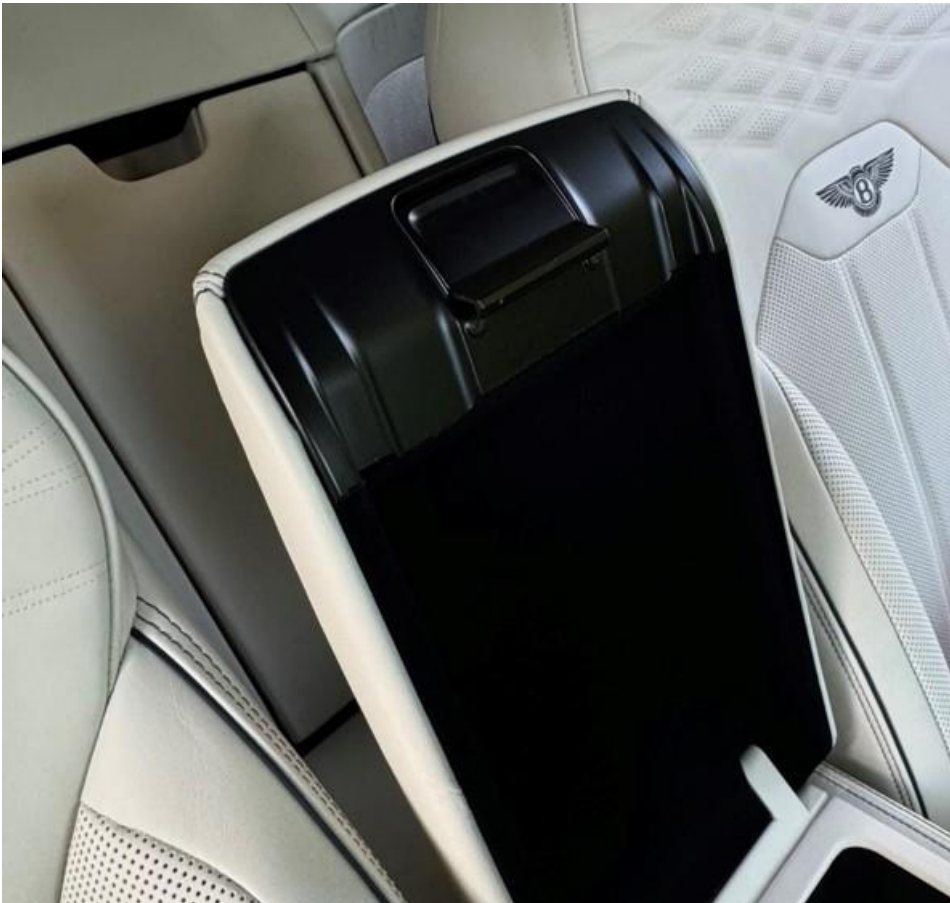
Figure 3

1) Open armrest (Figure 3)

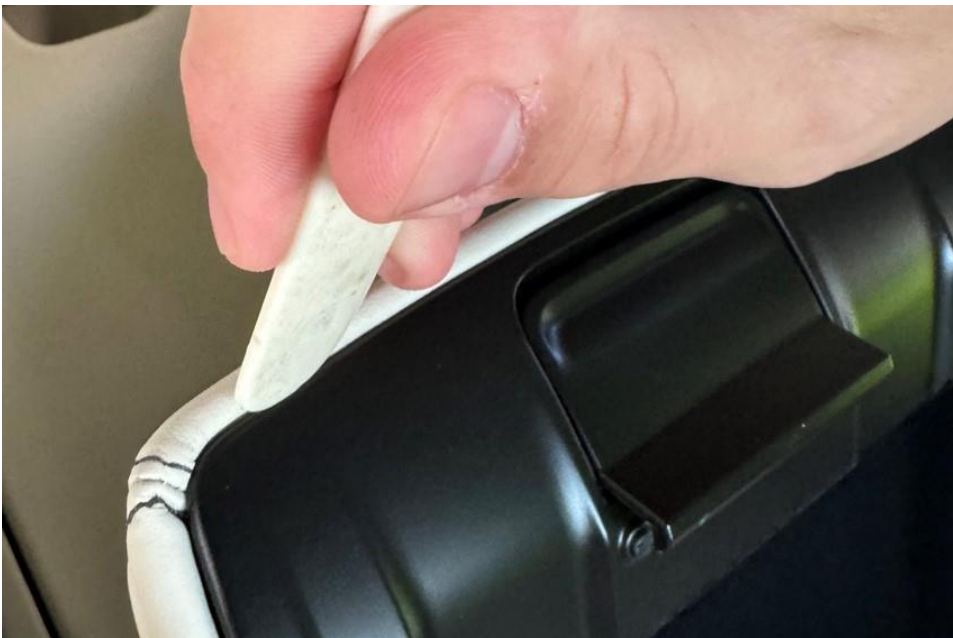
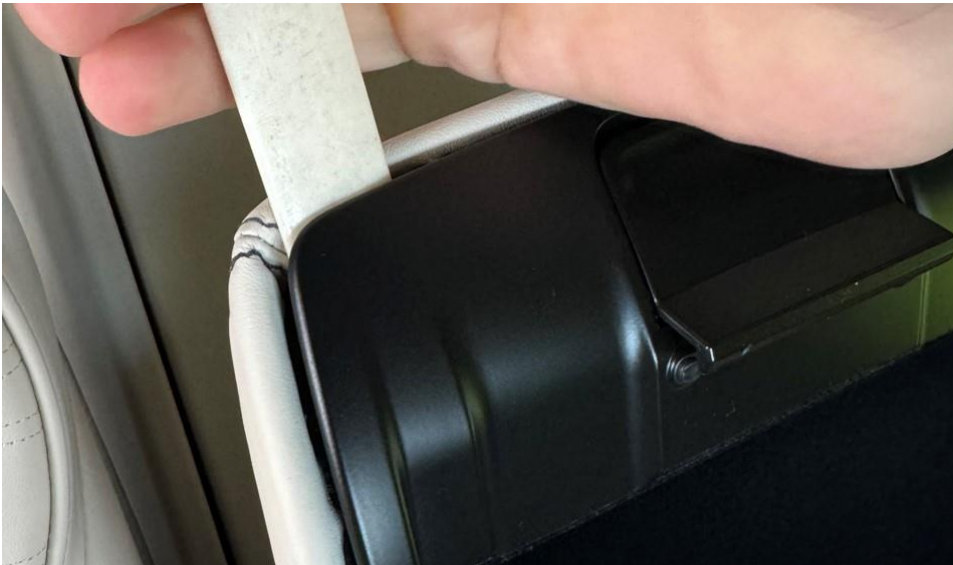
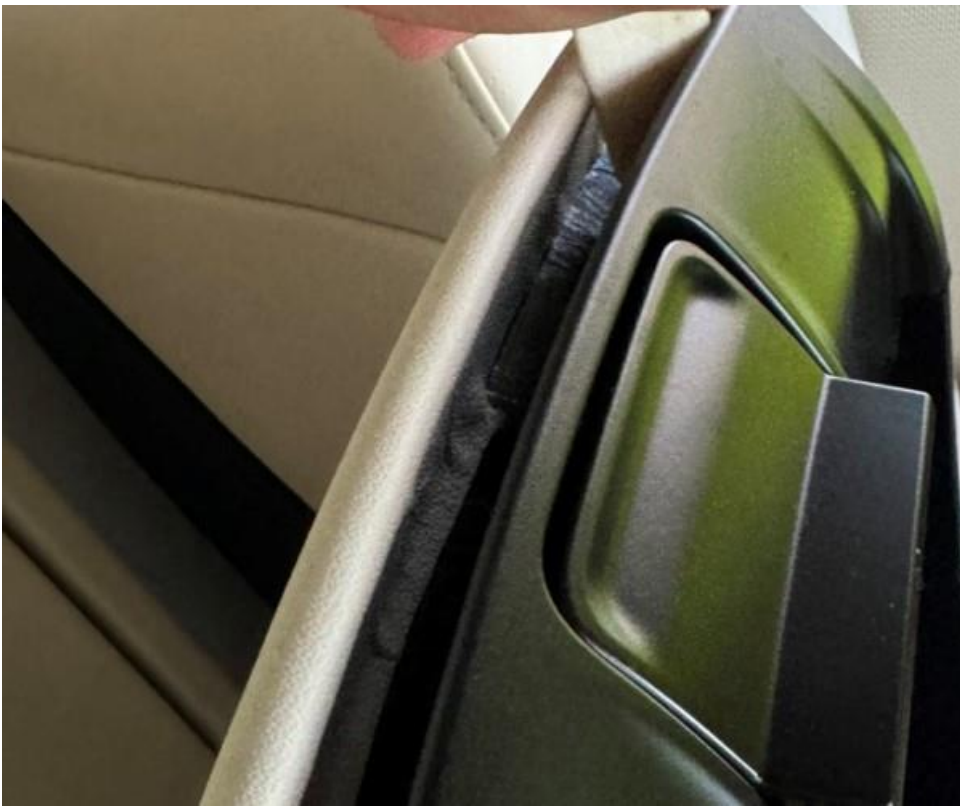
2) Using a suitable trim tool remove the lower armrest (Figures 4, 5 and 6)

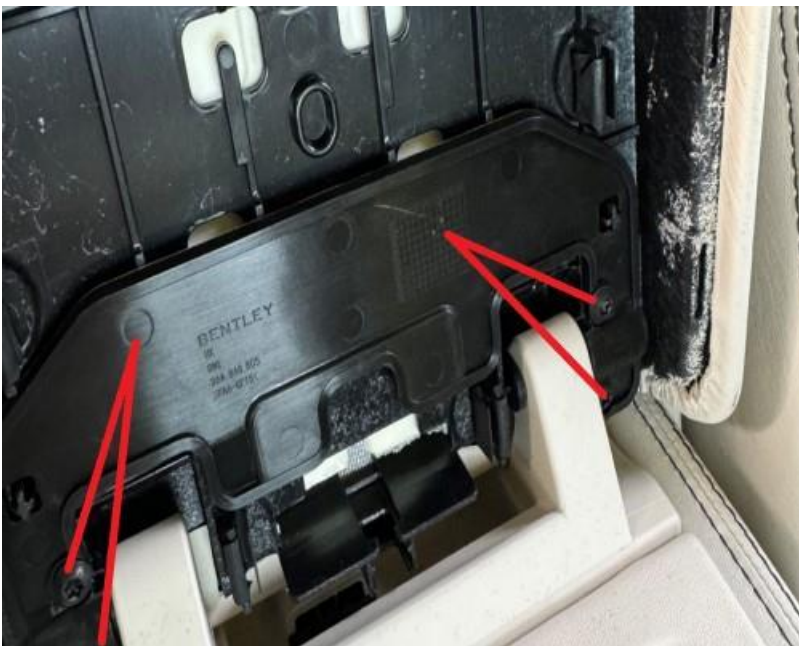
3) Remove x4 screws (Figure 7)

8) Refit the retaining plate - Secure all screws 2.7 Nm (x4) **Hint:** Refer back to Figure 7

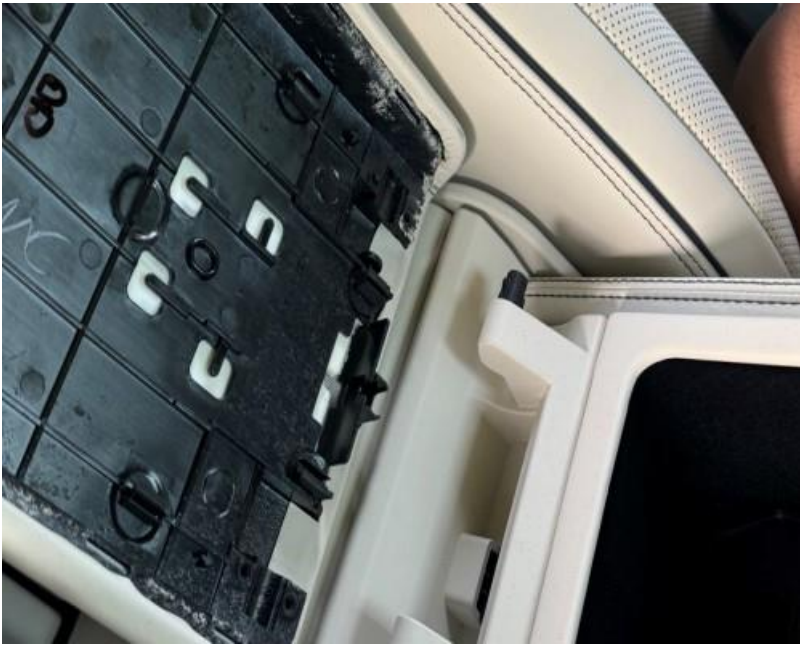
Figure 8

4) Remove the armrest (Figure 8)

The original armrest and lower armrest should be discarded ensuring all local environmental guidelines are followed

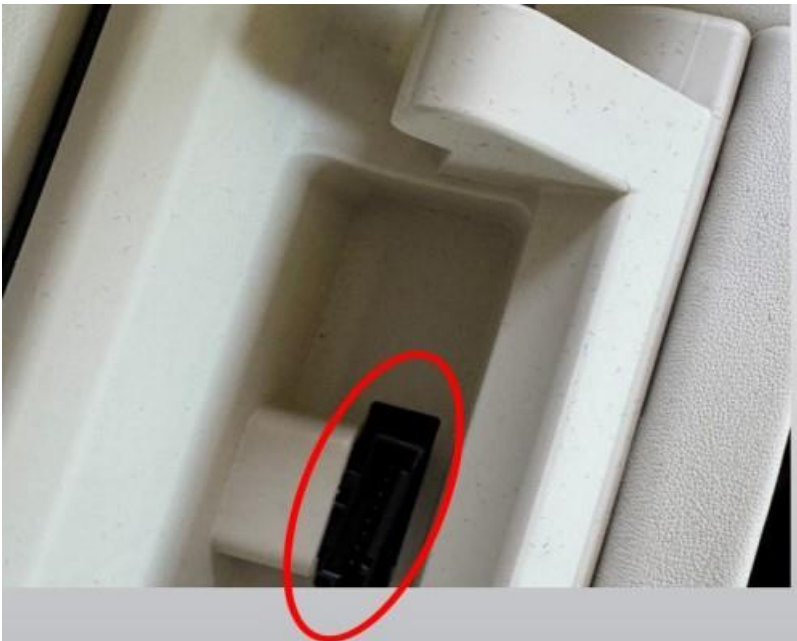
Figure 9

5) Locate the new armrest and locate the plug (Figure 9)

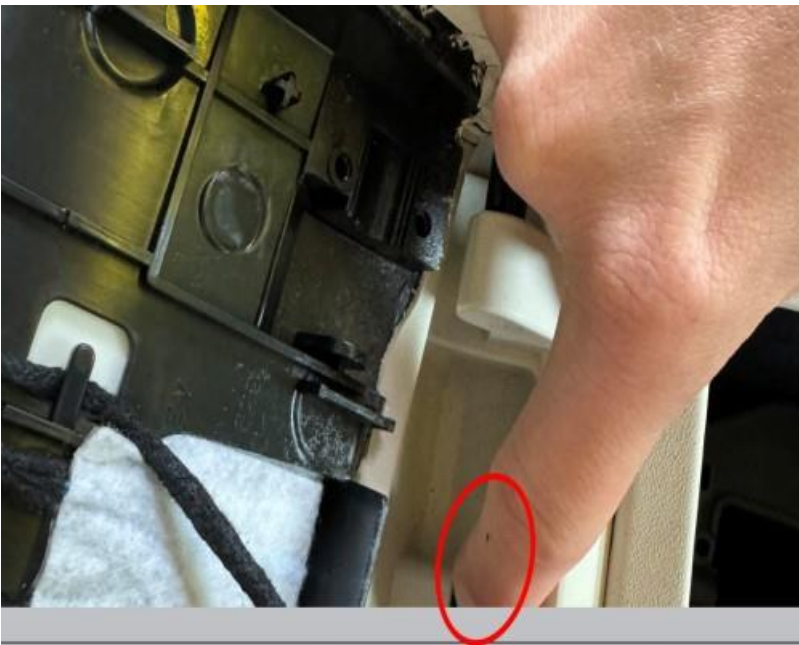
Figure 10

6) Connect the armrest connector into the plug (Figure 10)

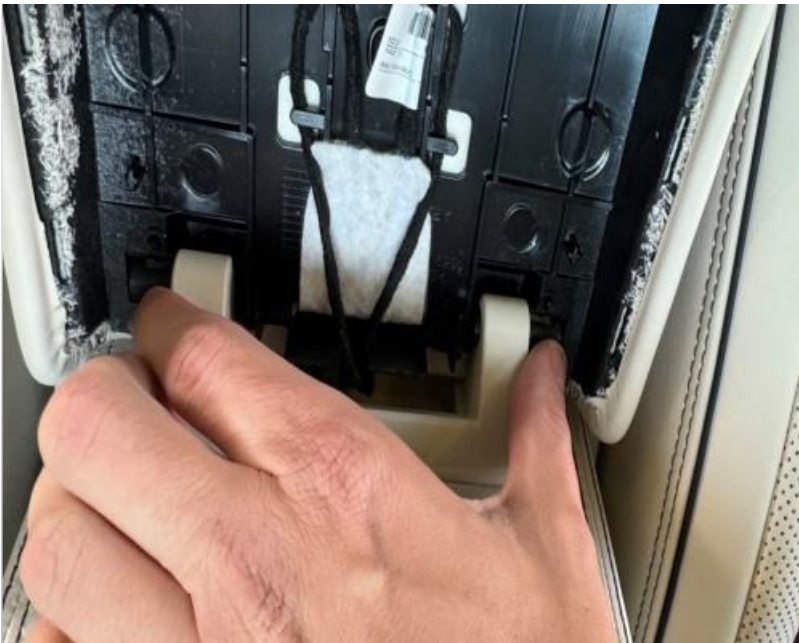
Figure 11

7) Clip / locate the armrest back into the points shown (Figure 11)
