## Volvo Car USA LLC

## Technical Journal

Technical Journal Title Door Stop noise		Ref. No. TJ 37085.1.0	
Issuer (Dept.) Technical Service		Issue Date 10/22/24	Status Date 10/31/24
Car Market United States and Canada	Partner 3 US 7510 Volvo Car USA	Function Group 8315	
Function Description Door stop		Page Page 1 of 3

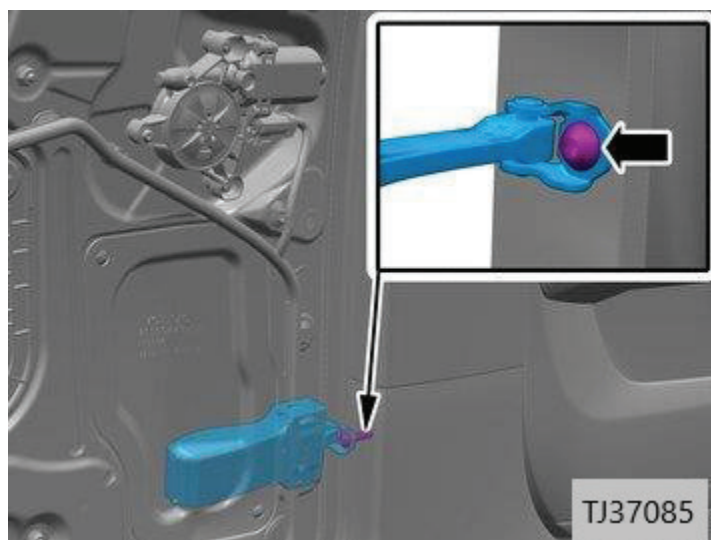
File Name	File Size
TJ 37085.jpg	0.0194 MB

If customer complains of noise when opening/closing the door or if the door stop is loose, please follow advice under "Service".

1. Use a torque wrench, set at 30Nm
2. Open the door
3. Tighten the screw according to the picture
