LIGHTS FLICKERING REPAIR

Bulletin Type:	SRP	Publication Date:	December 2024
Bulletin #(s):	24-020	Make(s):	Highland, Starcraft
Job Code(s):	<i>If affected unit has warranty remaining, submit your claim following the normal process</i>	Model(s):	Range Lite TT, Mesa Ridge S-Lite TT, Silverstar S-Lite, Range Lite Air TT, Olympia Lite TT, Super Lite Maxx TT, Super Lite TT
Flat Rate(s):			Model Year(s):

Incident:	Lights Are Flickering When The Water Pump Comes On During Camping
Affected Units:	2022-2025 Highland Range Lite TT, Mesa Ridge S-Lite TT, Silverstar S-Lite, Range Lite Air TT, Olympia Lite TT; certain 2022-2025 Starcraft Super Lite Maxx TT, Super Lite TT
Parts List:	1 - HOLDER,FUSE 5AMP IN-LINE (Jayco Part #0170414) 1 – CONNECTOR,SPLICE 3 WIRE CLR PLSTC WAGO 12-24GA MFR# 221-413 (Jayco Part # 0288118) 1 – CONNECTOR,SPLICE 5 WIRE CLR PLSTC WAGO 10-20GA MFR# 221-615 (Jayco Part #0348607) 1 – FUSE,15AMP ATC/ATO-15 SPADE (Jayco Part #0038536)
Misc. Tools & Supplies:	Wire Strippers Screw gun with square head bit

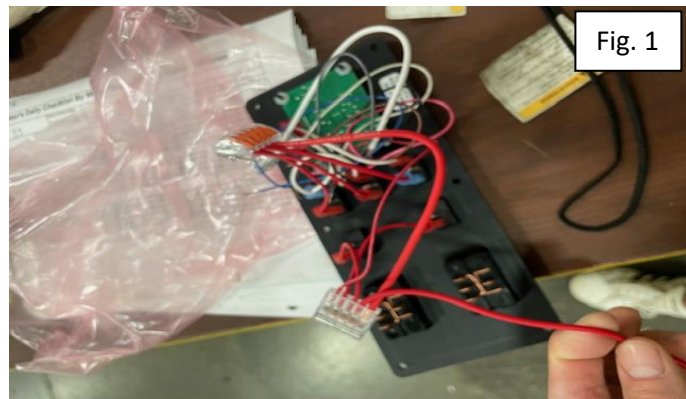
- Figure 1 shows the incorrect configuration that it is now.
