HYUNDAI
Technical Service Bulletin

GROUP BODY	NUMBER 24-BD-009H
DATE DECEMBER 2024	MODEL(S) IONIQ 5 (NE1)

SUBJECT: SPOILER MOLDING REPLACEMENT

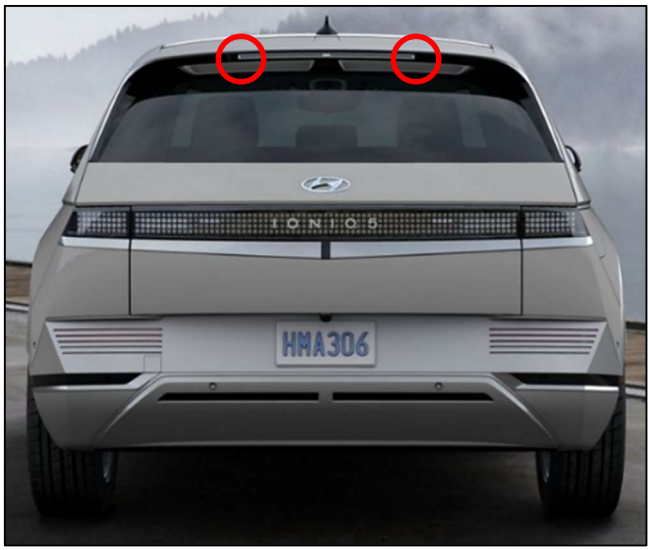
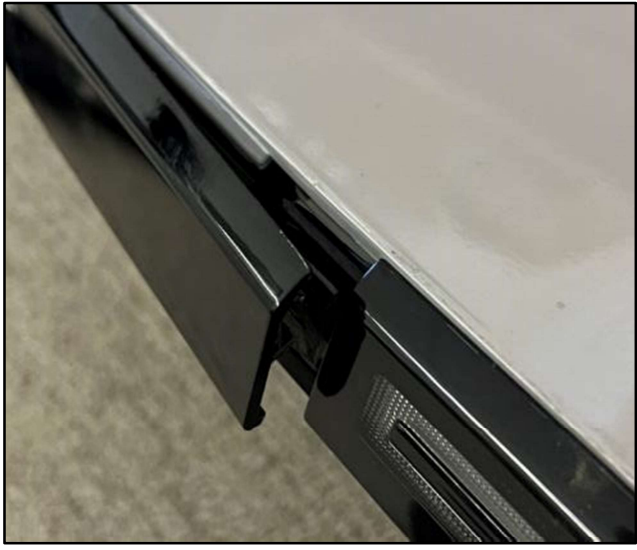
Description: Certain IONIQ 5 (NE1) vehicles may exhibit lifting/separation on the spoiler molding(s) by the Center High Mount Stop Lamp (CHMSL). This bulletin provides instructions to replace the molding(s) on the spoiler.
