# Service Bulletin

Bulletin No.: 22-NA-168

**Subject: Diagnostic Tip for Checking Exhaust System for Leaks for the LM2 Engines, Malfunction Indicator Lamp (MIL) Illuminated - DTC P11D5, P14D9, P20EE, P2C7A, P0421 and/or P0402 Set**

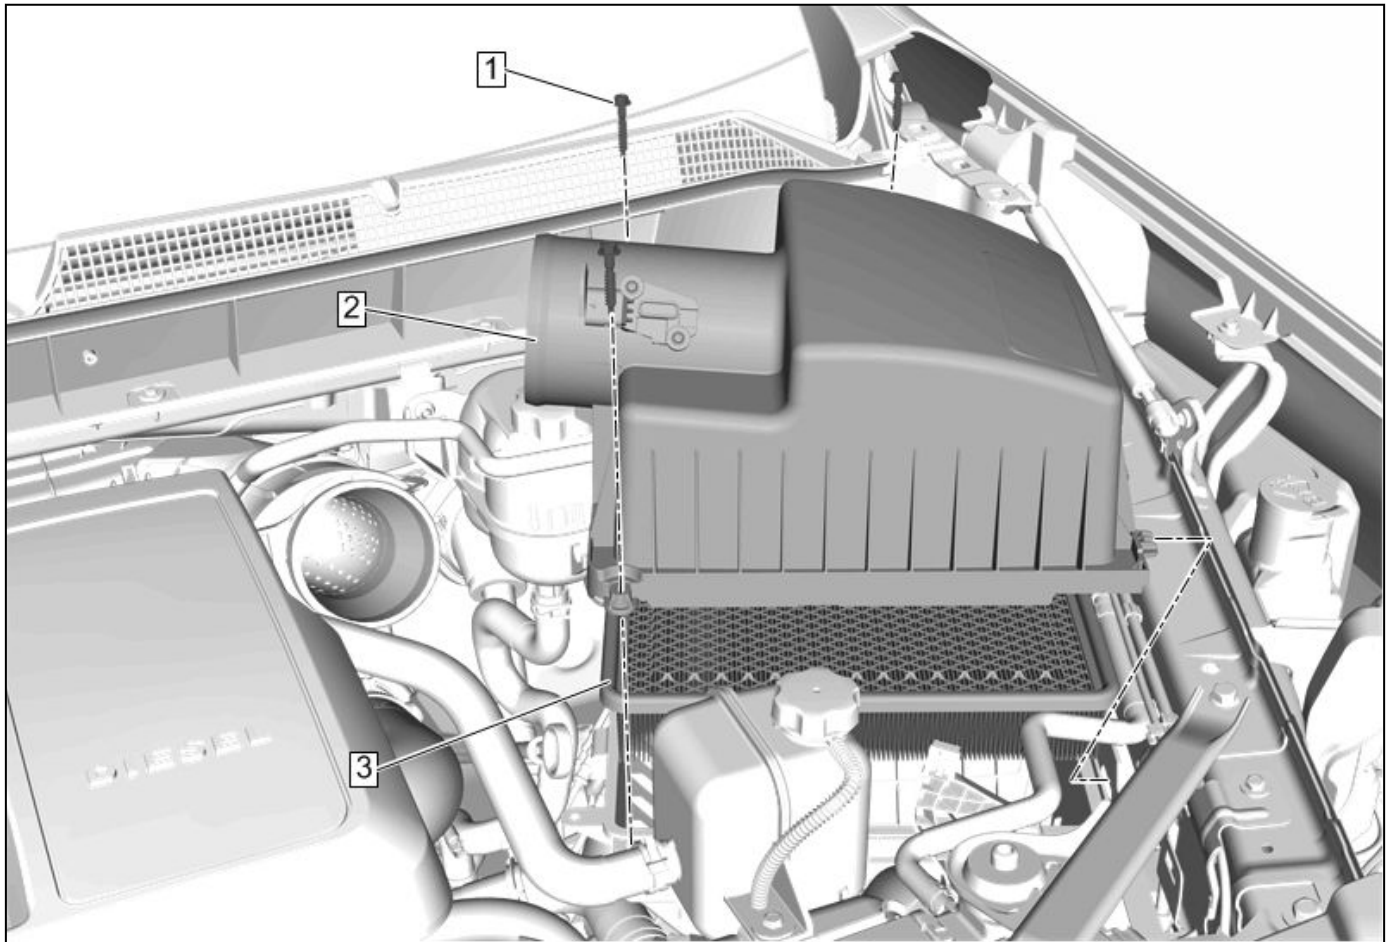
1. Remove the air filter (3) from the air filter housing. Refer to *Air Cleaner Element Replacement* in SI.

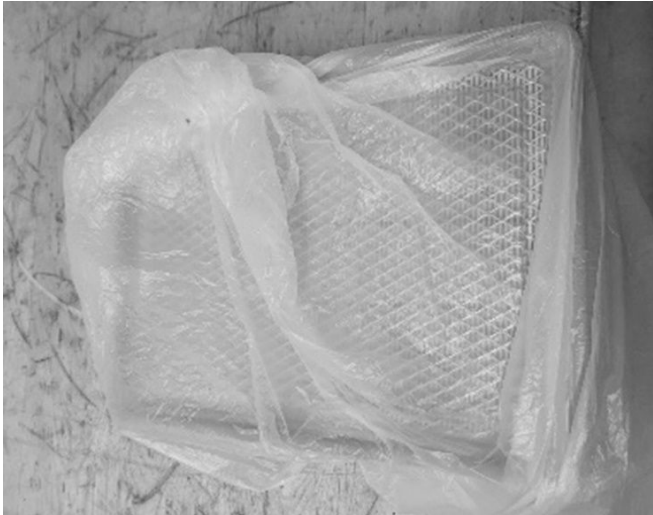
6140930

2. Put the air filter in a plastic bag.
3. Re-install the air filter into the air filter housing.
4. Raise the vehicle.

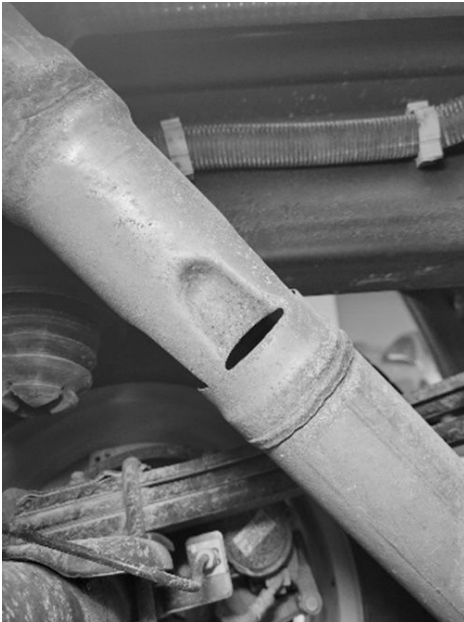
6140932

5. Locate the cooling ports in the exhaust system.

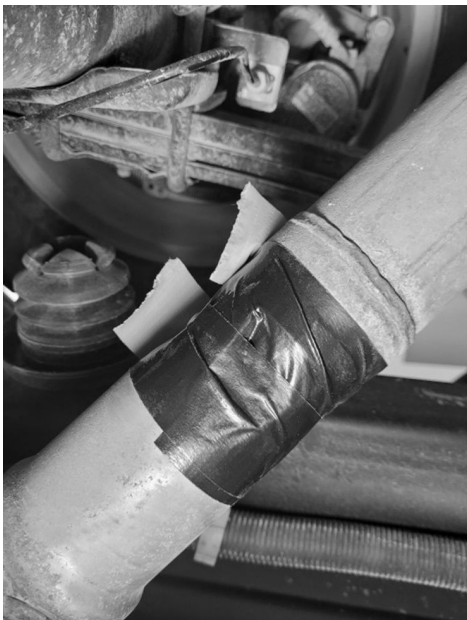
6140943

**Note:** The graphic depicts a single exhaust system. If equipped with a dual exhaust, both cooling holes will need to be taped off and one of the tail pipes sealed with a rag or equivalent.

6. Tape the holes utilizing duct tape or equivalent.

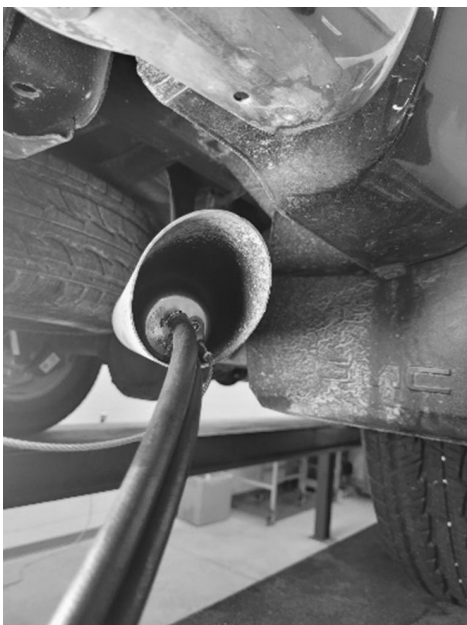
6140928

7. Install the inflatable adapter (second largest adapter for our application) for the GE-52250 machine and insert it into the tailpipe.
8. Attach the GE-52250 to the adapter and shop air supply.
9. Command the vapor test, and adjust the test pressure to 34–55 kPa (5-8 psi).

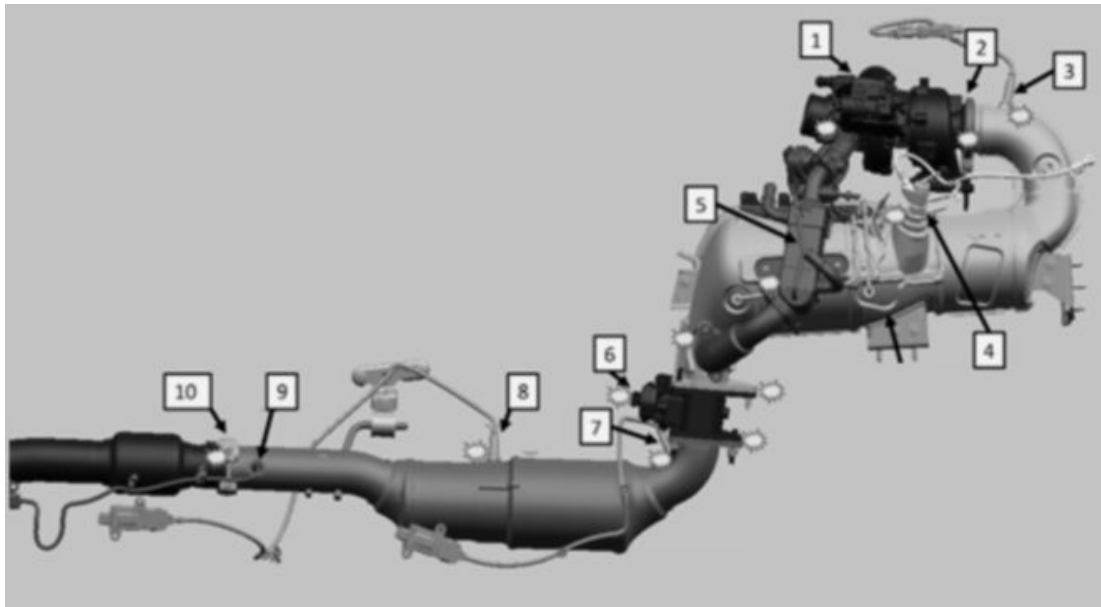
6141008

LM2 After Treatment Exhaust System	
<b>Note:</b> The areas that have been marked on the graphic require inspection for leaks.	
Exhaust Leak Areas of Concern	
1	Turbocharger
2	V-Band Clamp
3	NOx Sensor
4	Def Injector
5	LP EGR Cooler
6	EXH. Throttle/Back Pressure Valve
7	NOx 2 Sensor
8	NOx 3 Sensor
9	Particulate Matter Sensor
10	Norma Band Clamp

10. Using a soapy water mixture, spray all connections, welds, and sensors with the soapy water mixture, and look for air leaks (See Examples of Exhaust Leak Areas of Concern section below).
11. Once all the leaks are detected and corrected, verify that the exhaust is sealed by retesting with the GE-52250.

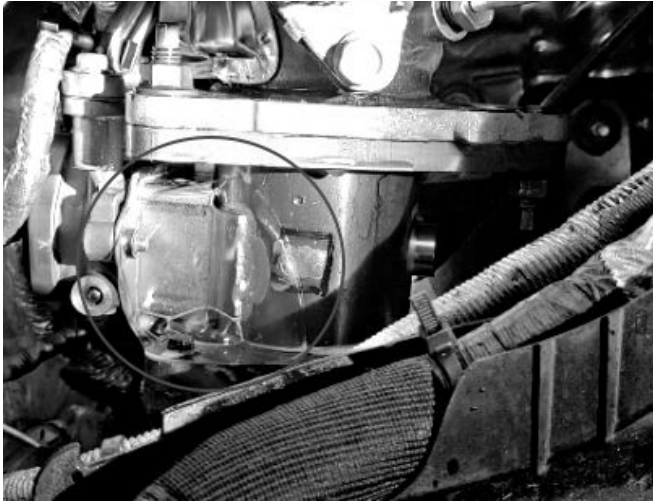
6289019

Normal backpressure valve shaft seal leakage.

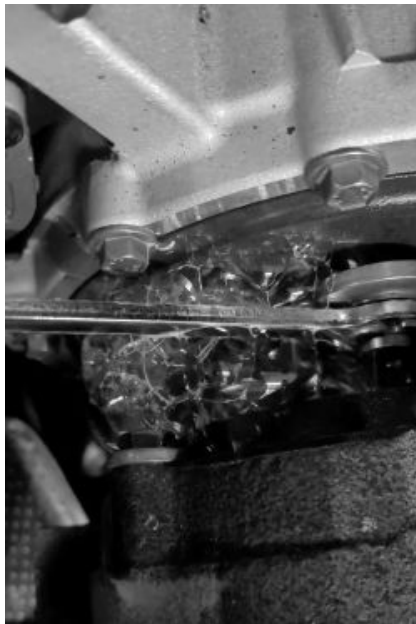
6288860

**Note:** A leak at the turbocharger vane actuator shaft is considered a normal condition. Any smoke or bubbles from this area should be ignored.

Normal turbocharger VGT shaft seal leakage.
